# Our Work in the Ghost Watershed in 2025

Presented by:  
Marina Krainer  
Executive Director

GWAS AGM  
November 8, 2025

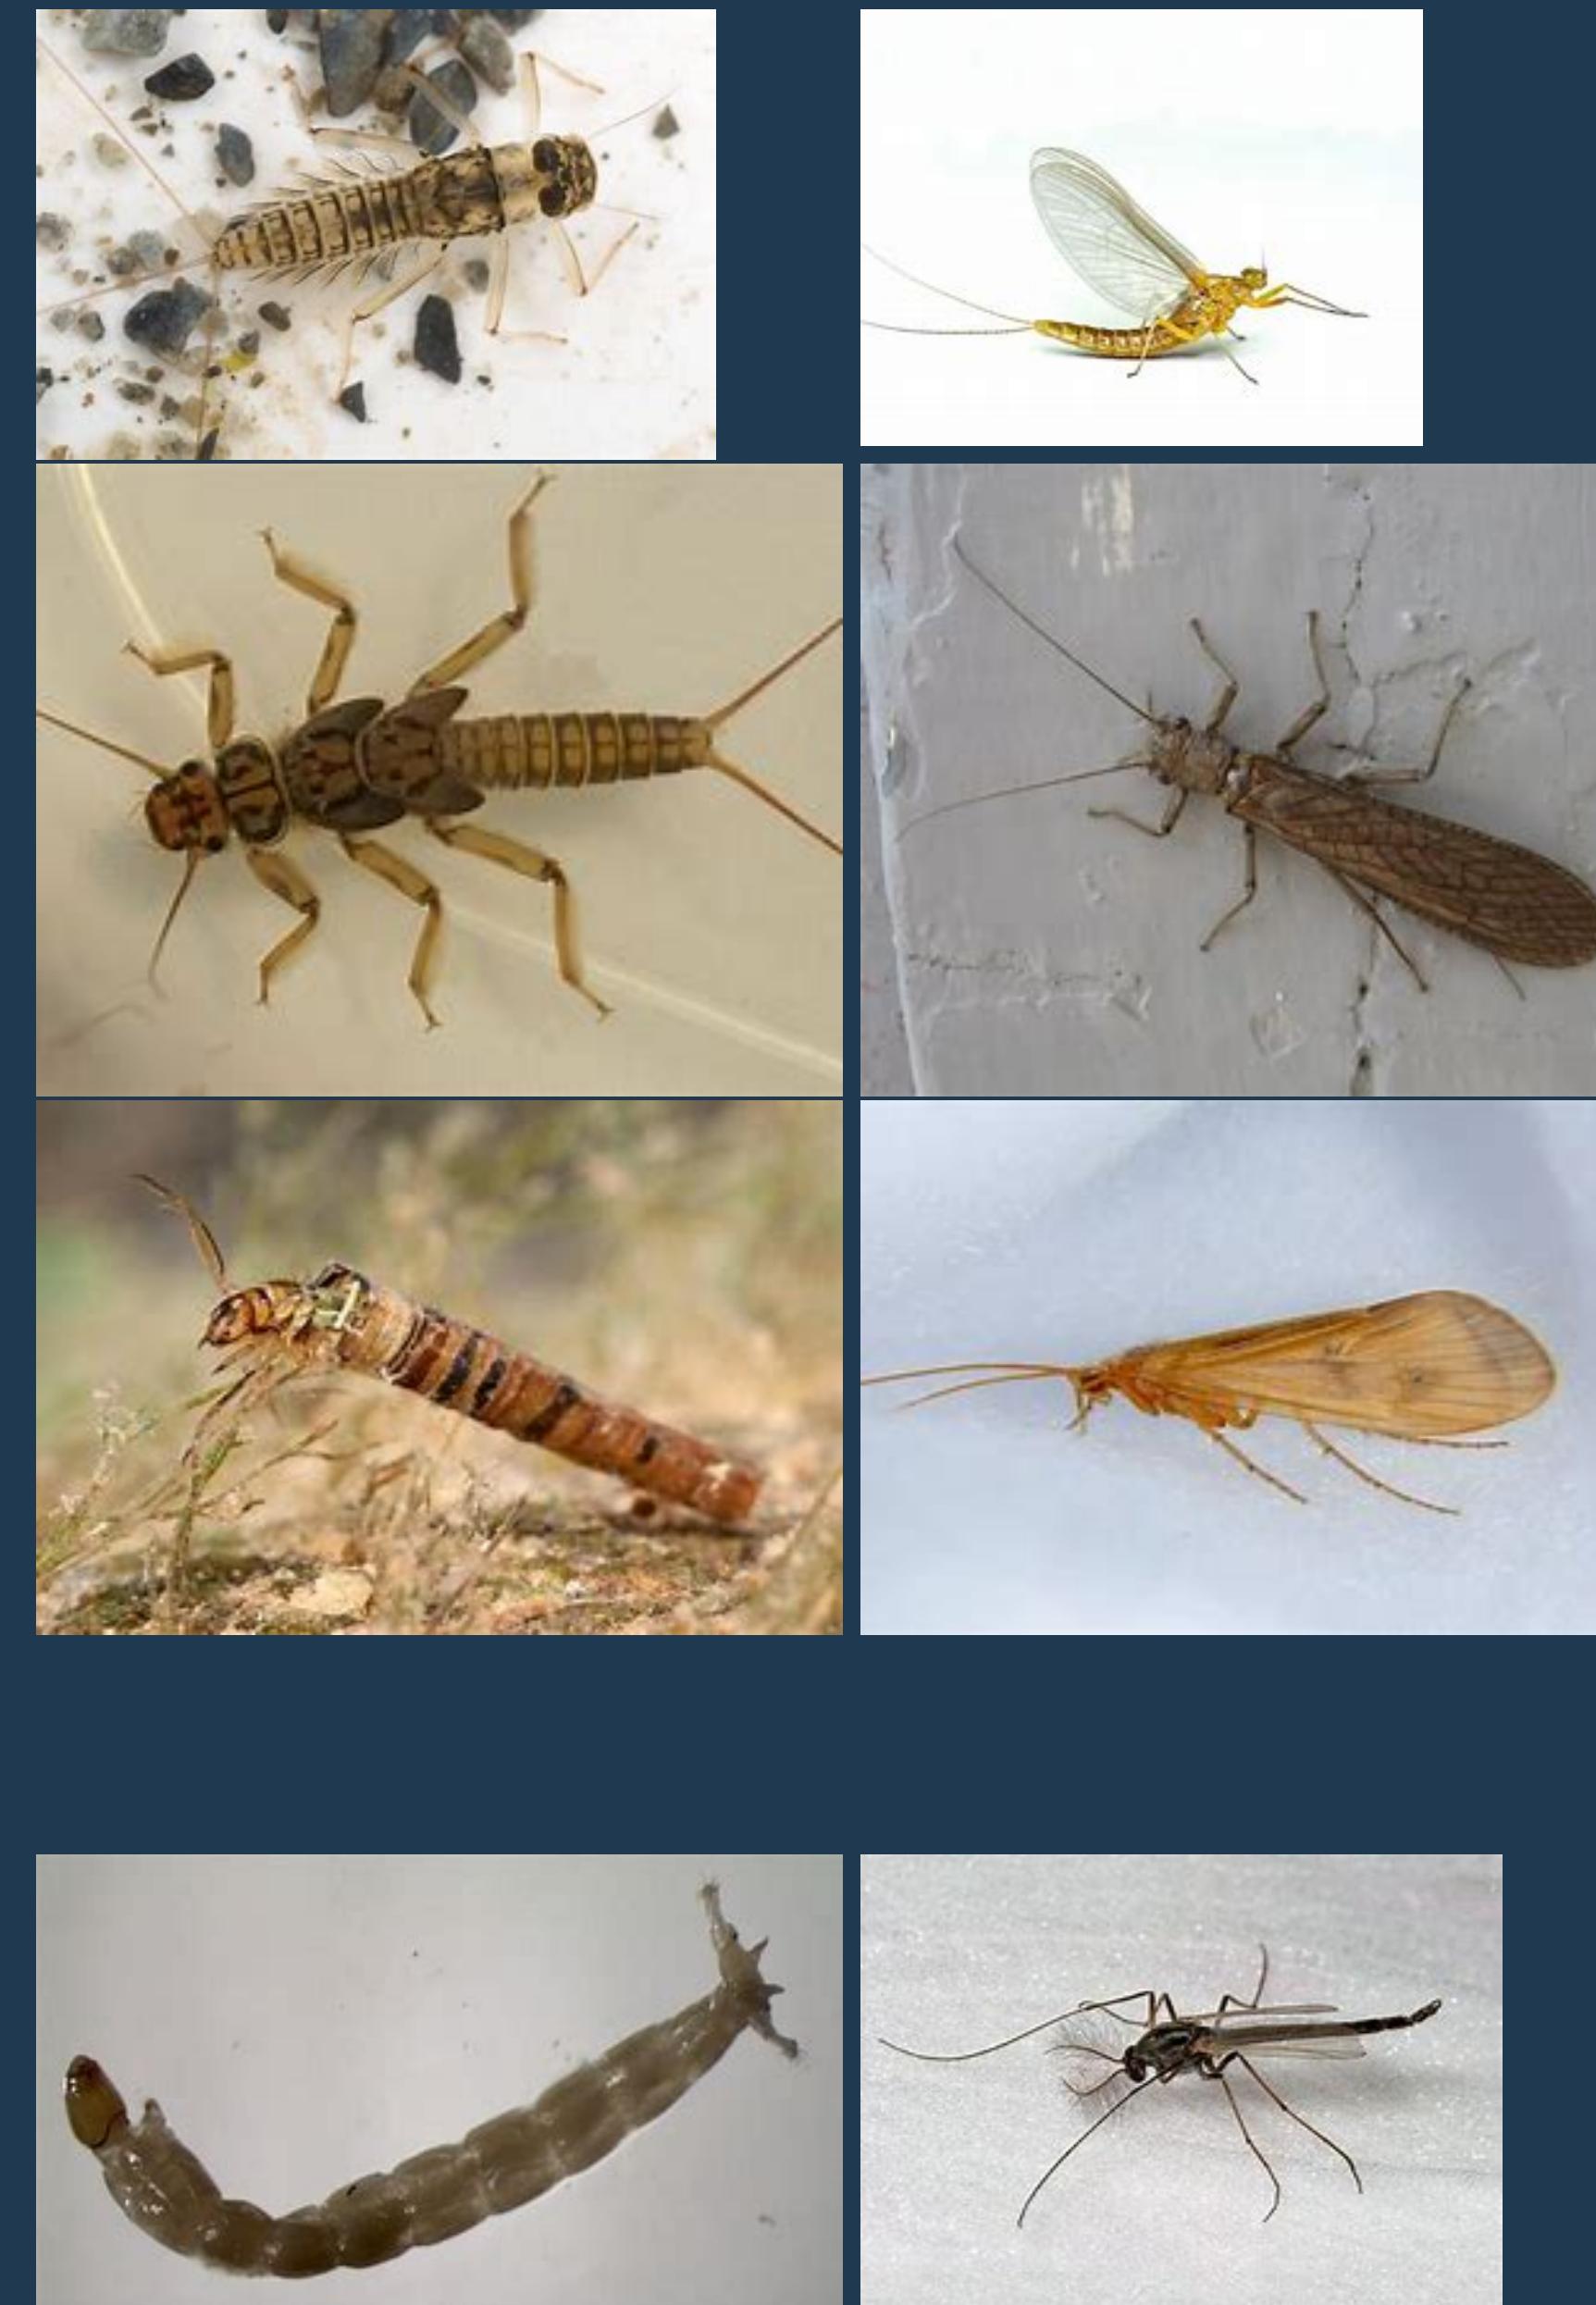
Ratio of pollution sensitive vs. pollution tolerant species is an indicator for watershed health.

Mayflies (E)

Stoneflies (P)

Caddisflies (T)

Flies and Midges (C)

Sensitive

Tolerant

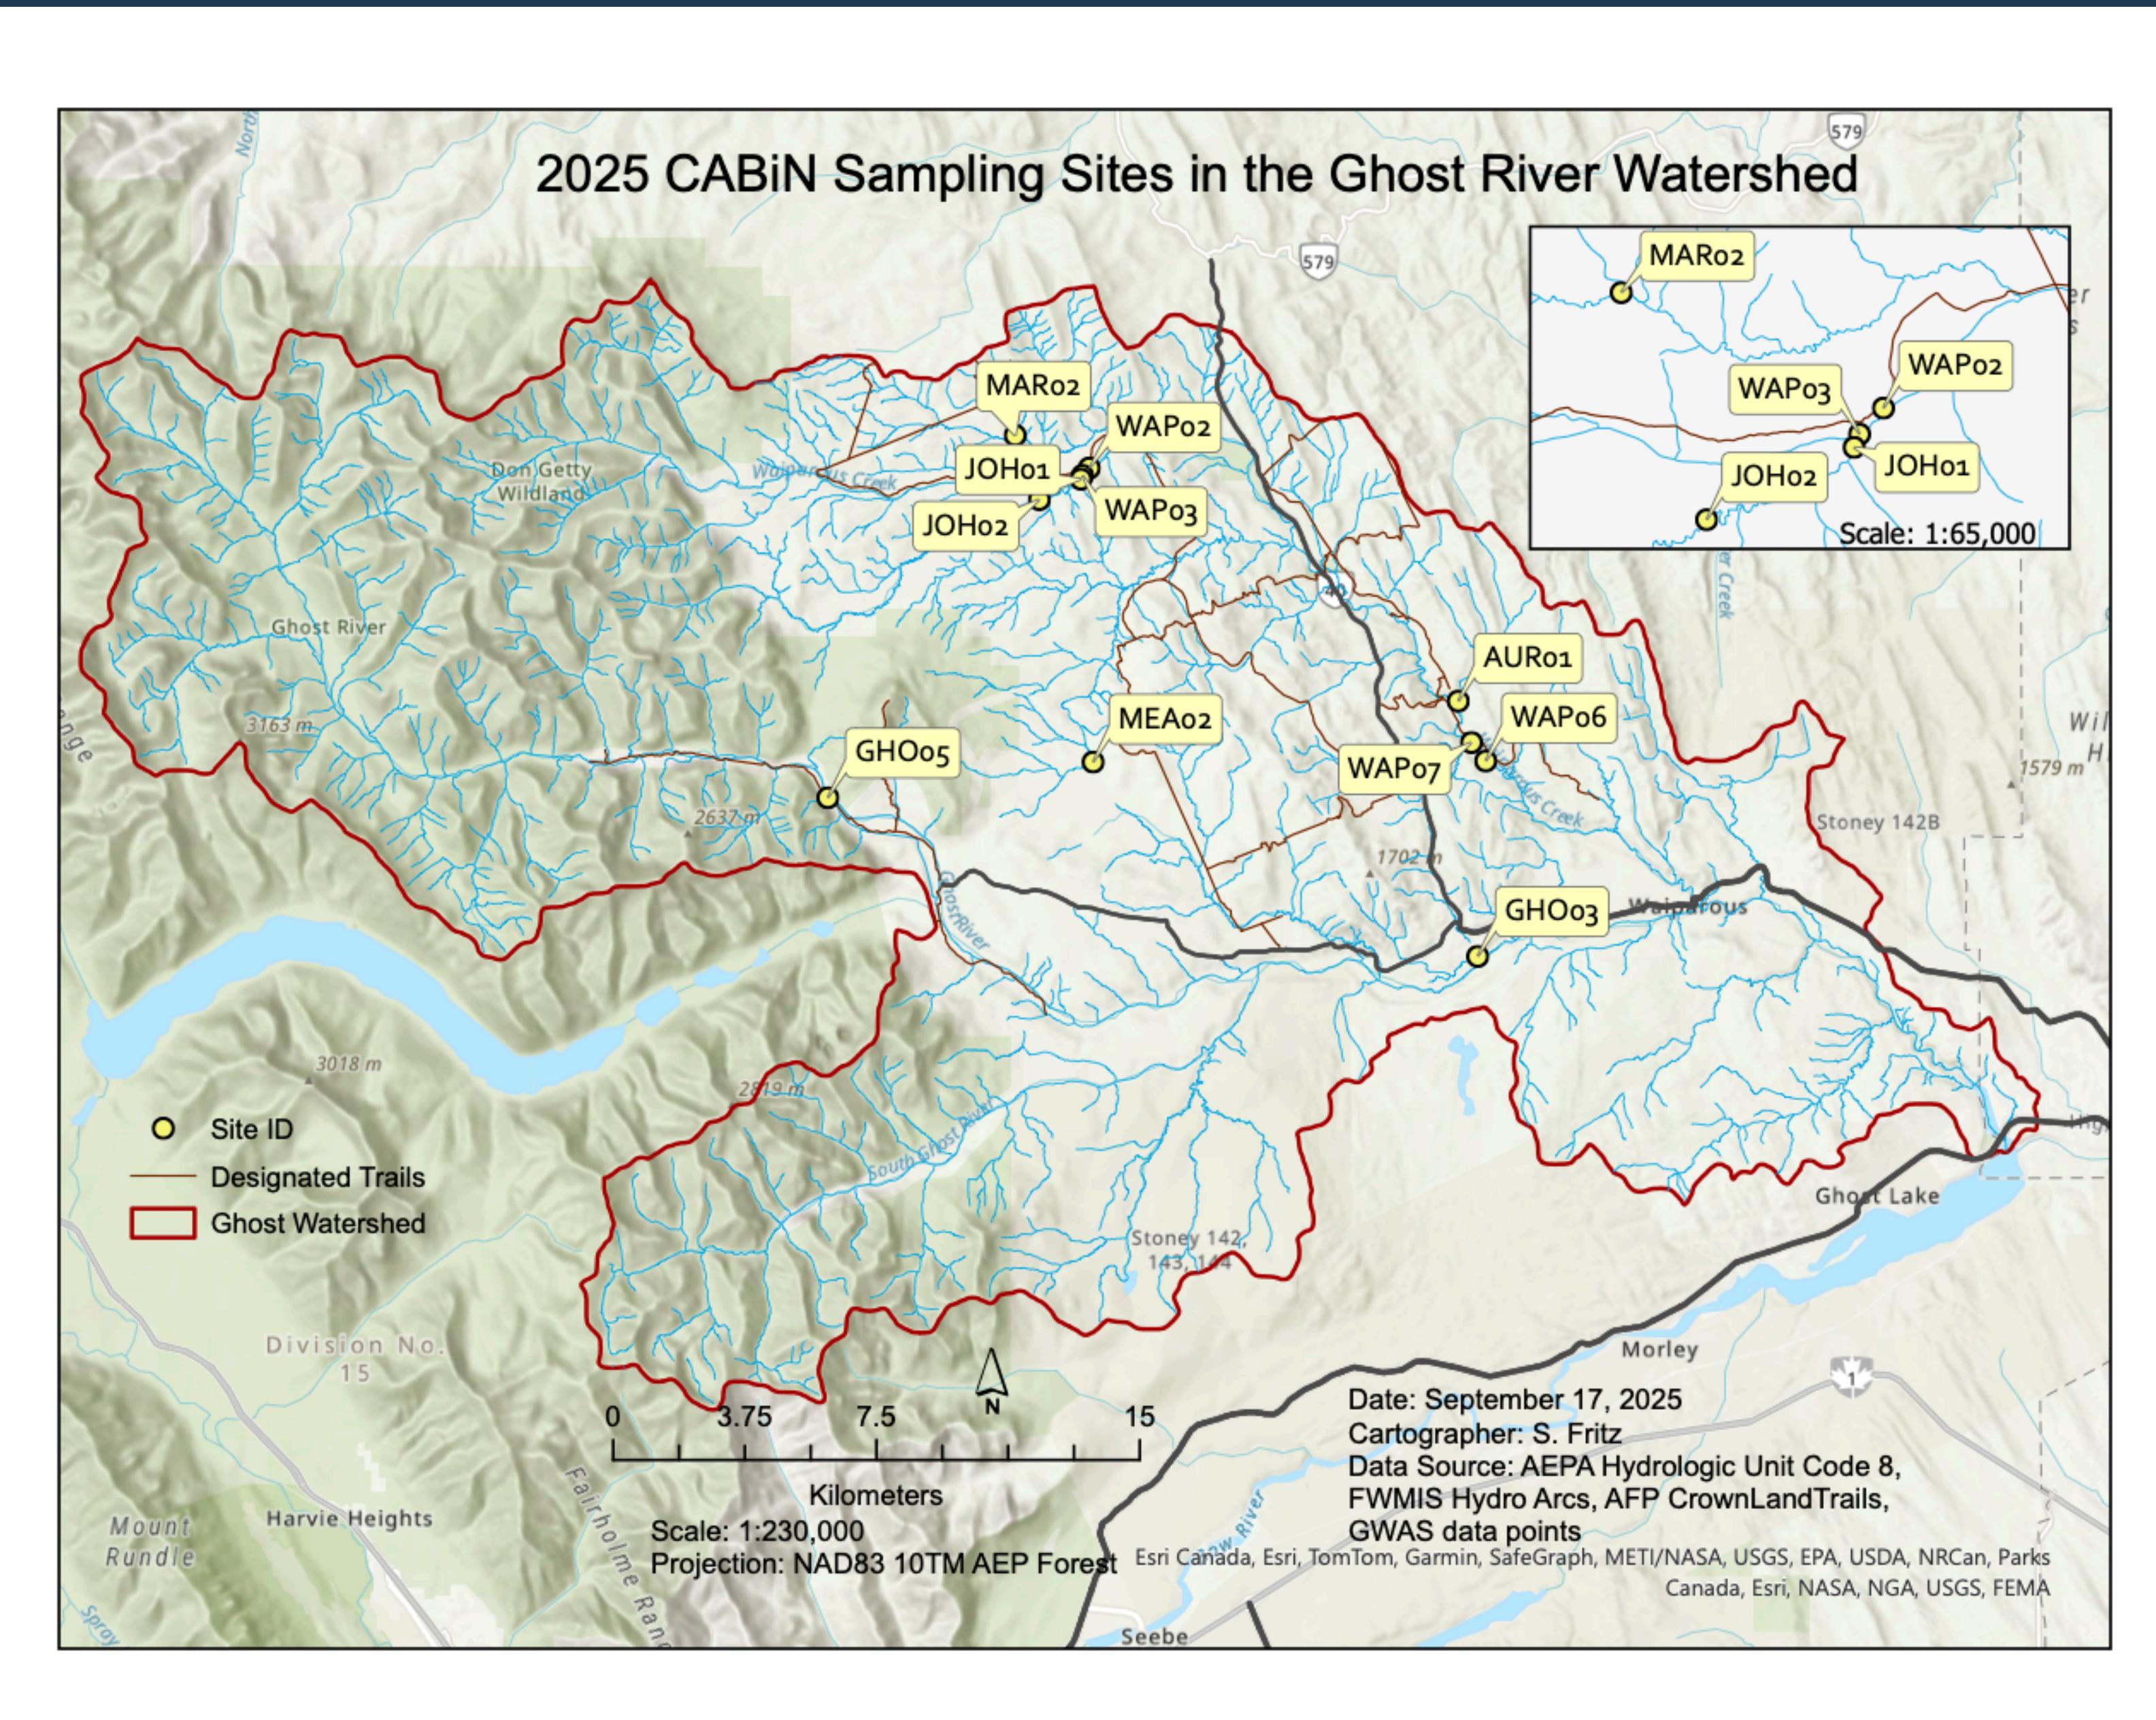
- ◆ 11 sites sampled this year!
- ◆ 54 samples collected since 2020
- ◆ 31 unique sites to date

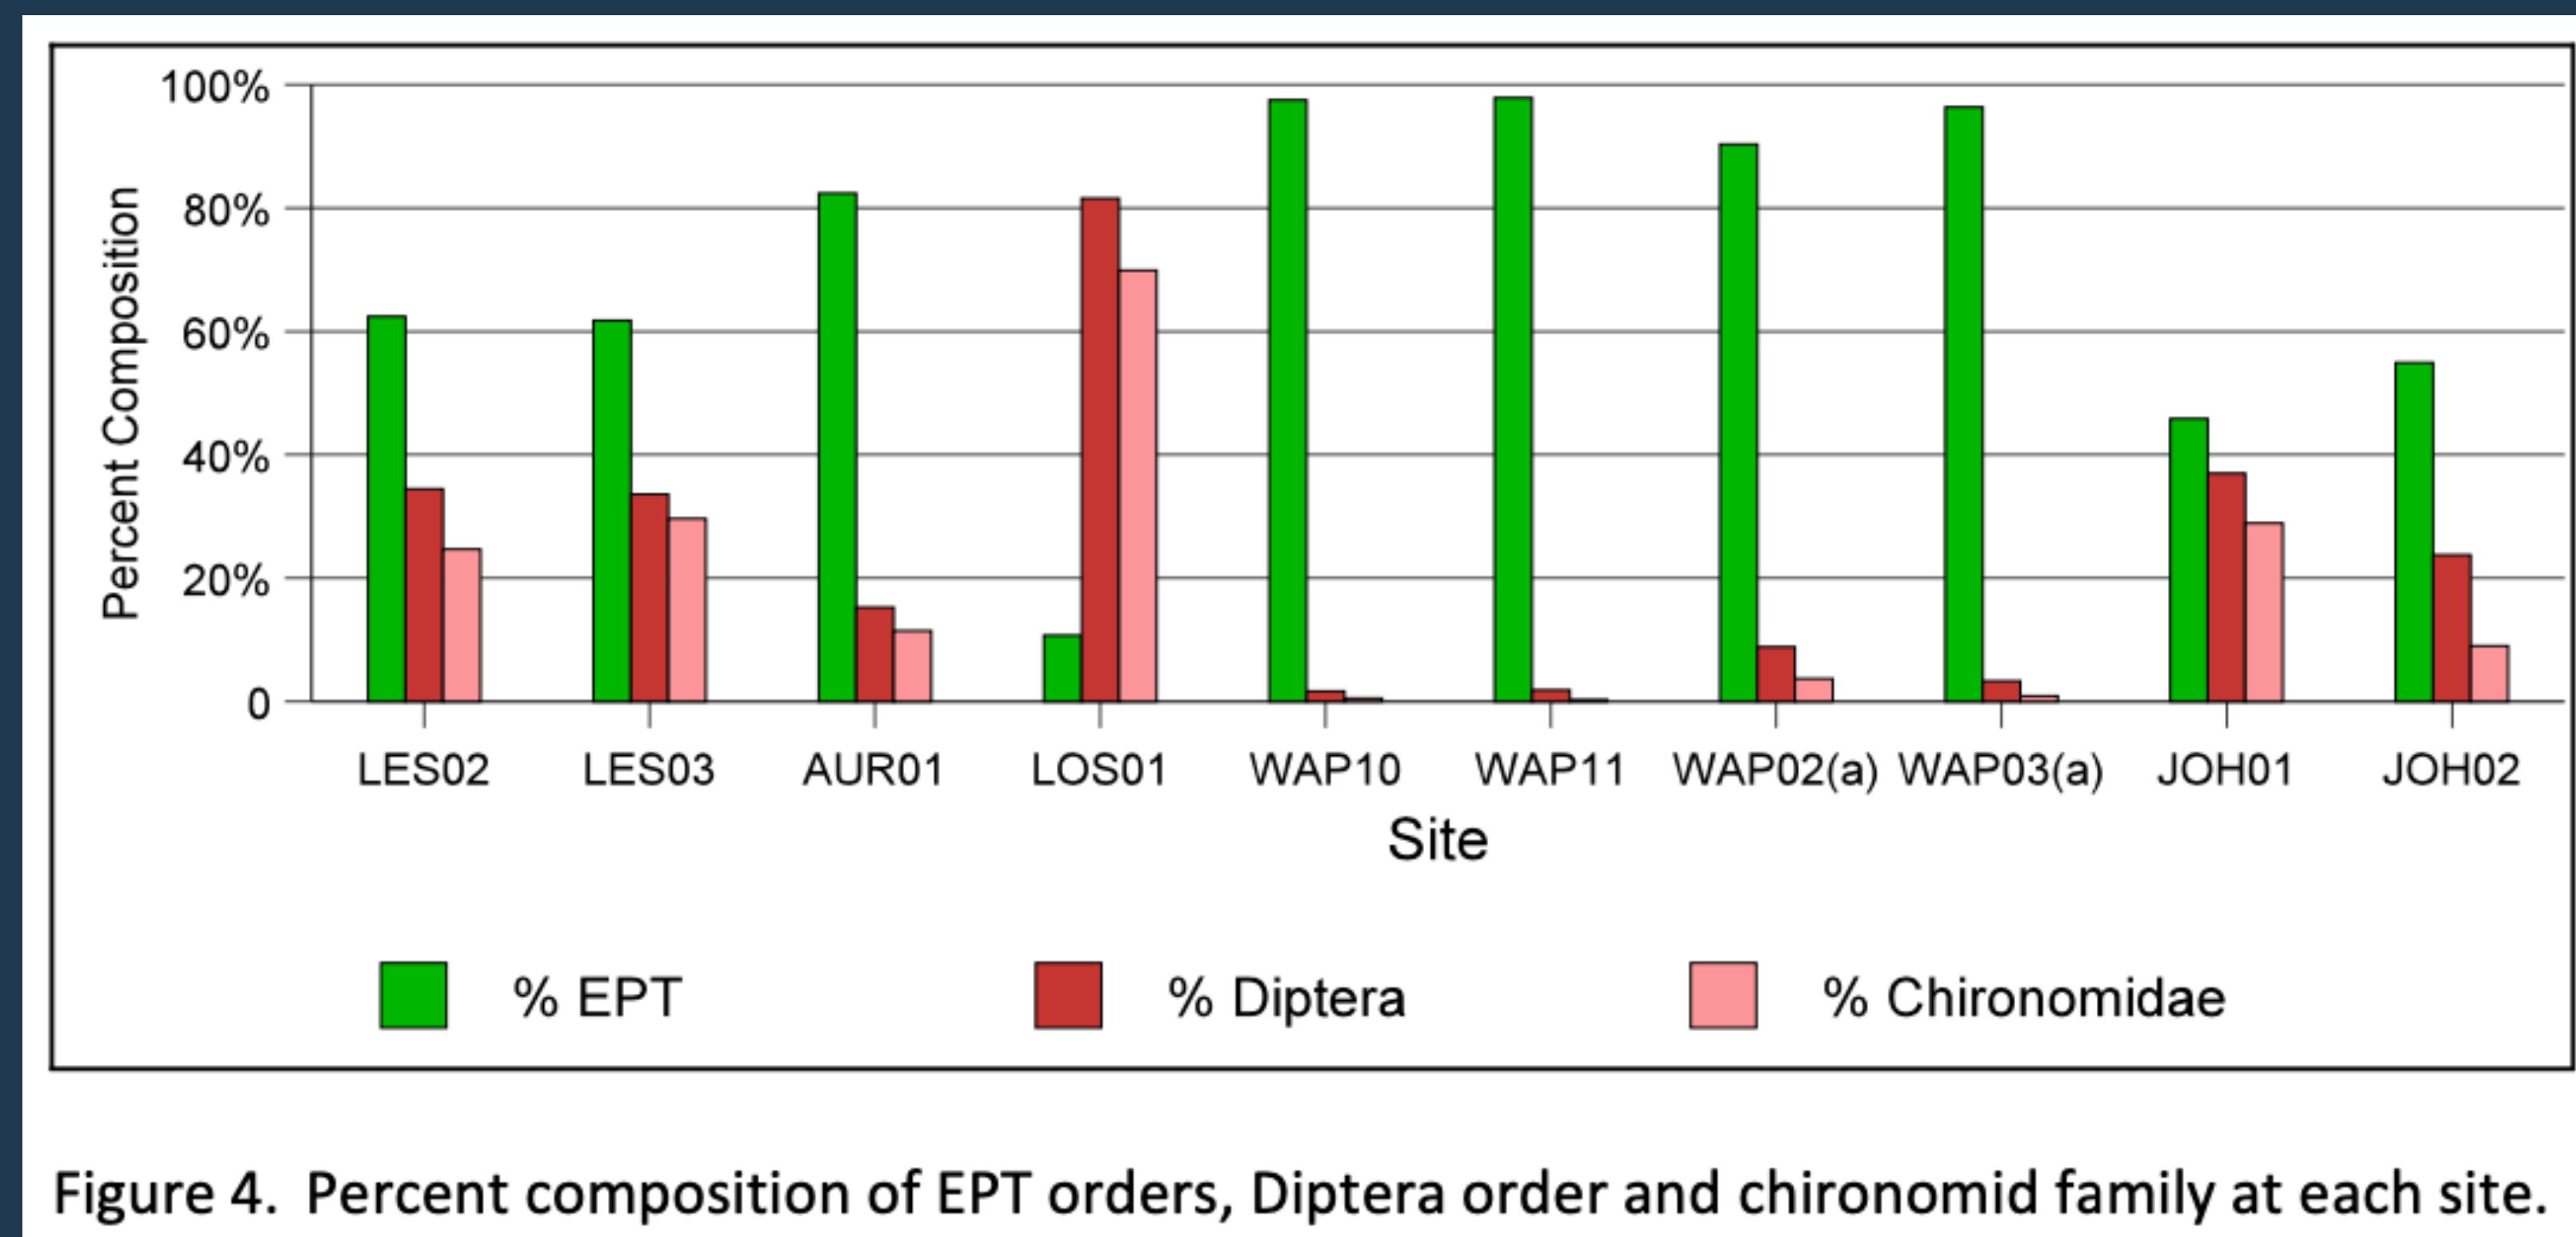
- ◆ Most sites in very good to excellent condition.
- ◆ Lost Knife Creek (LOS1), a potential reference site, was the anomaly in 2024. It was a much smaller creek than any sampled to date, with a largely silty bottom versus gravel and cobble, and with overhanging vegetation.

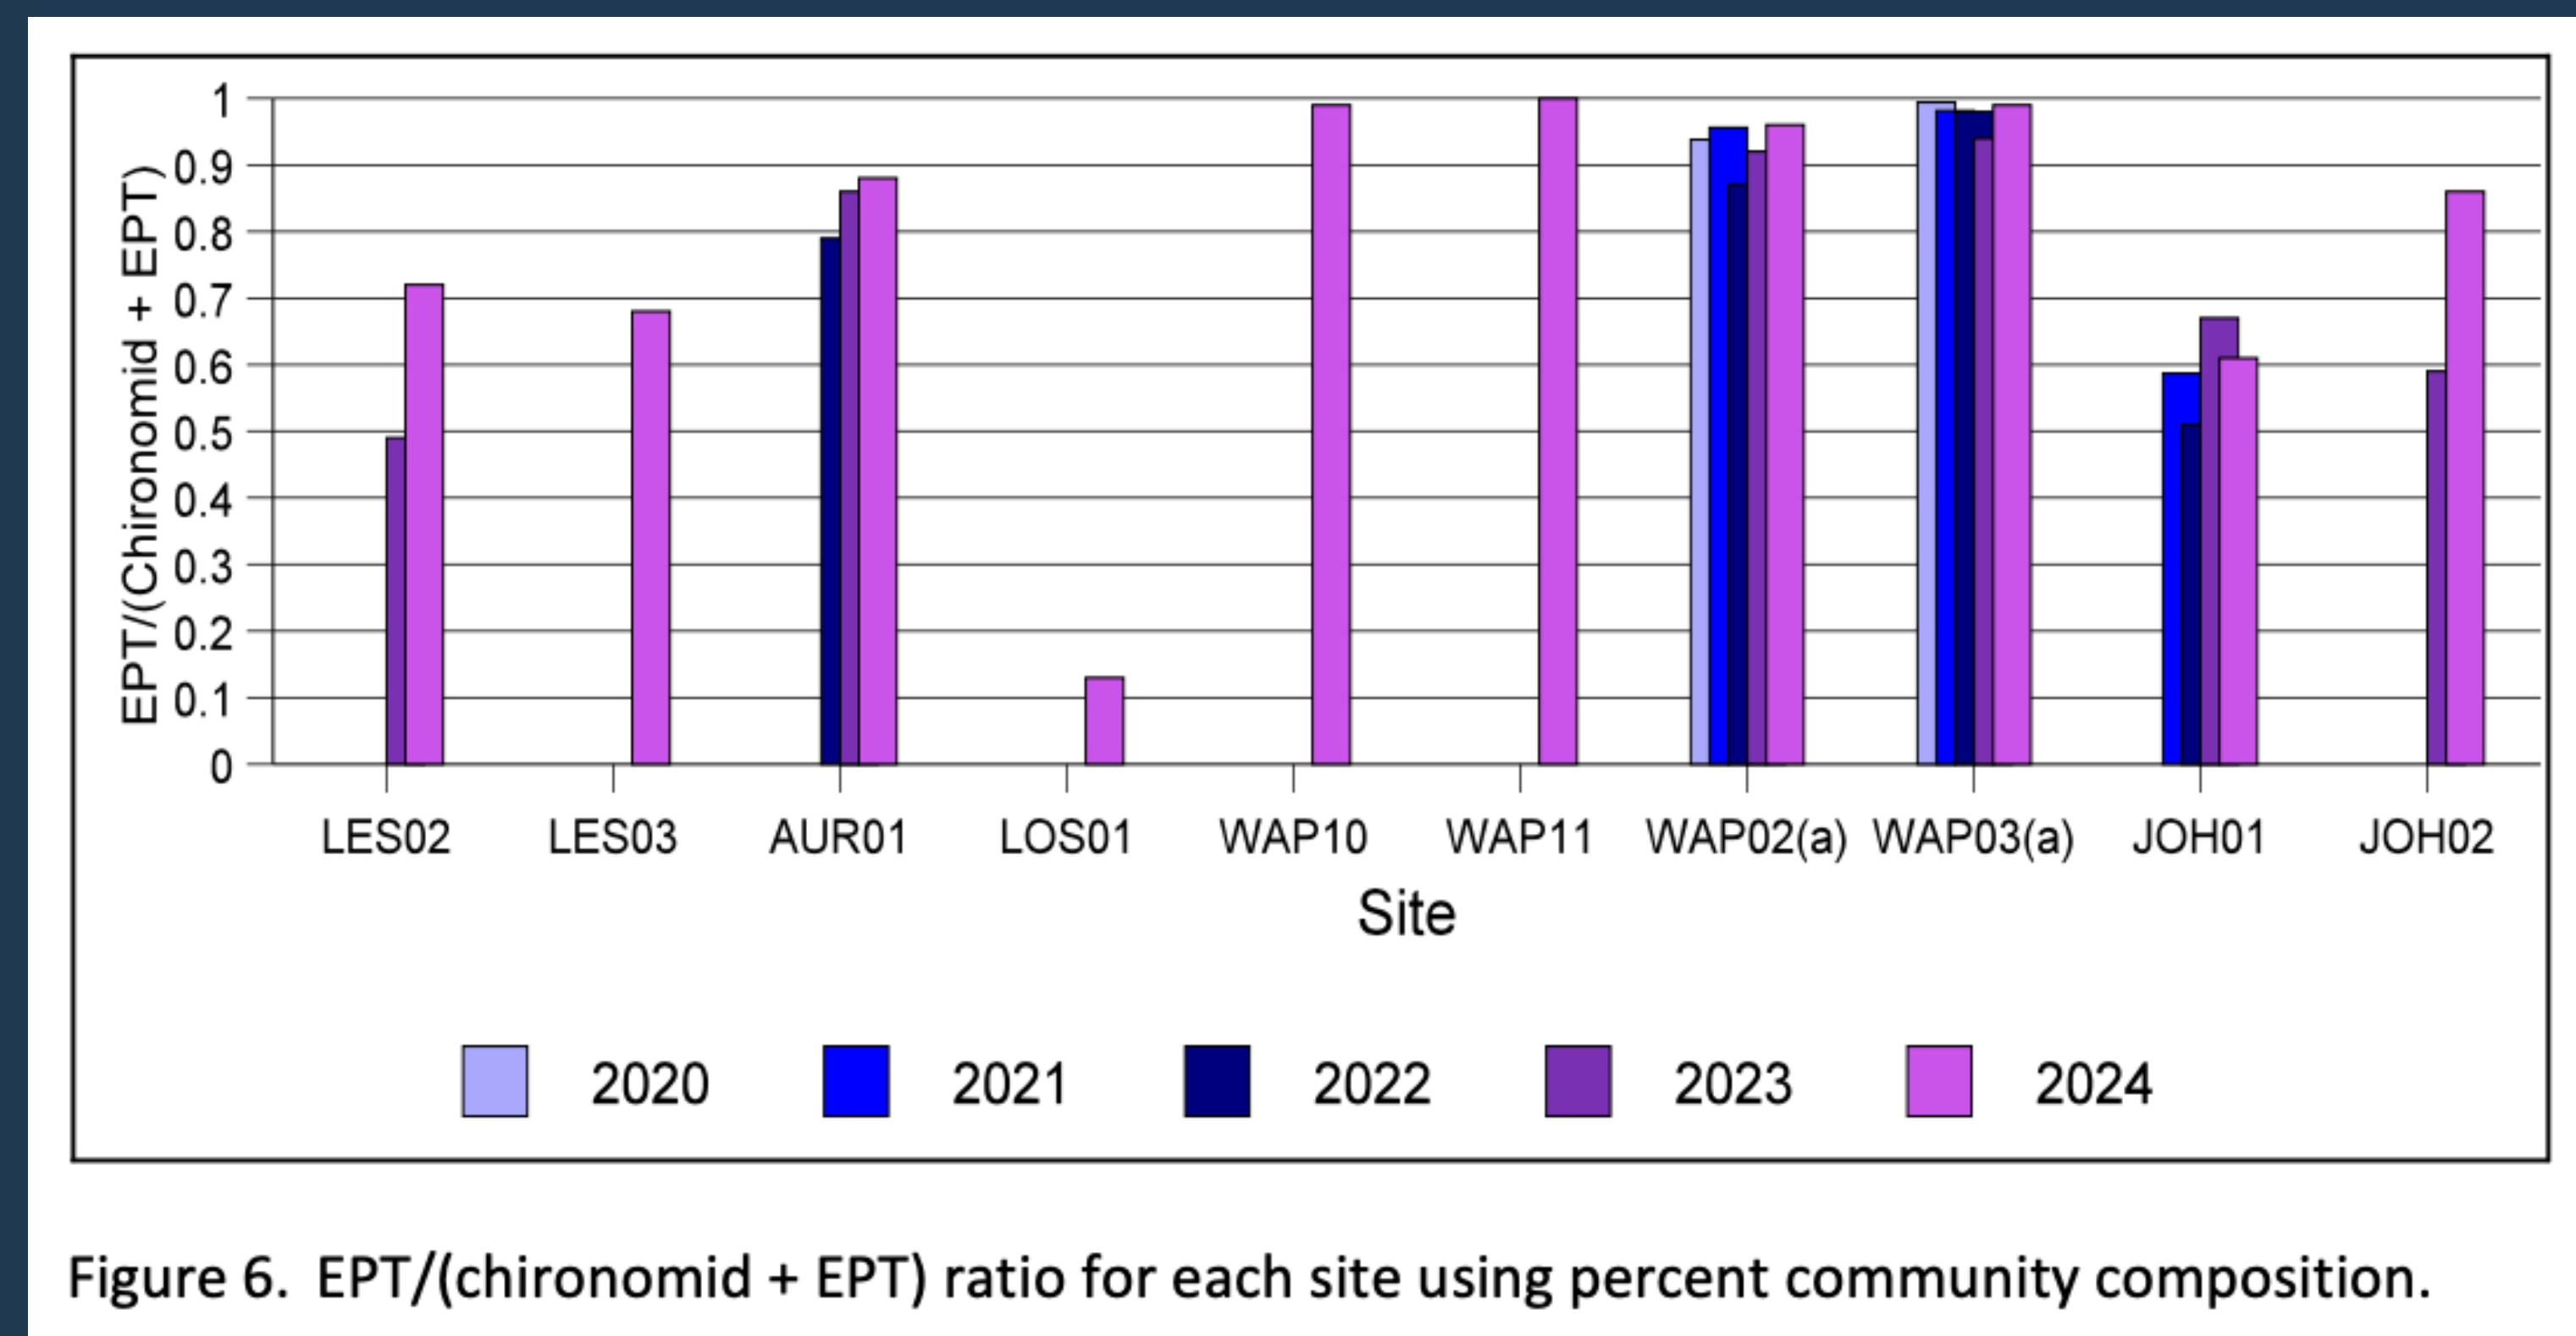
- ◆ Comparing 2020 to 2024 results on aquatic invertebrates, Lesueur Creek (LOS02) and the two Johnson Creek sites were of most concern.
- ◆ However, Lost Knife Creek (LOS1) again showed the lowest ratio. Not necessarily because of low water quality, but could be result of silty substrate.

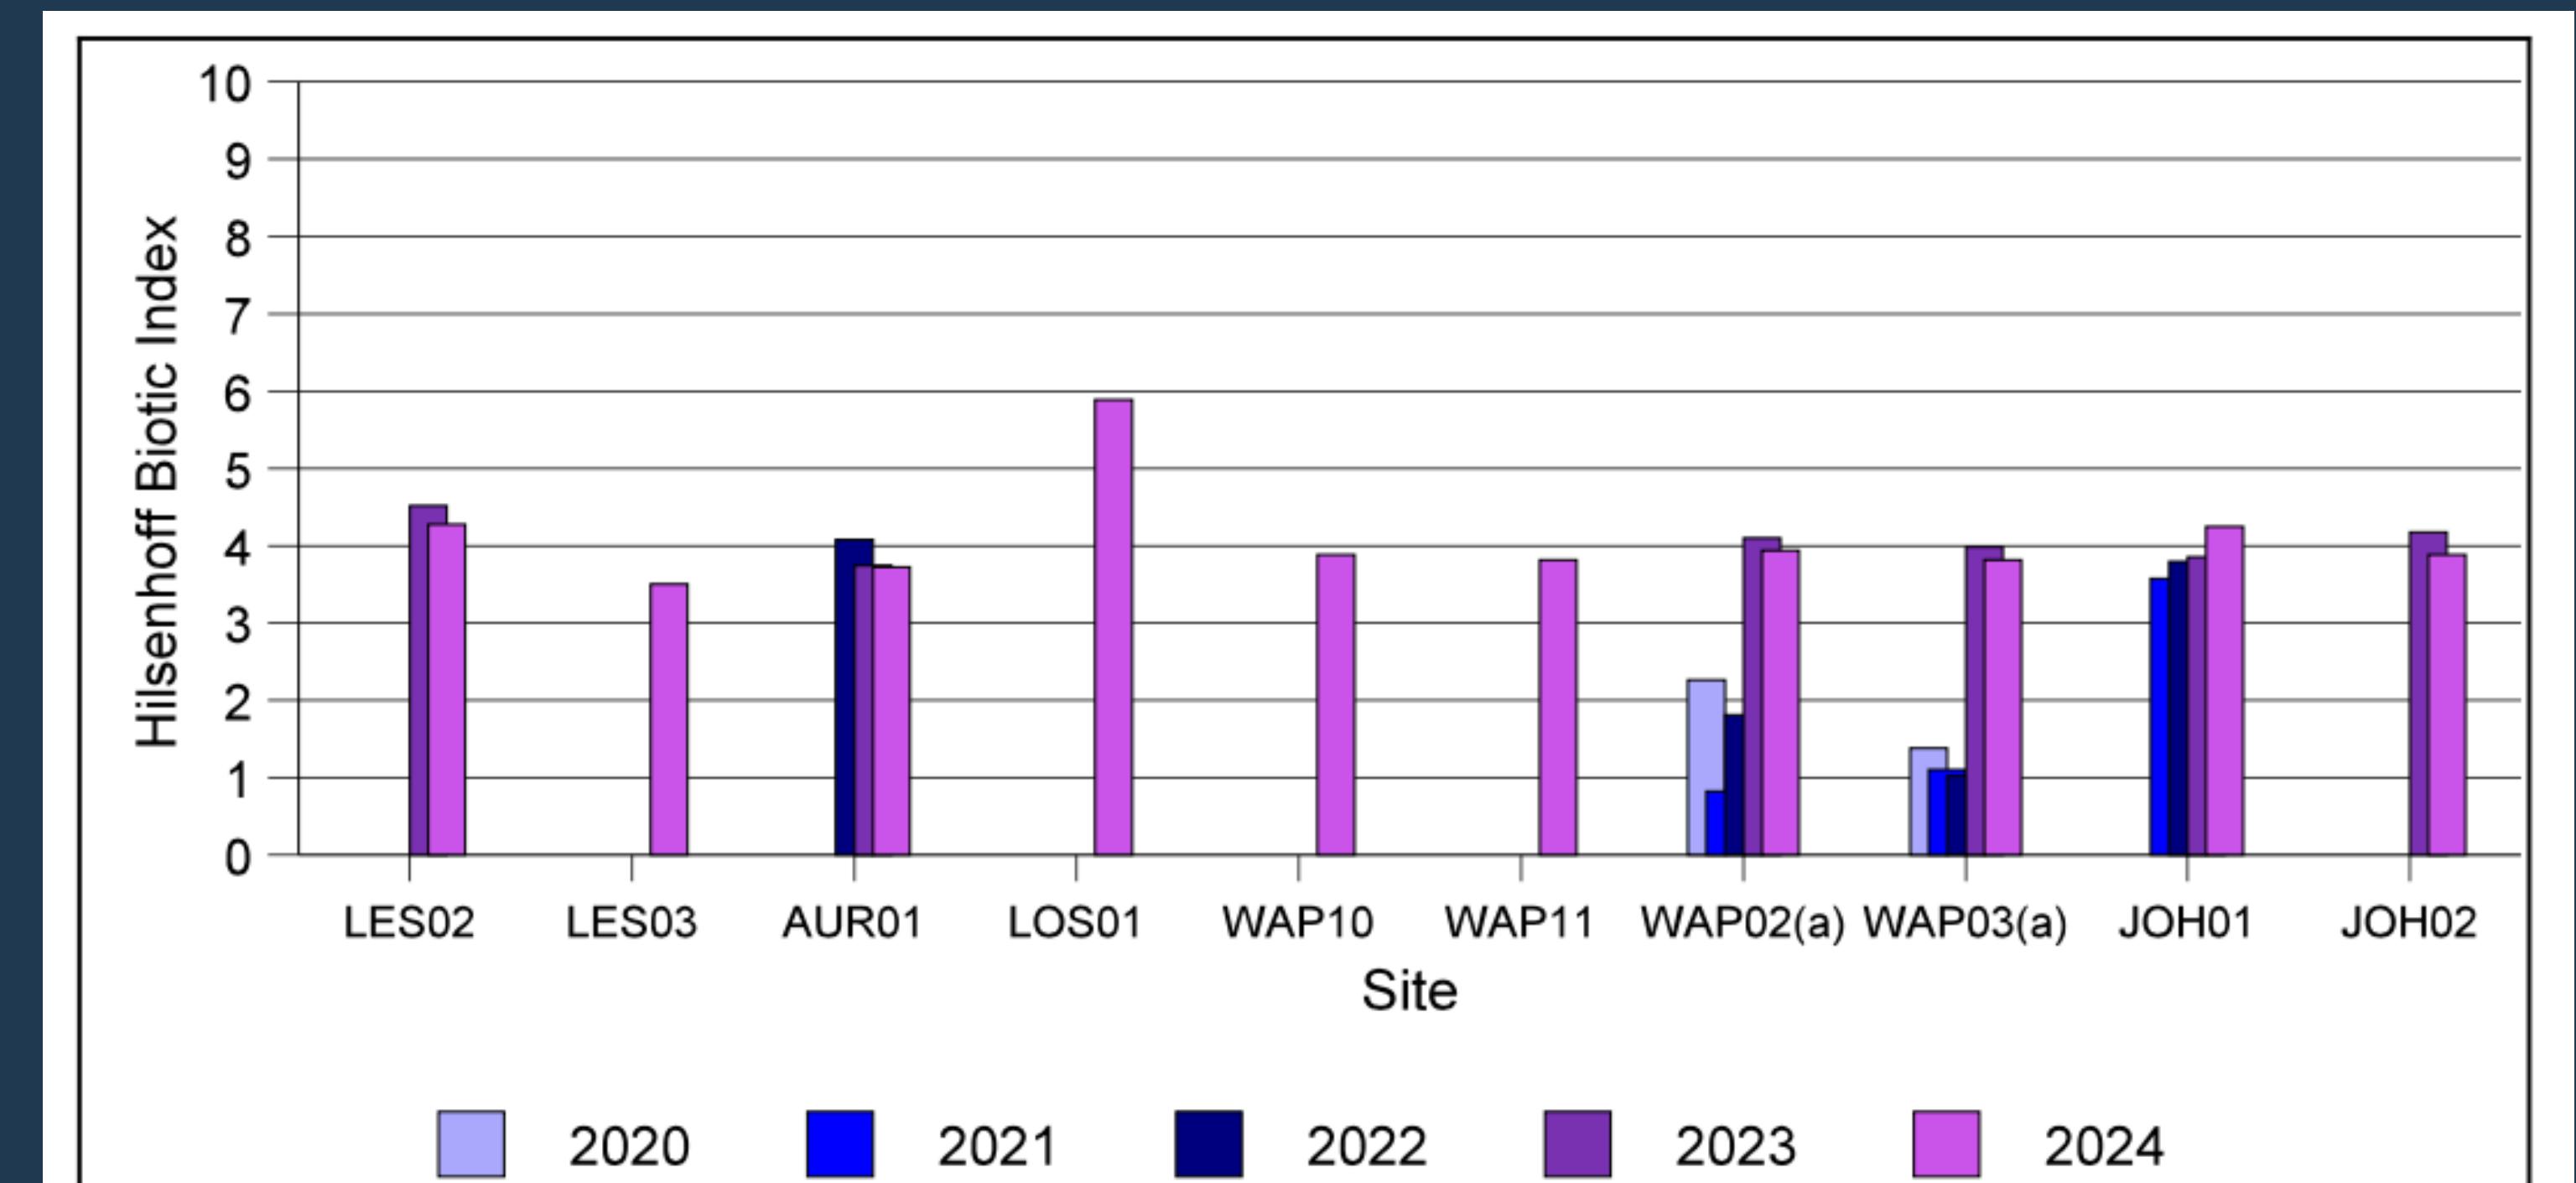
Figure 14. Hilsenhoff Biotic Index for each site.

- ◆ Waiparous Creek sites (WAP02, WAP03) have been rated as excellent from 2020 - 2022 and very good in 2023 and 2024, suggesting that organic enrichment increased.
- ◆ Johnson Creek sites rating of very good, but HBI index is indicating possible slight organic enrichment.
- ◆ Lost Knife site rated fair, but indicator not geared towards such small, slow flowing streams.

0.00 - 3.50	Excellent
3.51 - 4.50	Very Good
4.51 - 5.50	Good
5.51 - 6.50	Fair
