# Our Work in the Ghost Watershed in 2025

Presented by:  
Marina Krainer  
Executive Director

GWAS AGM  
November 8, 2025

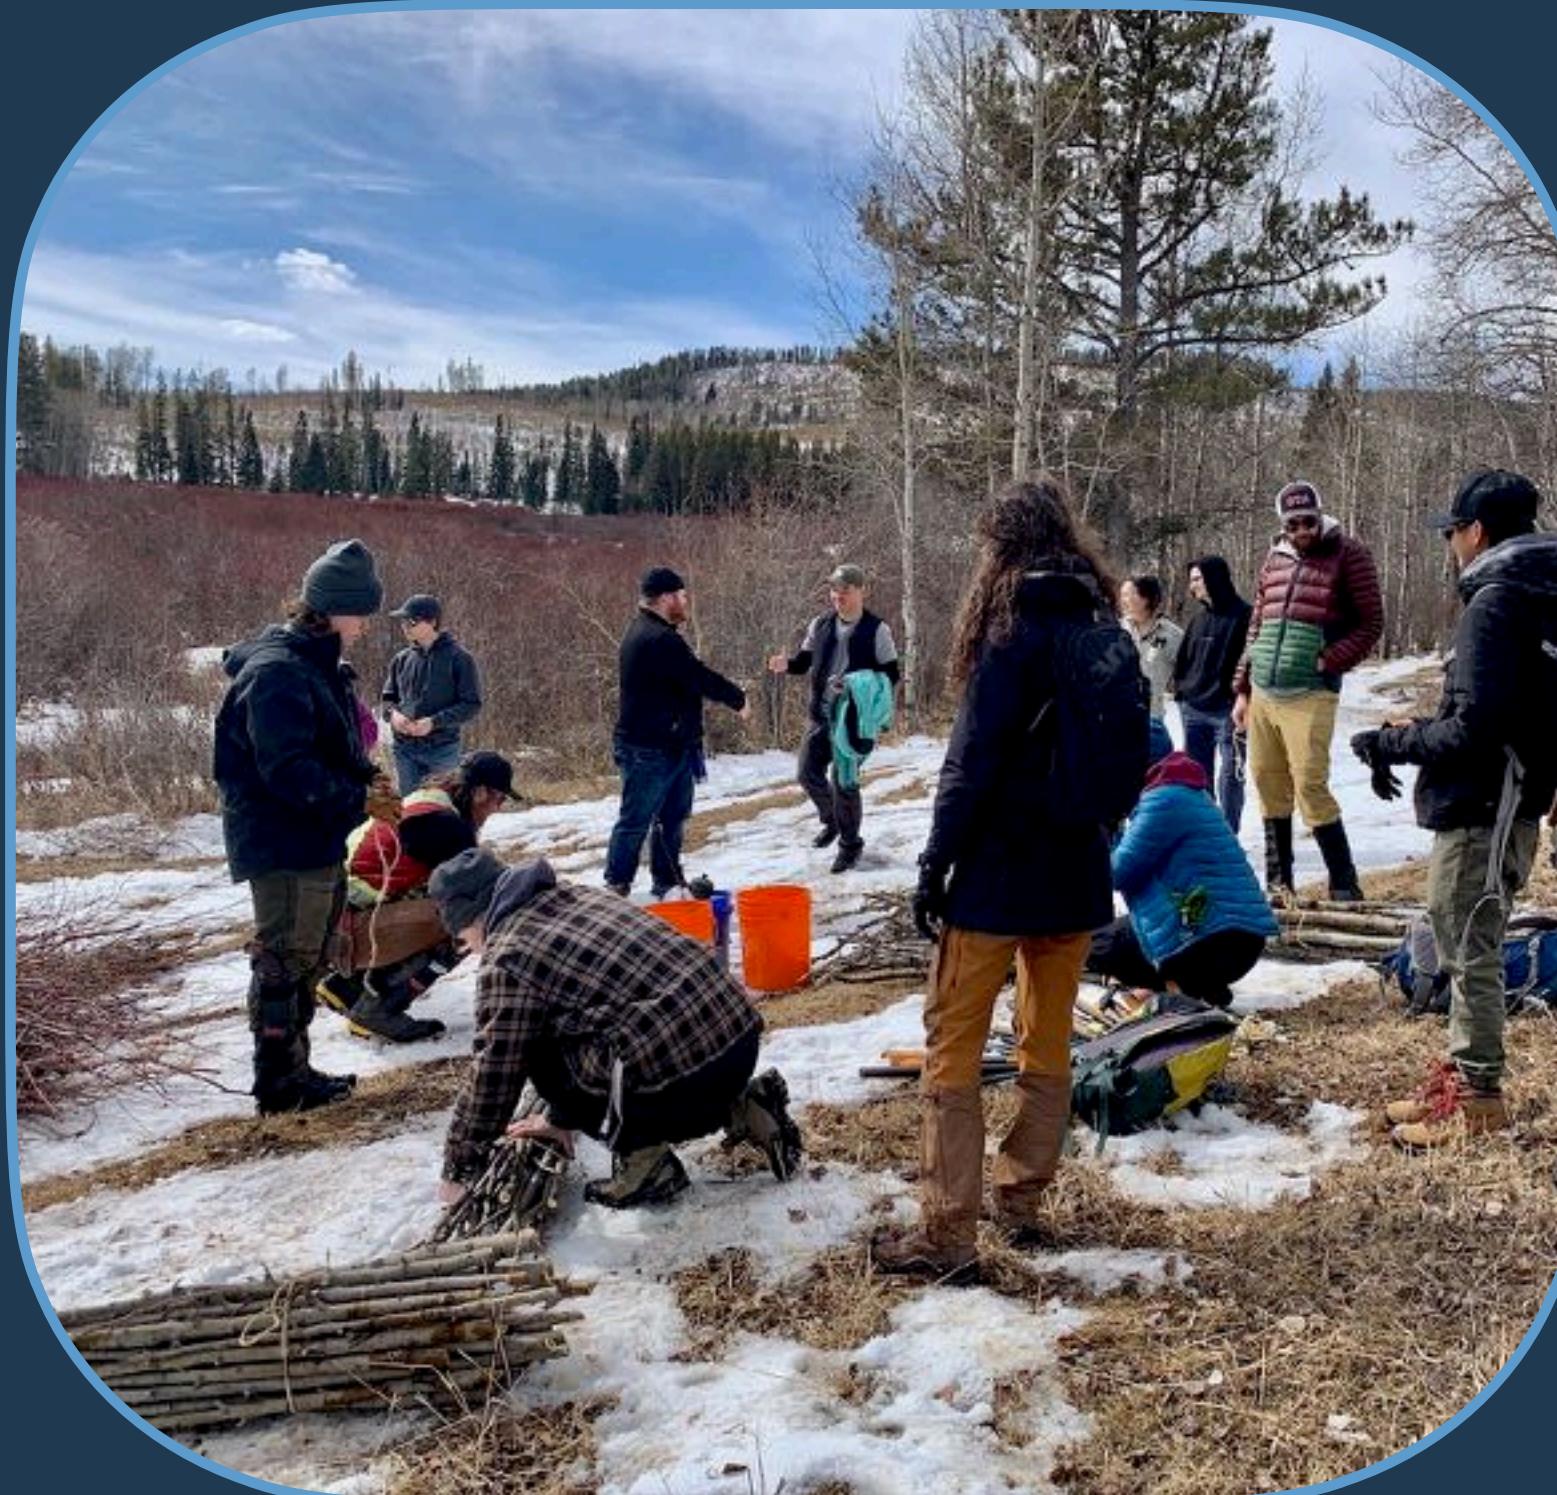
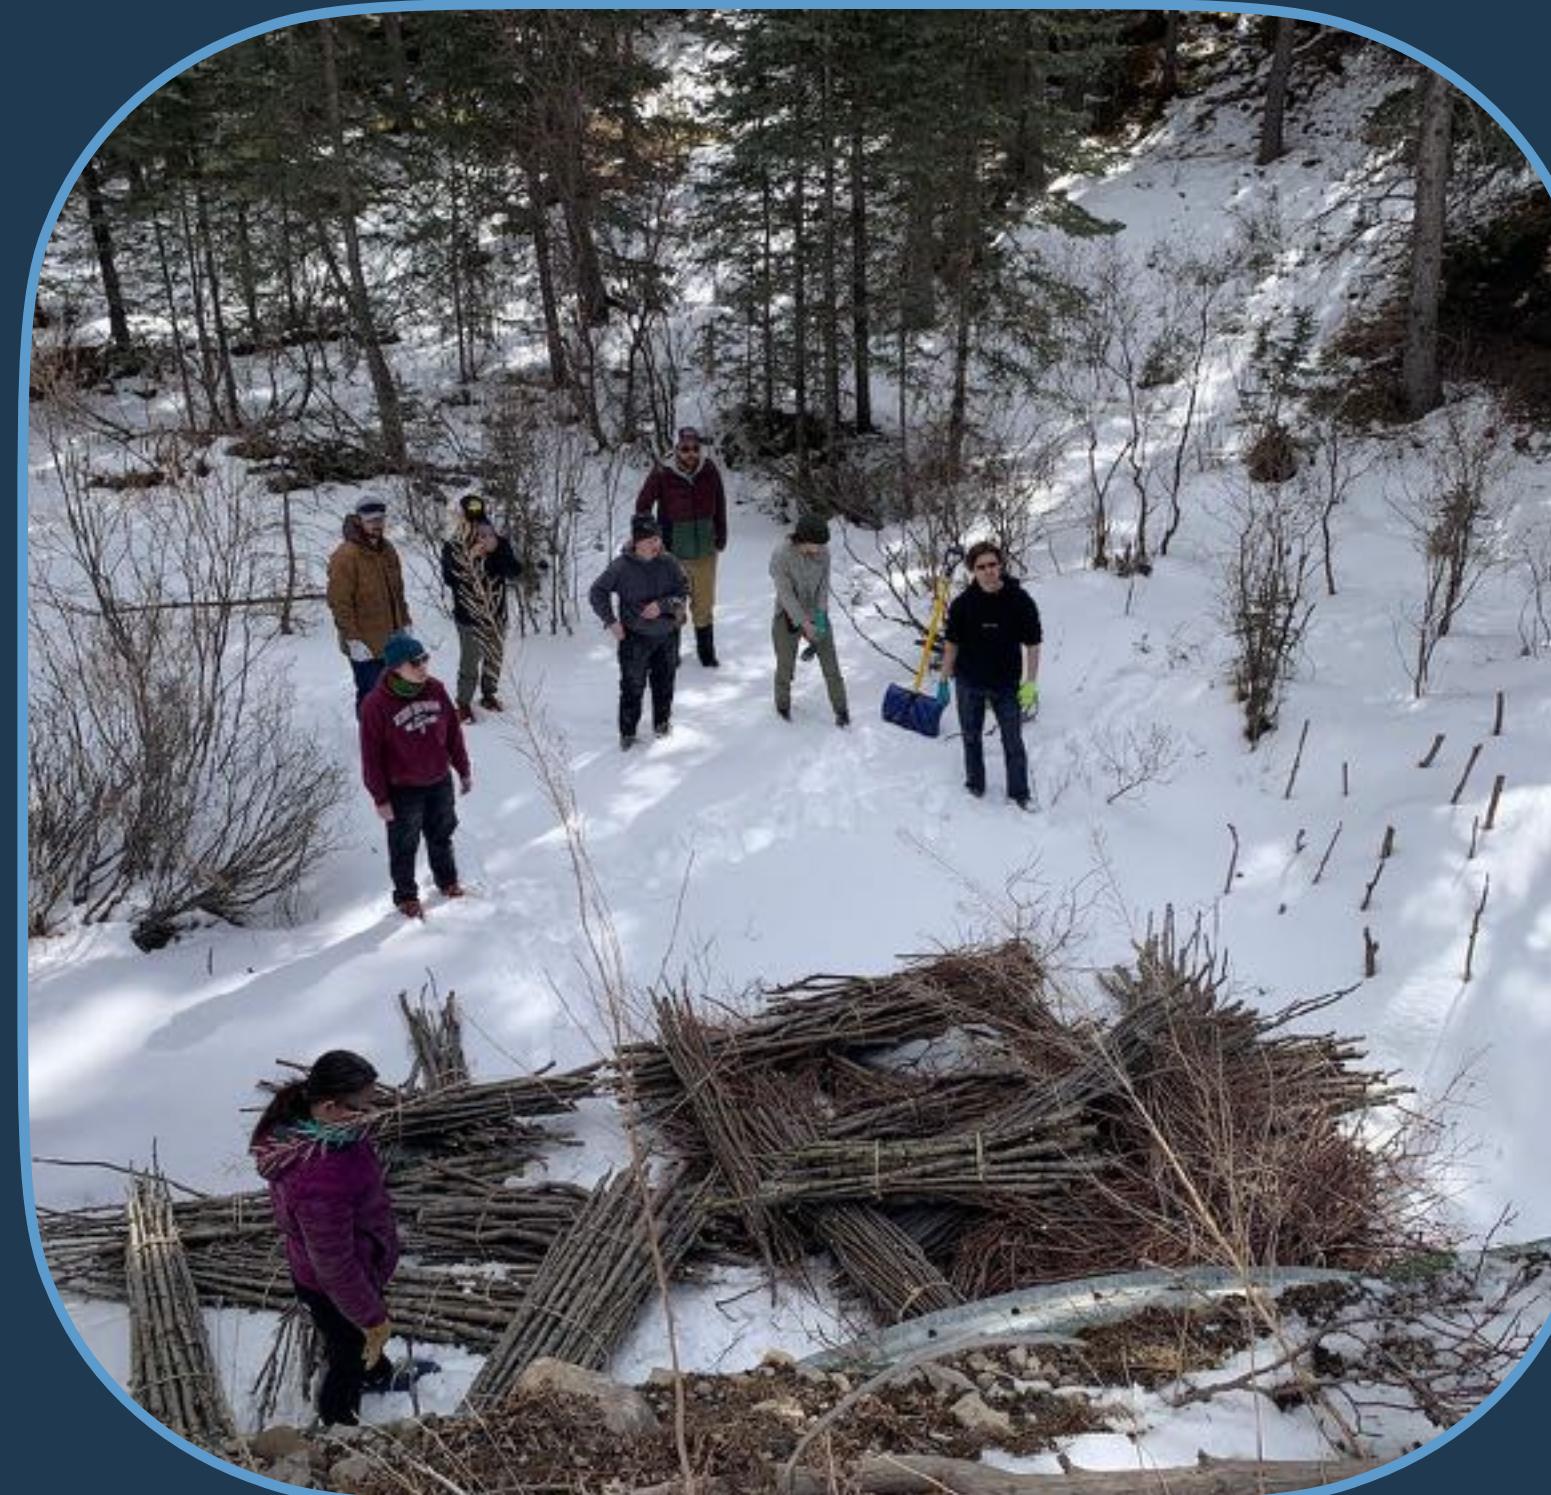
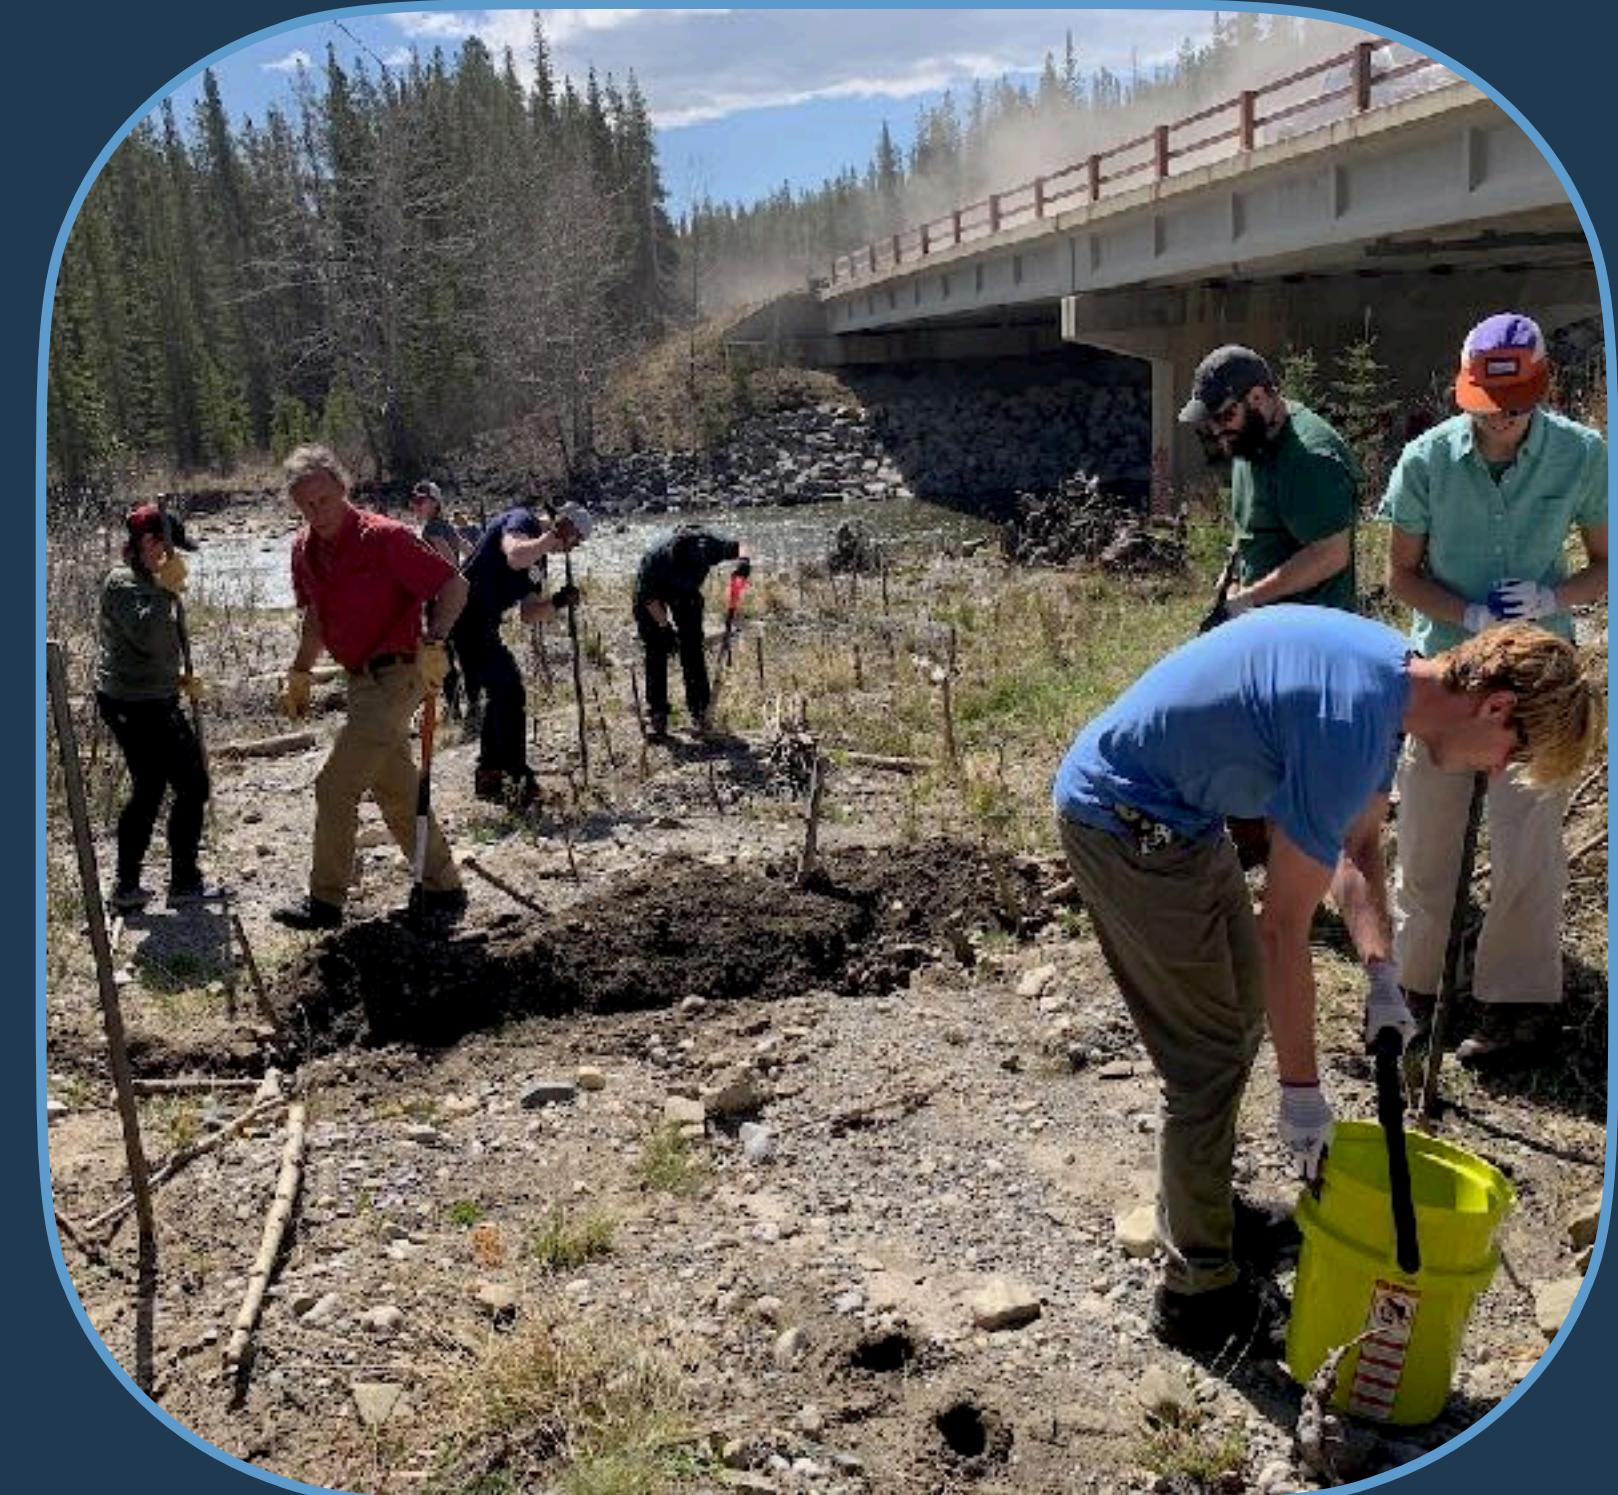
- ◆ March 22: Harvesting workshop (20 volunteers, app. 2,000 stakes)
- ◆ May 24: Field workshop at Waiparous bridge & west culvert (15 volunteers)

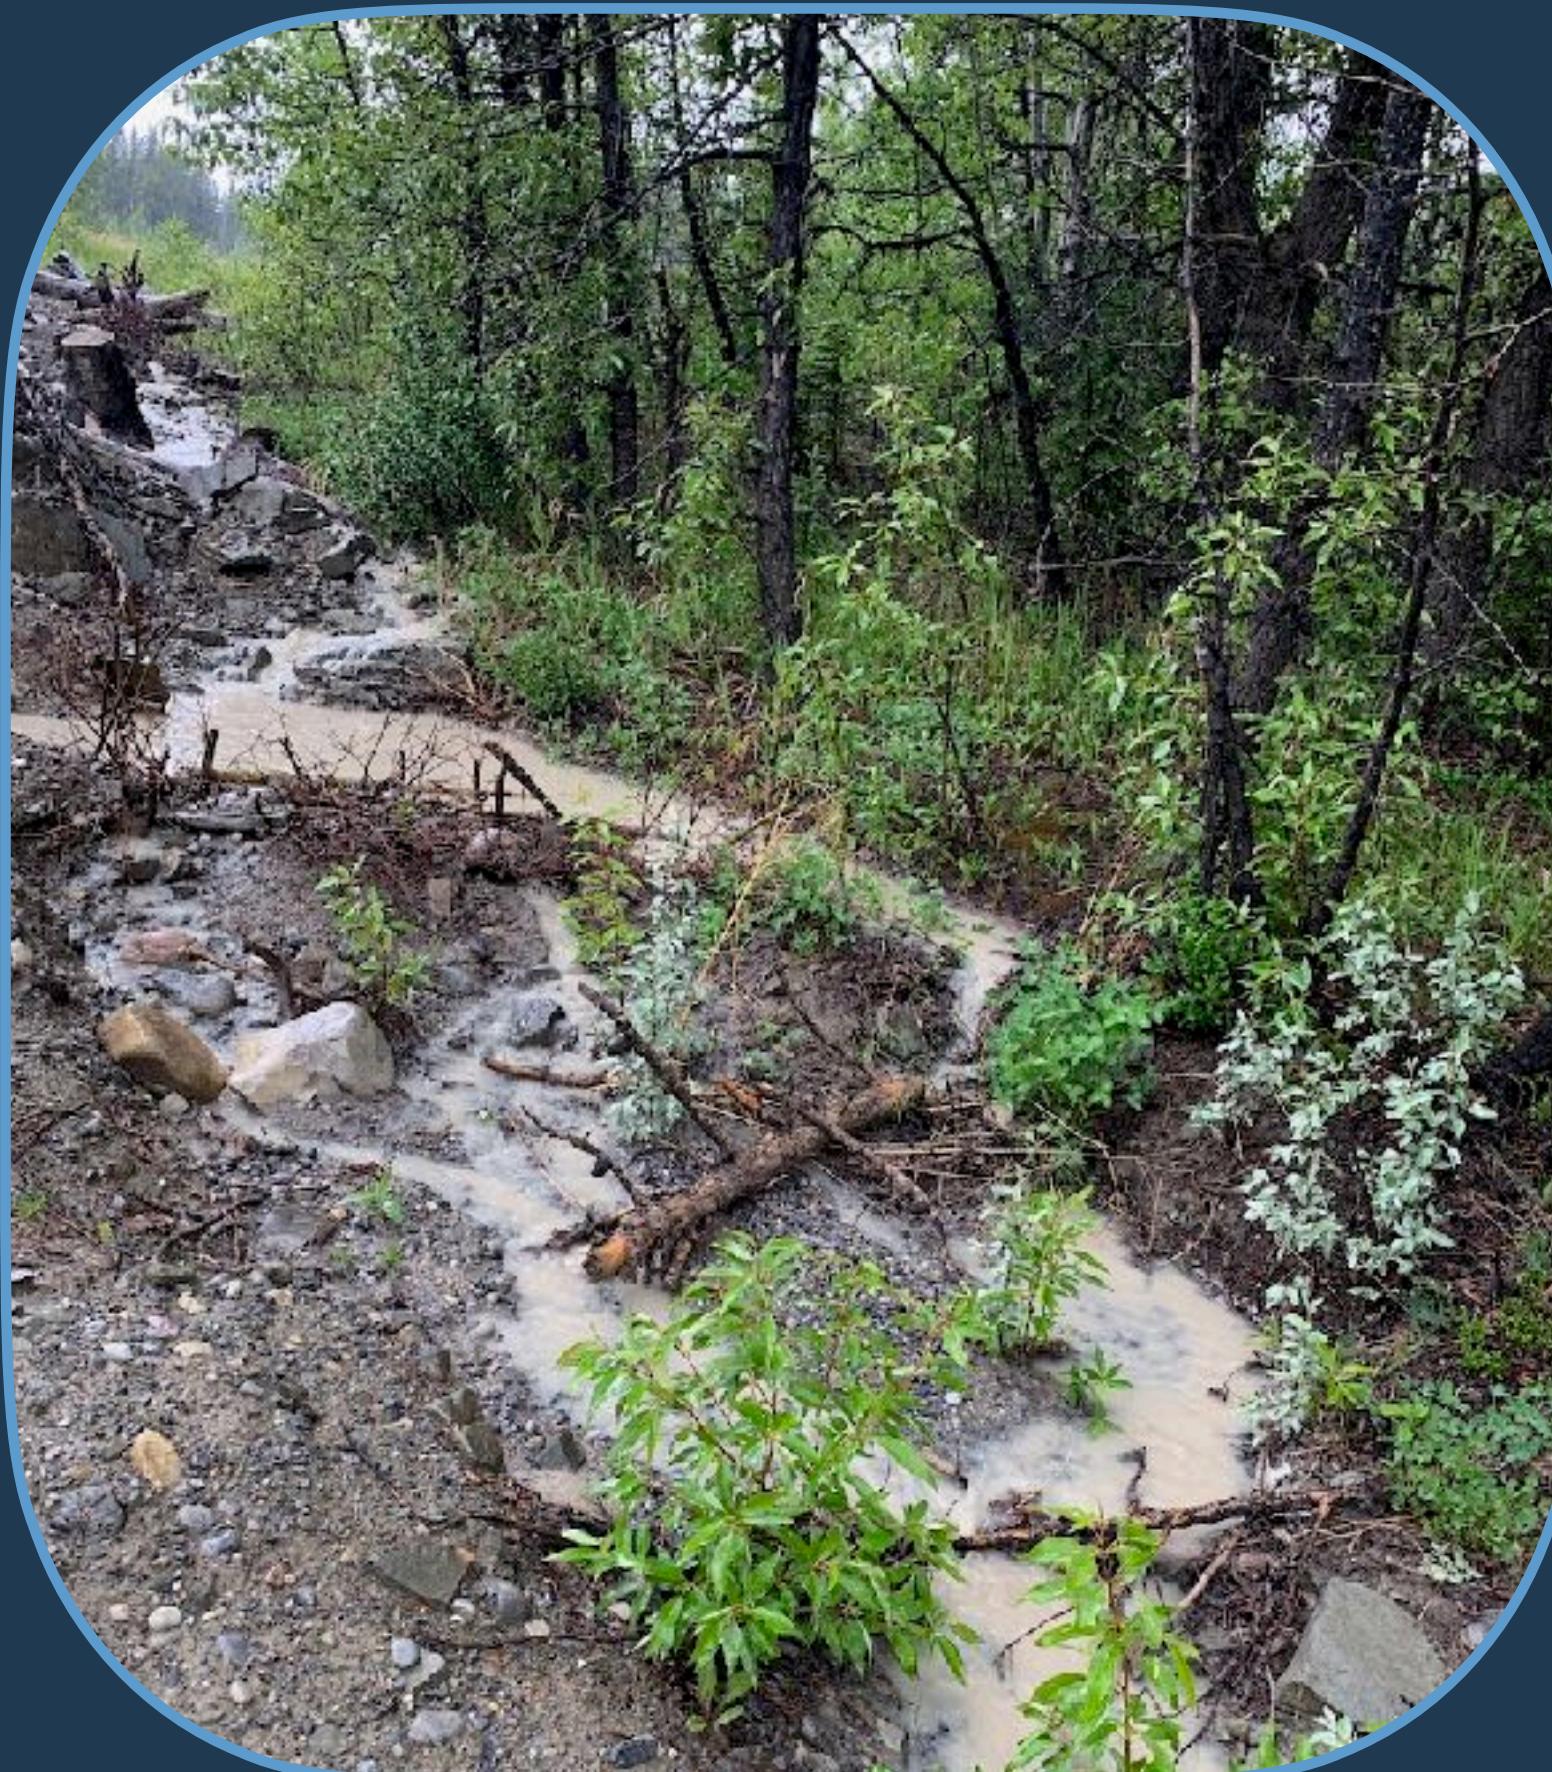
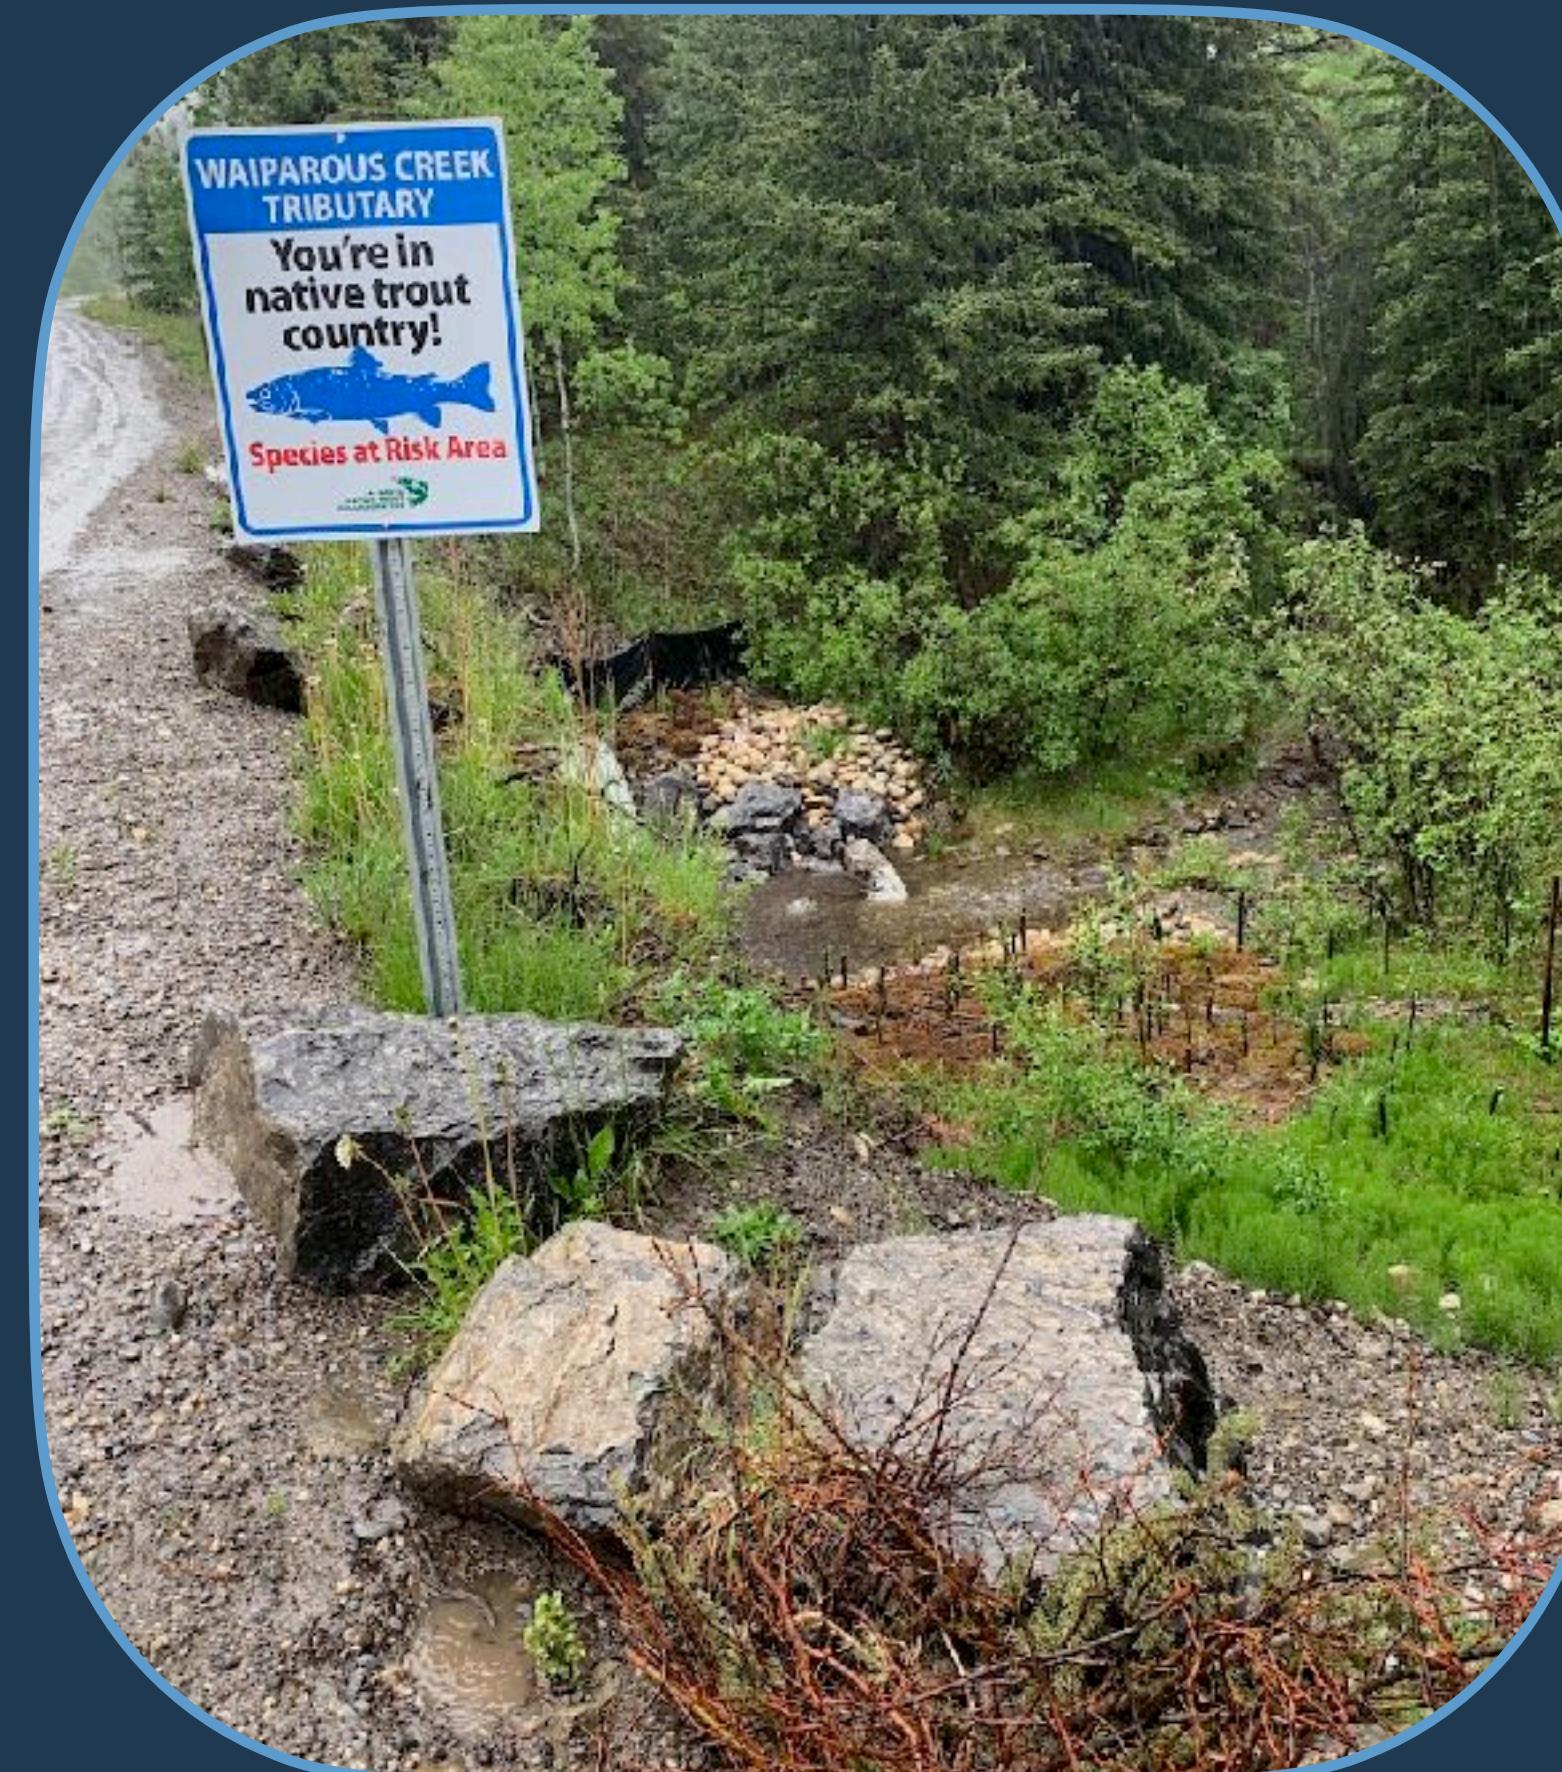
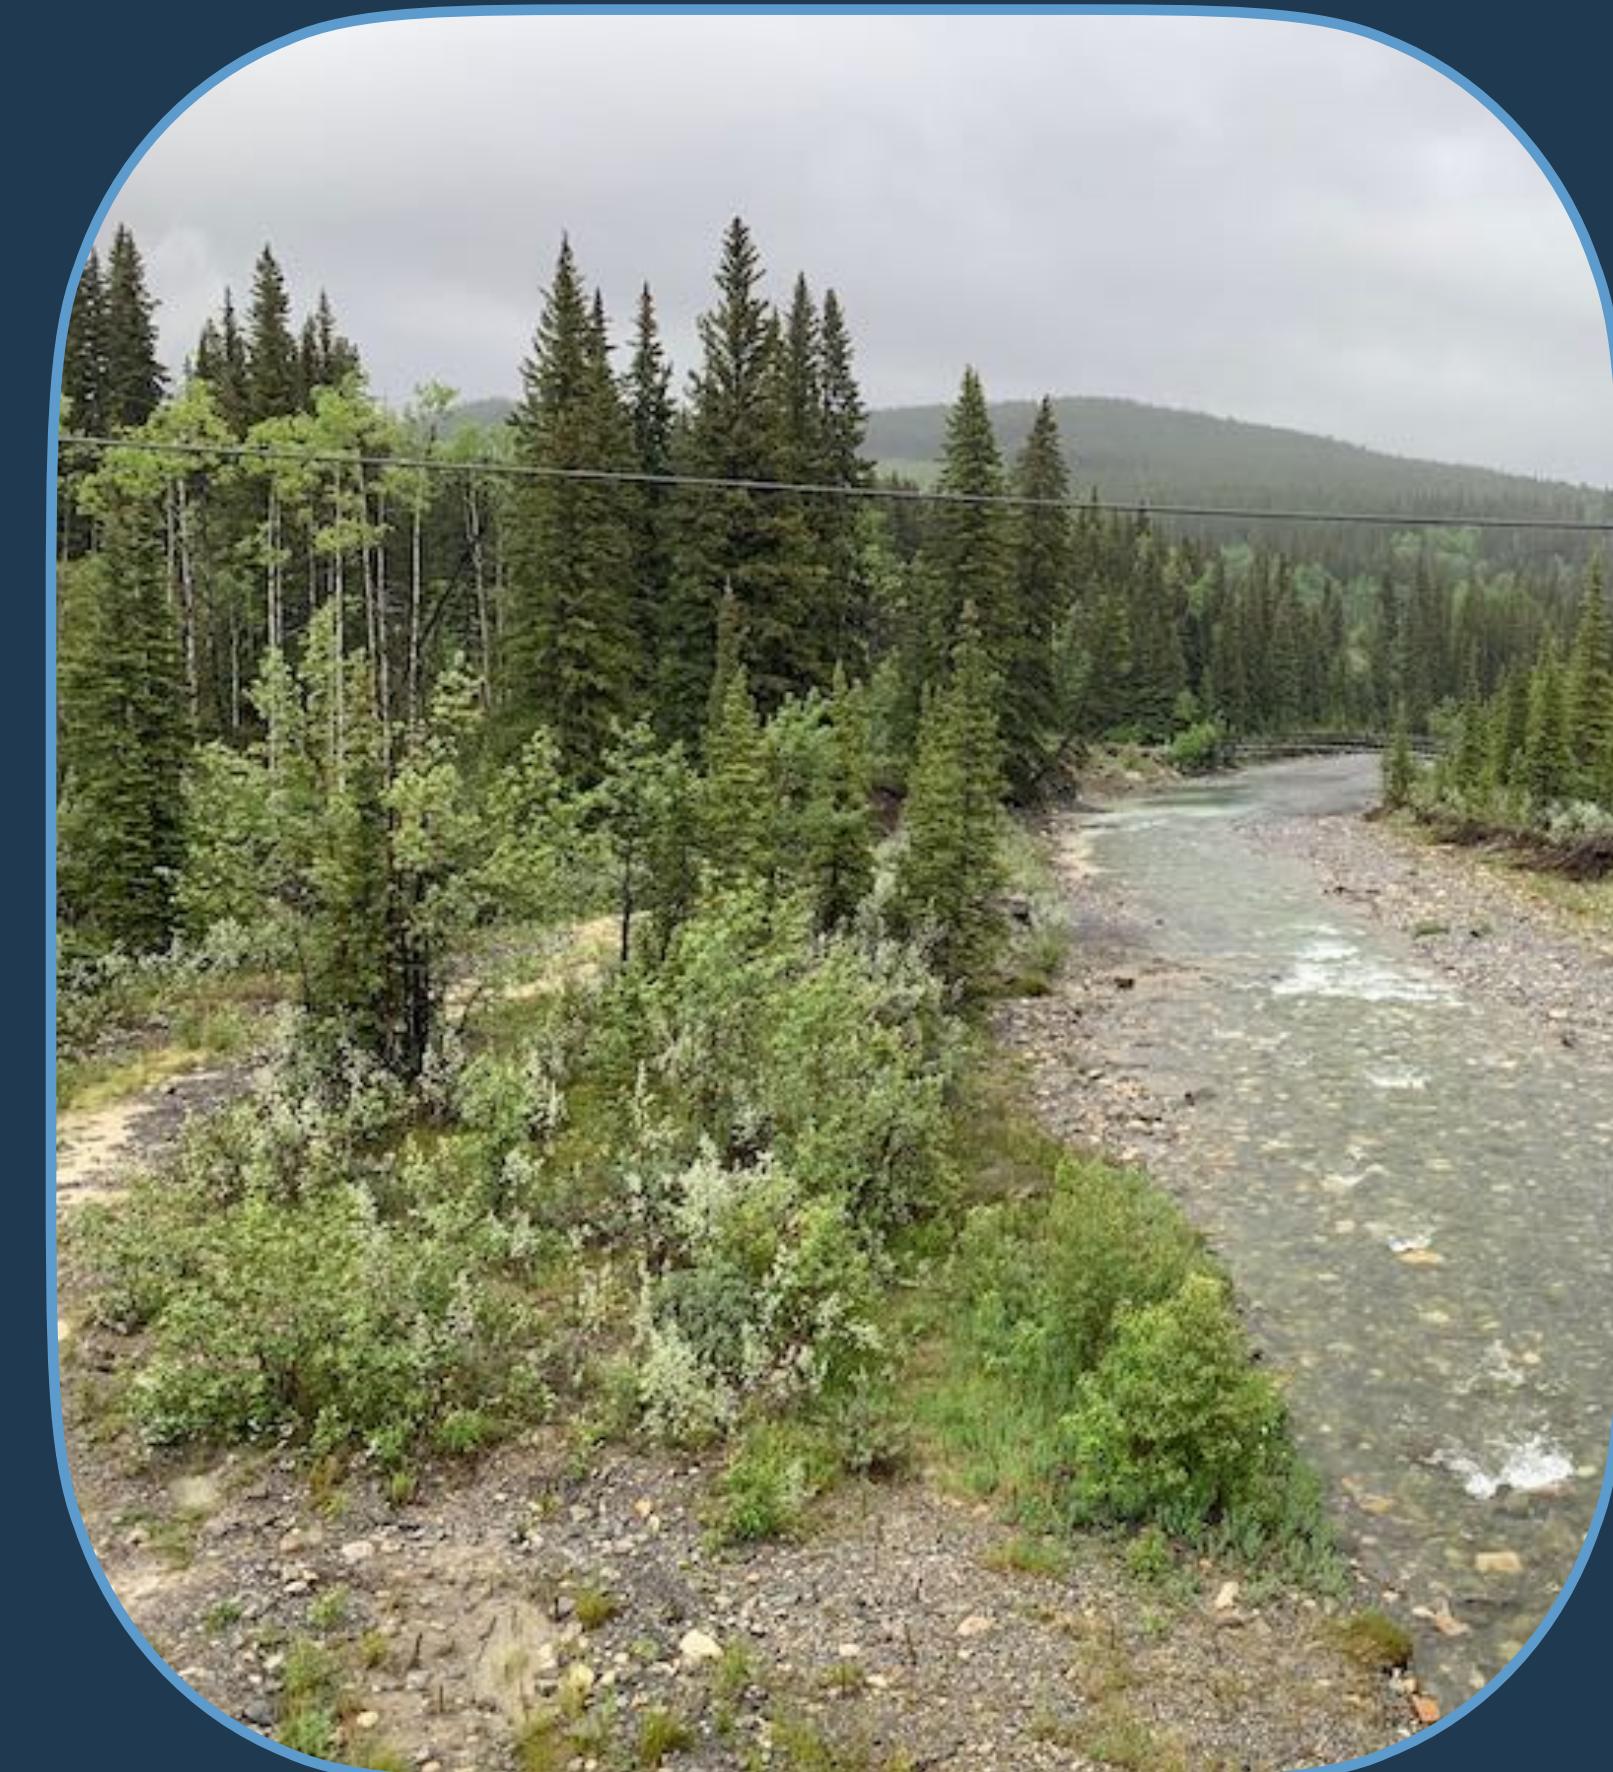
- ◆ June 20: Monitoring trip during rainfall event

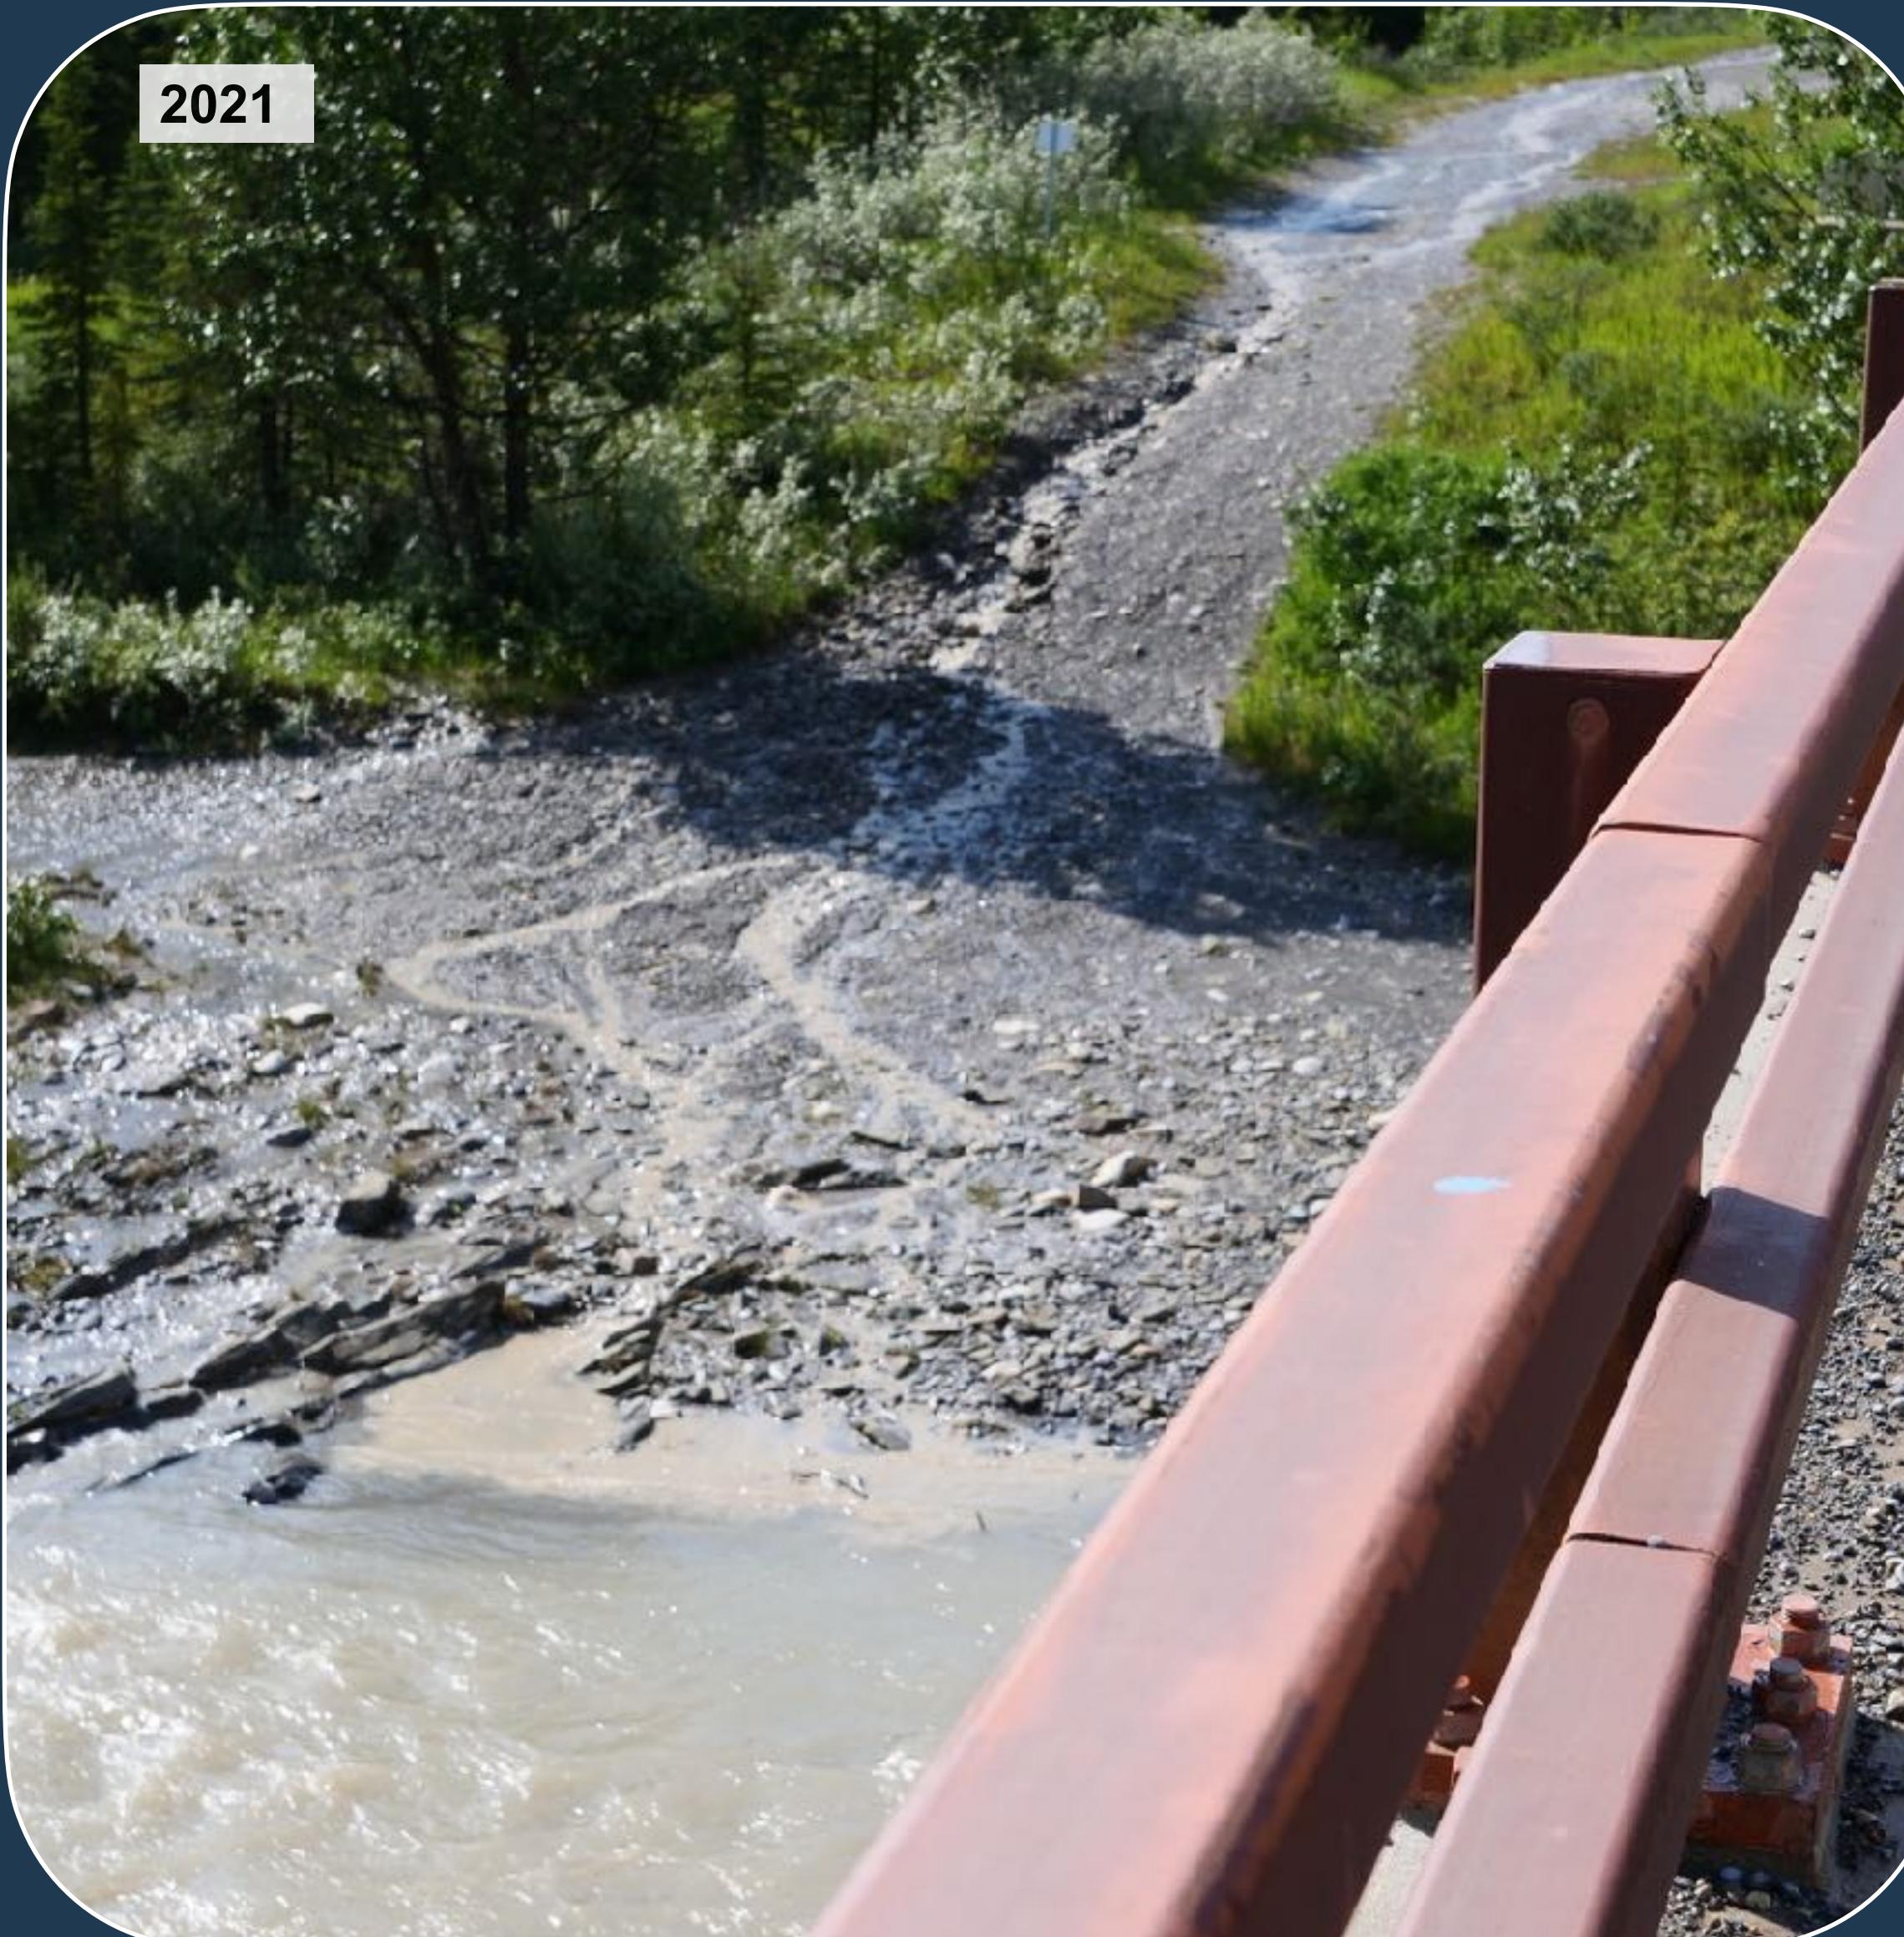
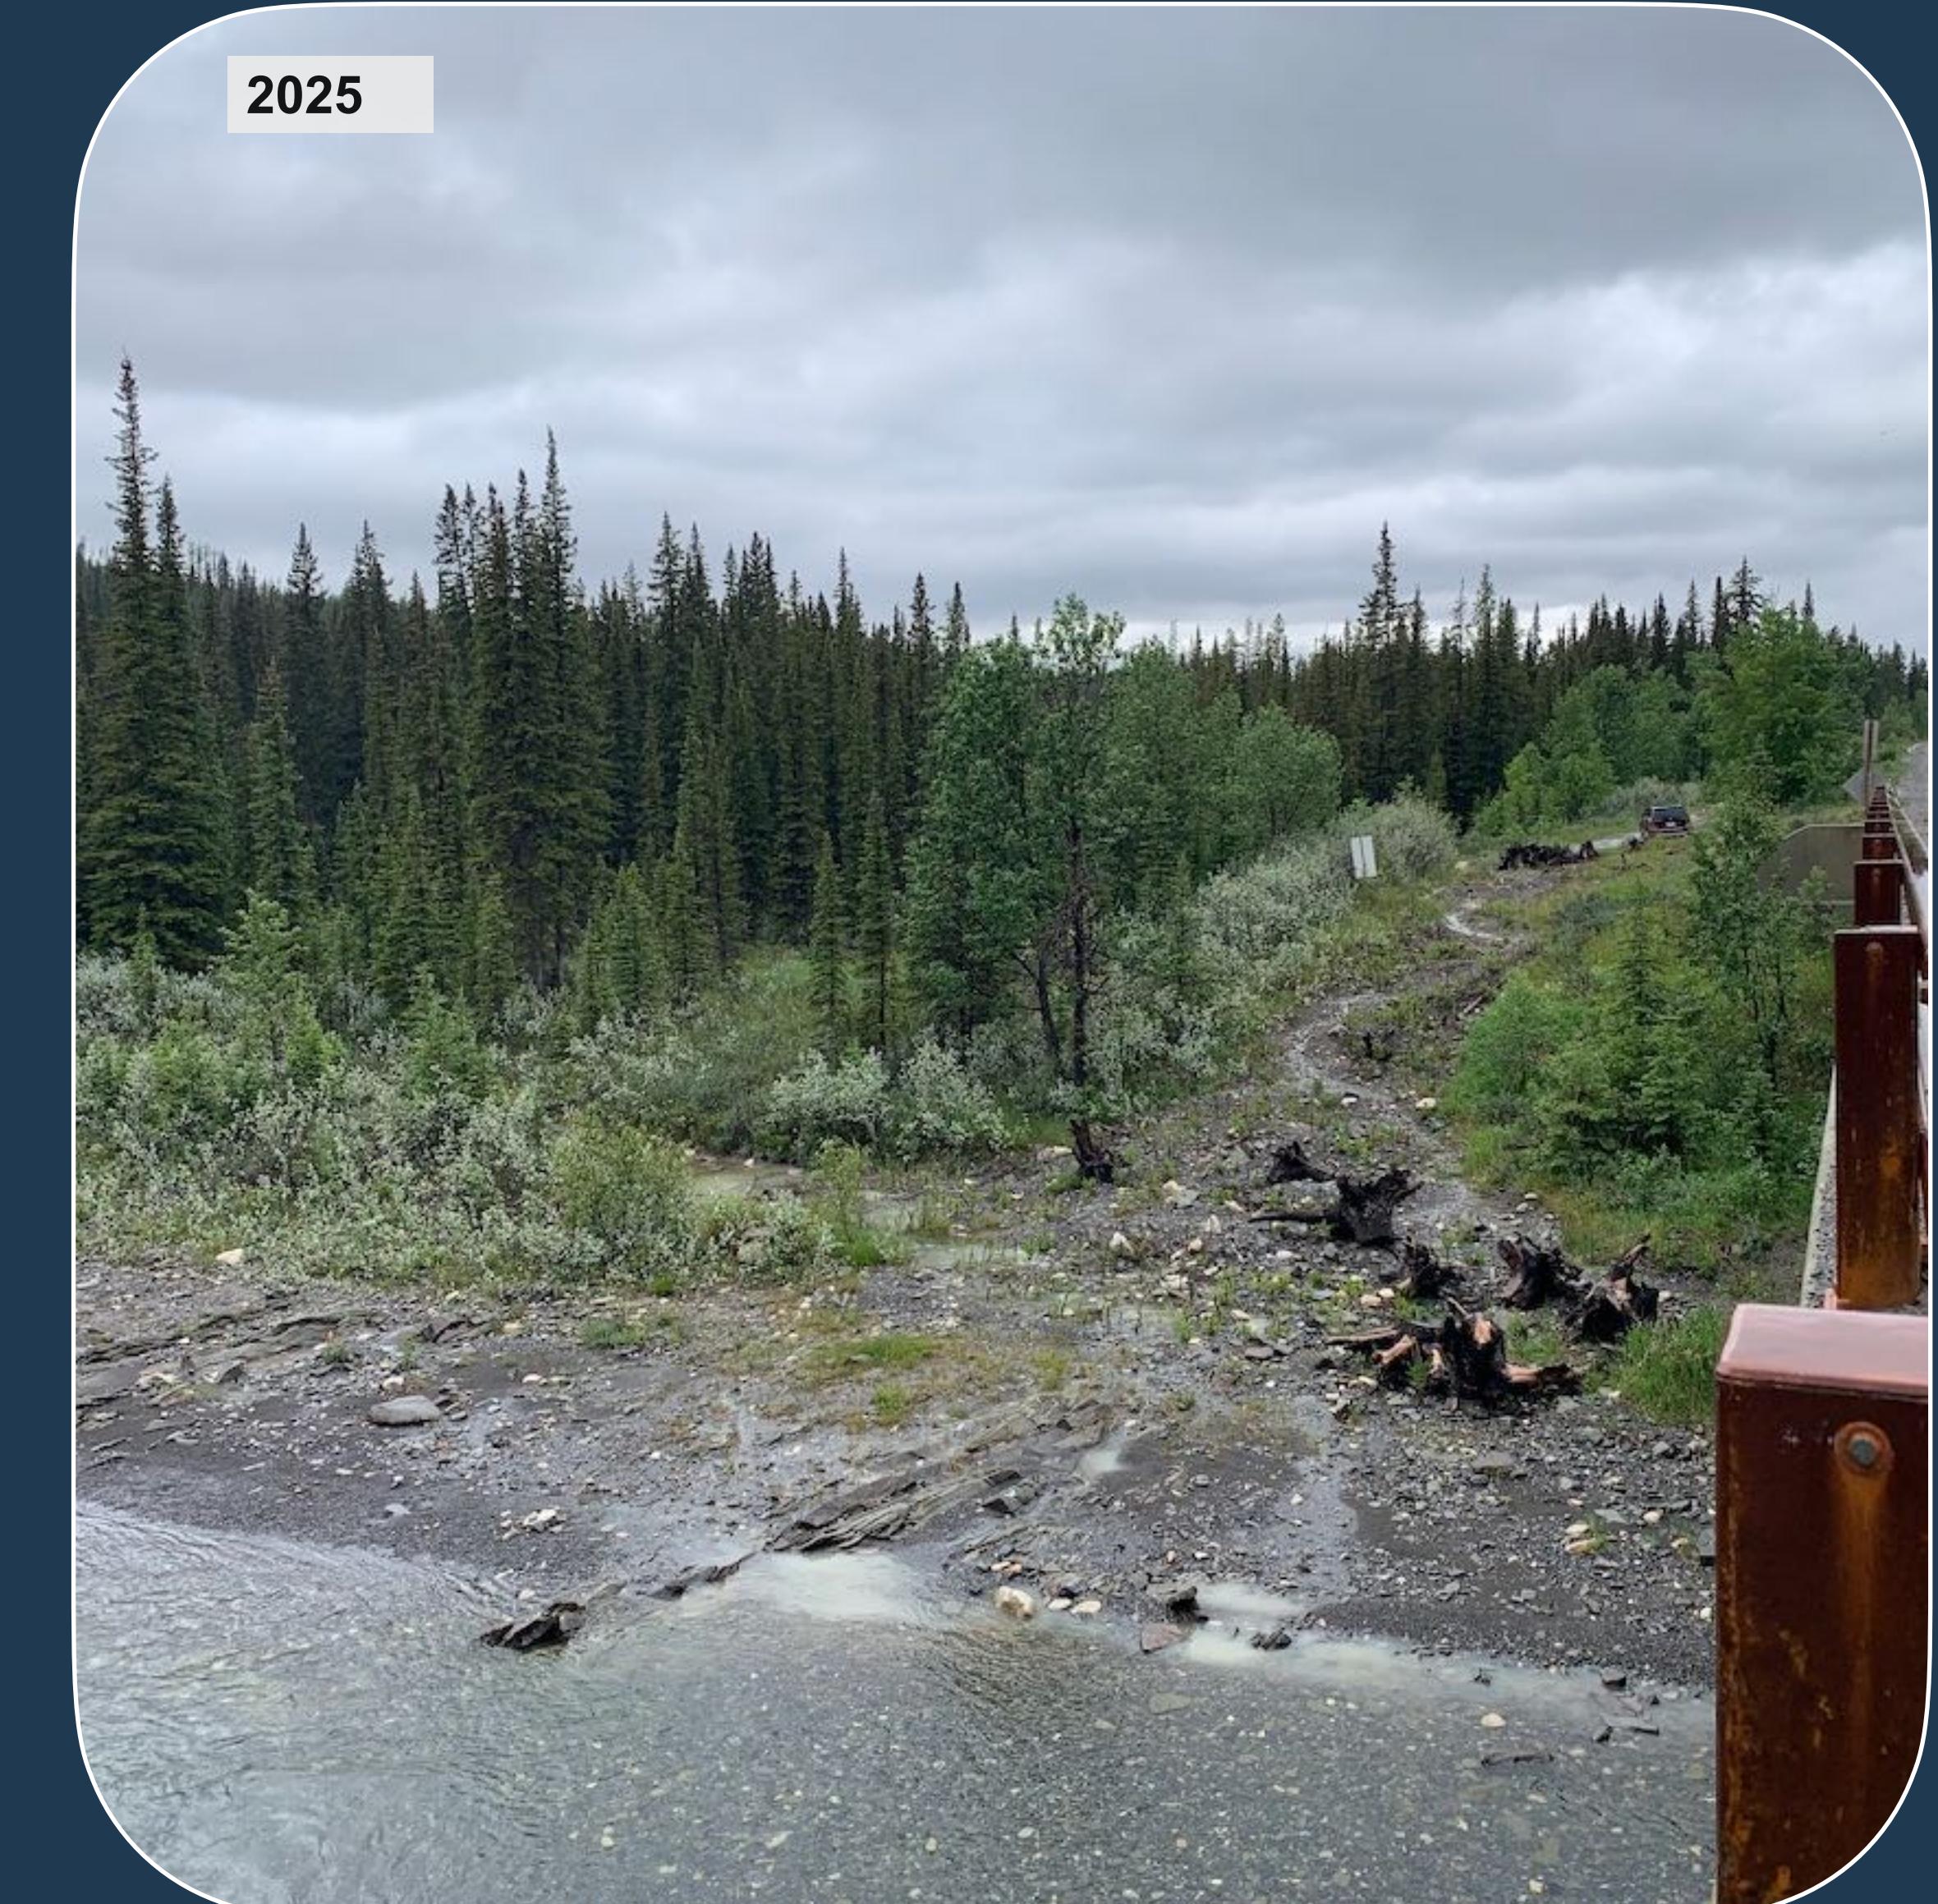
# Waiparous Creek Bio-engineering Site

2021

2025
