# Our Work in the Ghost Watershed in 2025

Presented by:  
Marina Krainer  
Executive Director

GWAS AGM  
November 8, 2025

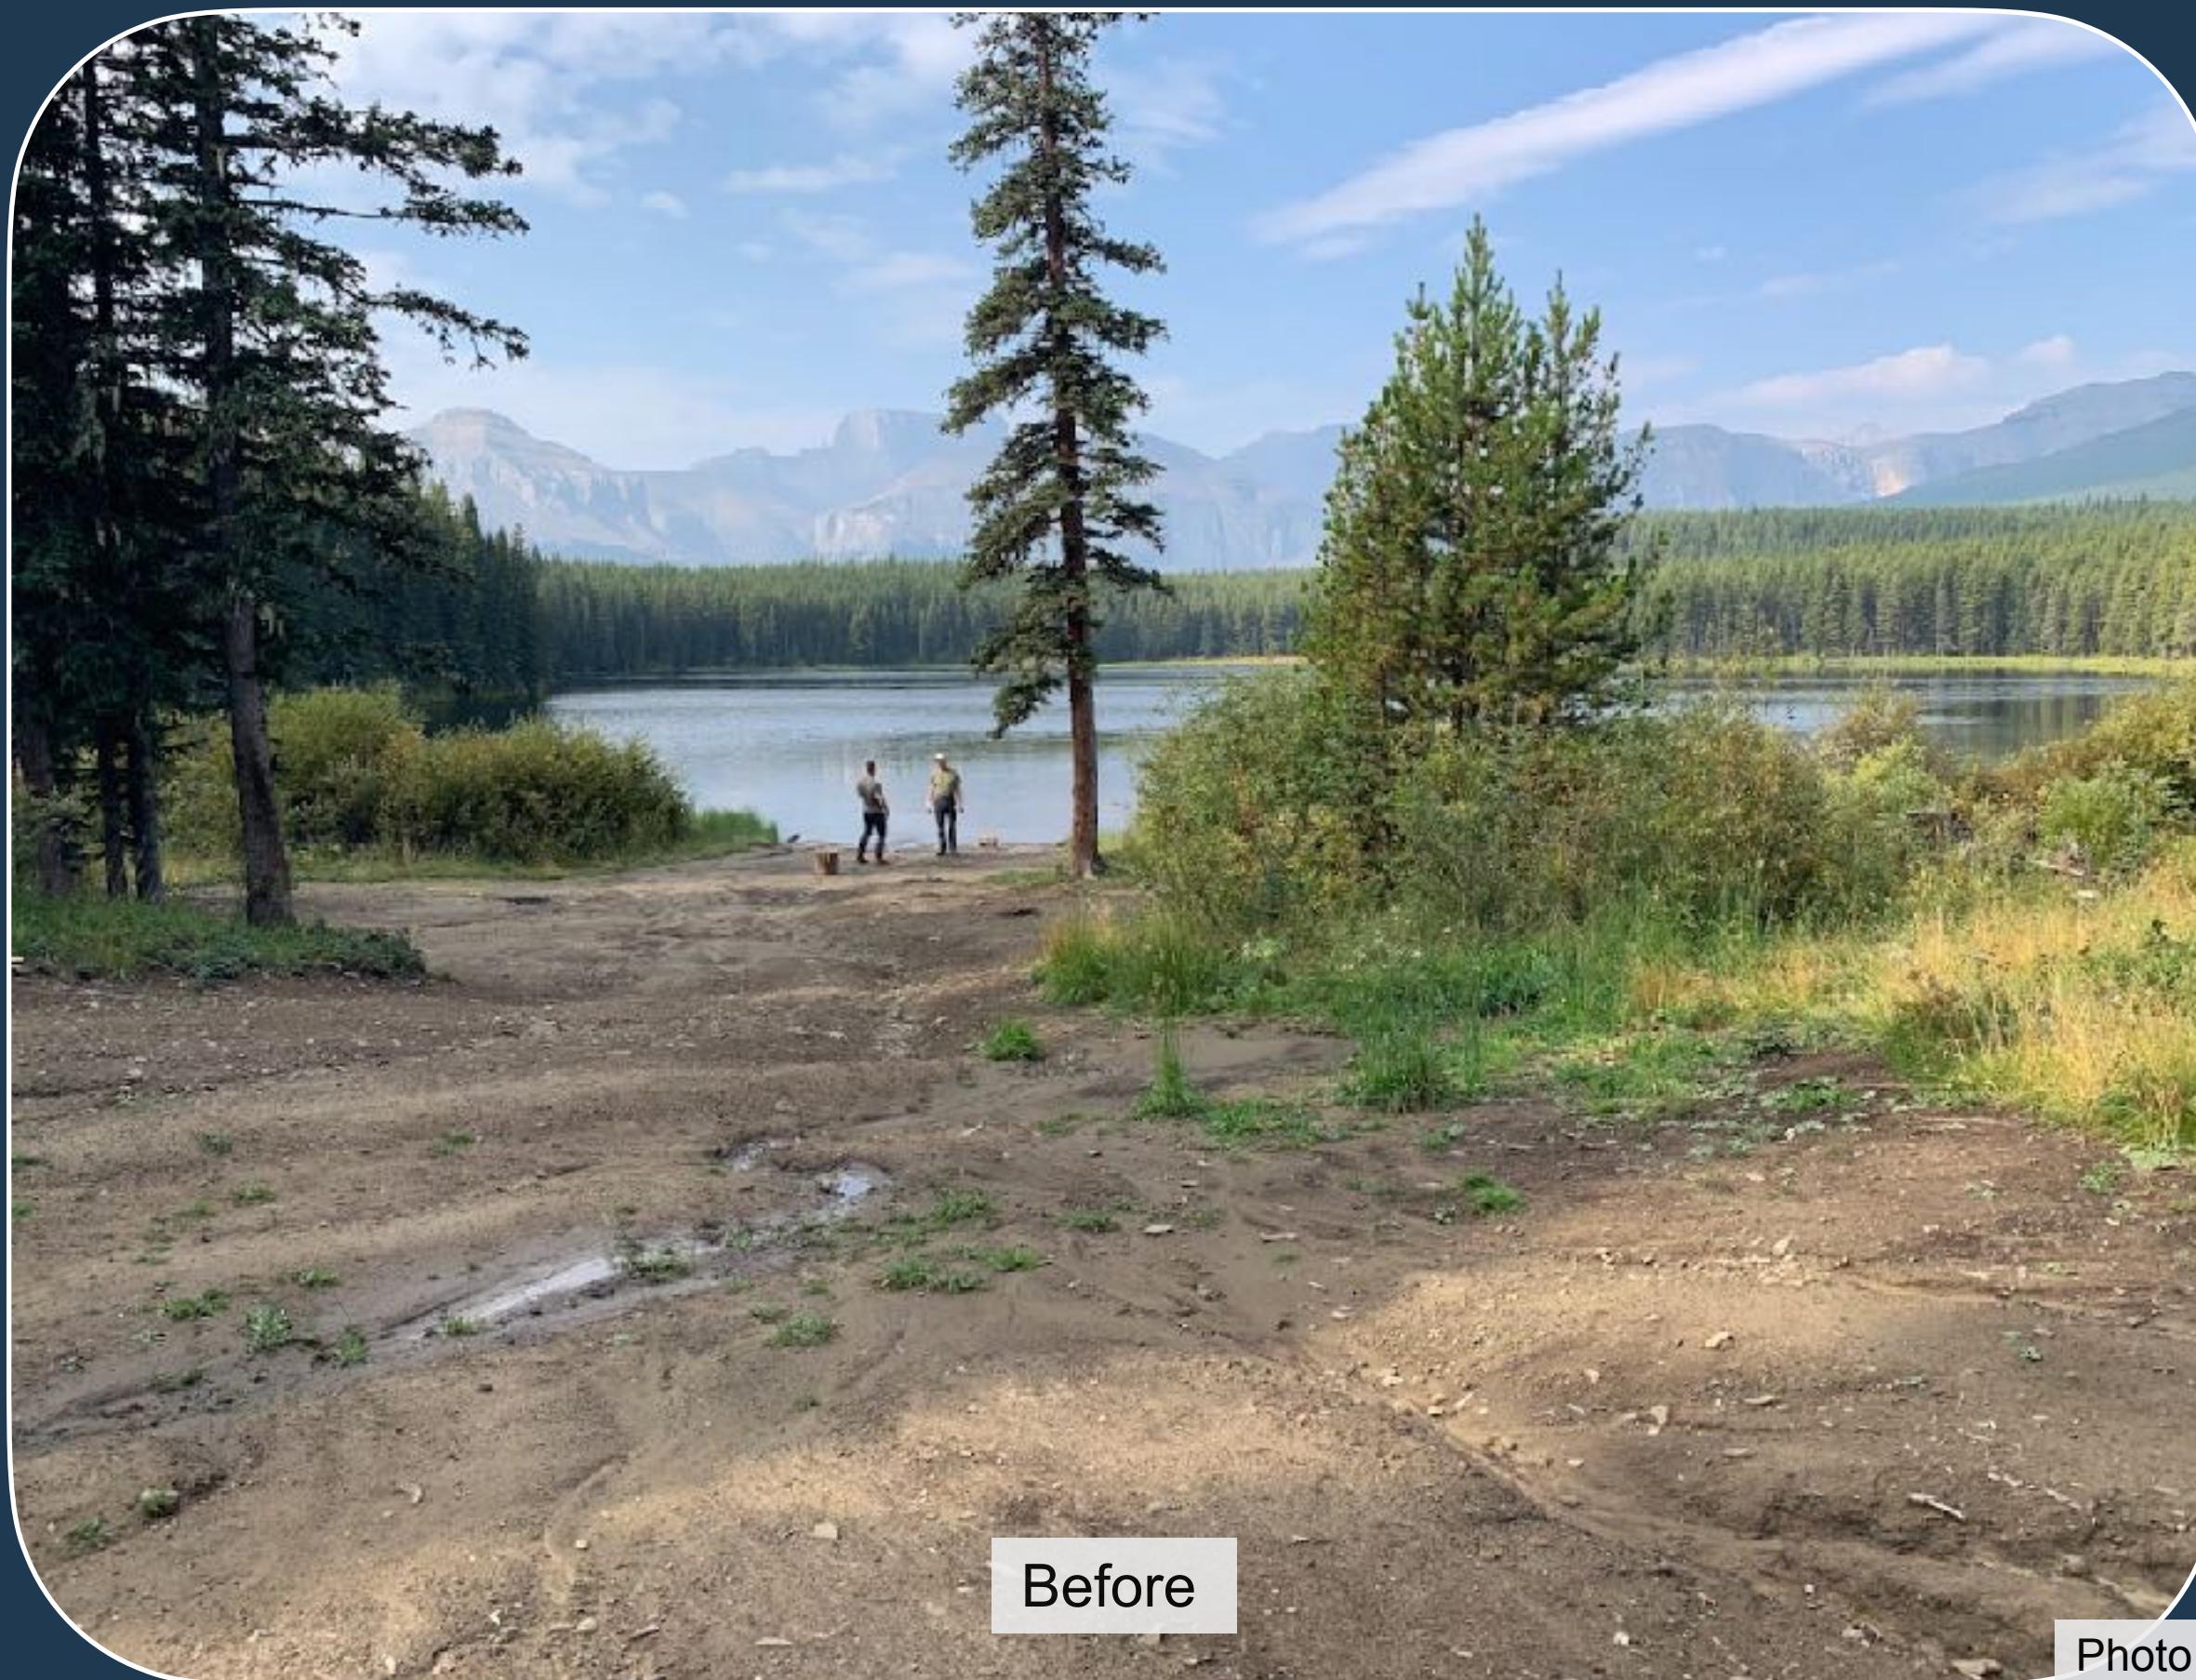
Before

- ♦ September 13: Bio-engineering to revegetate approach to lake
- ♦ Willow staking, transplanting spruce seedlings
- ♦ Collected and spread local seeds
- ♦ Spread mulch and large woody debris

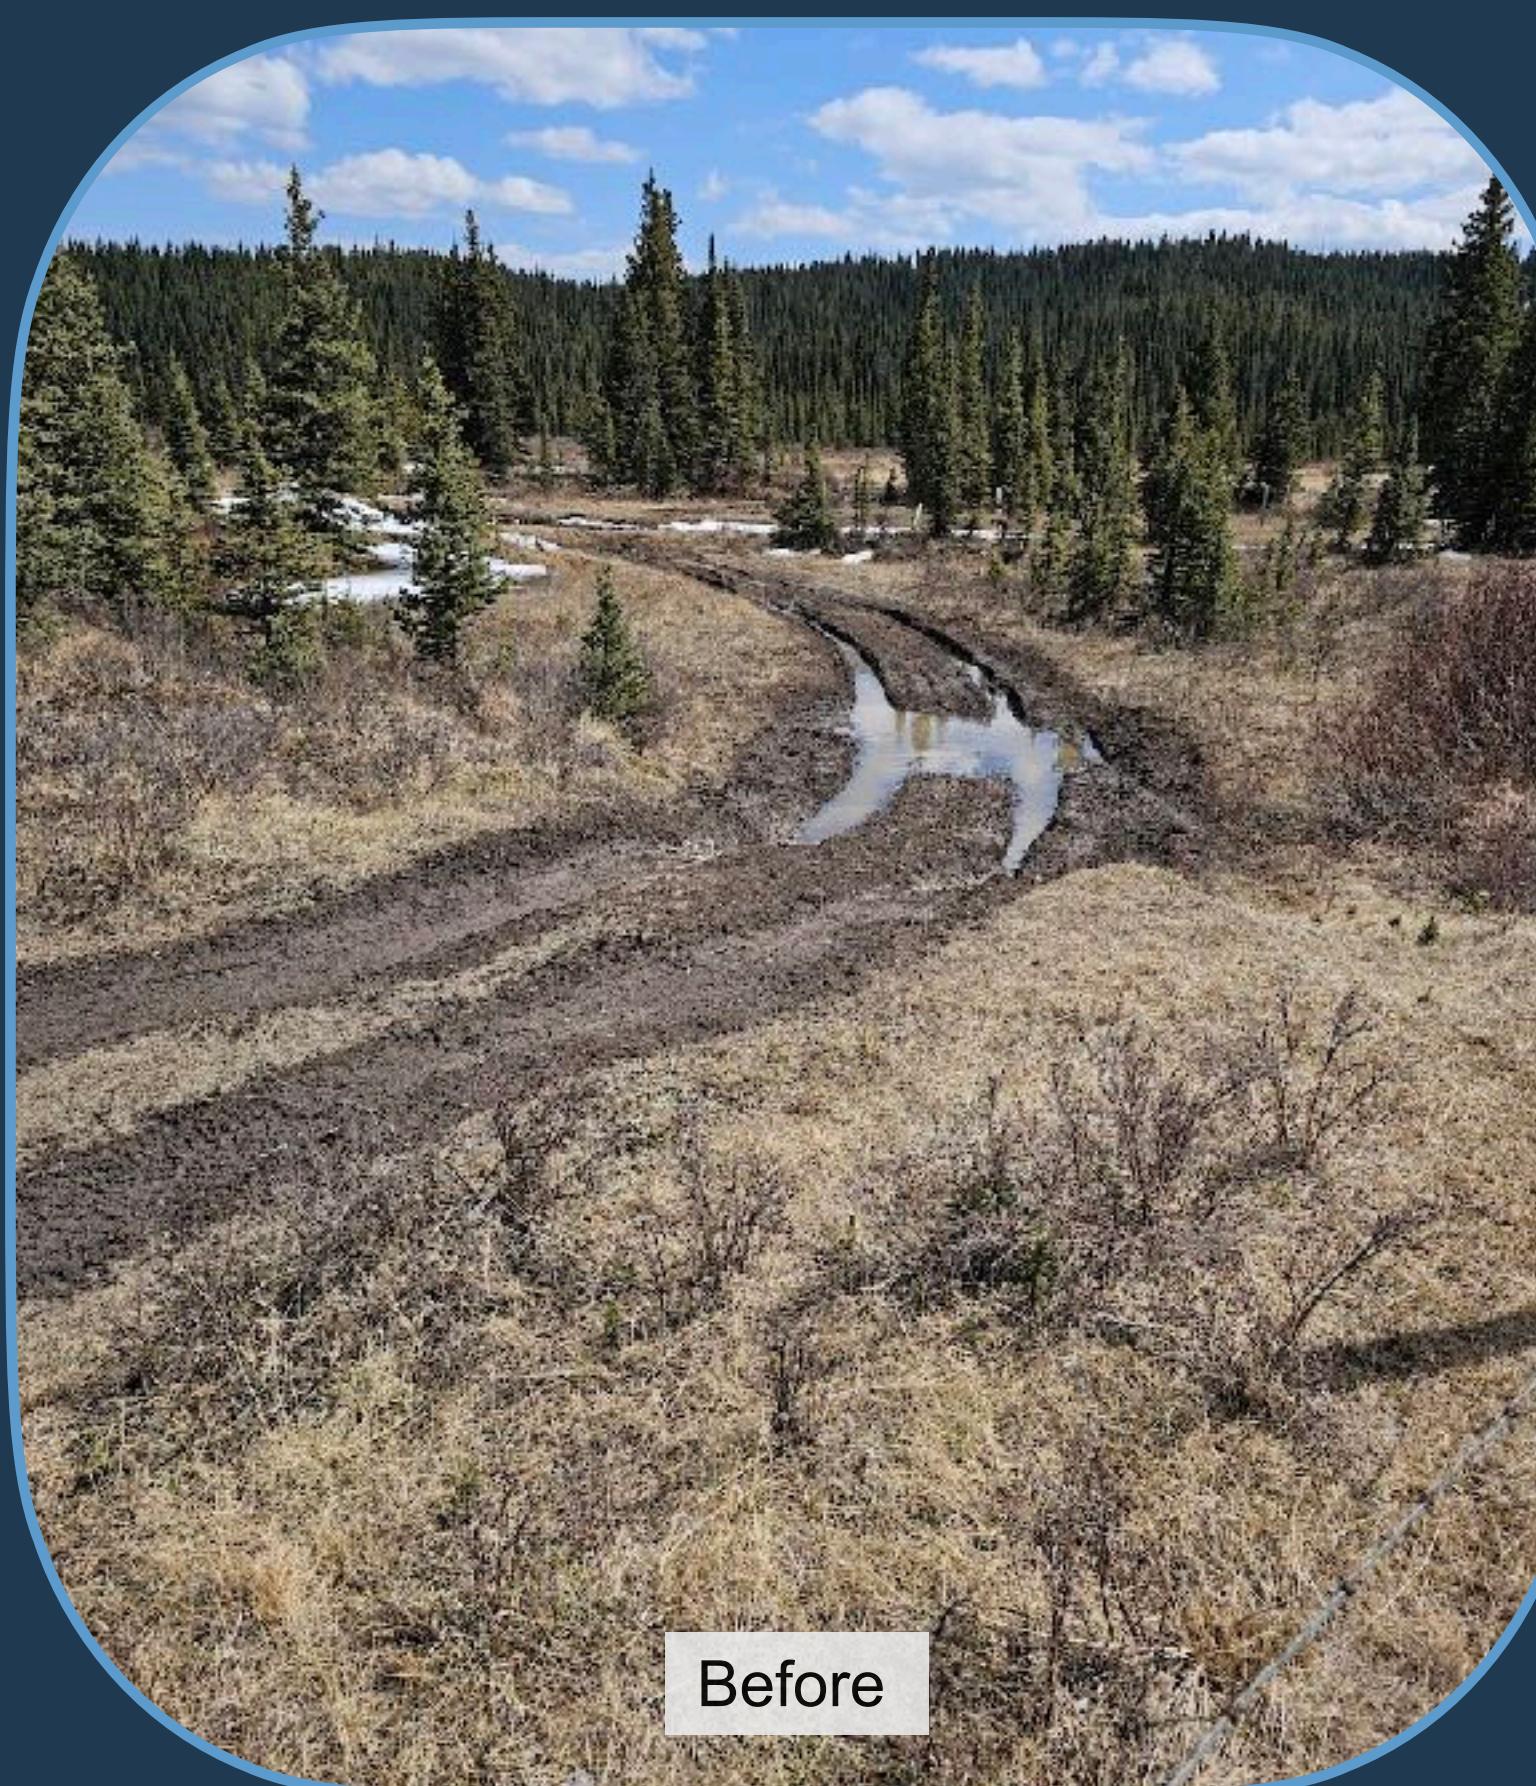
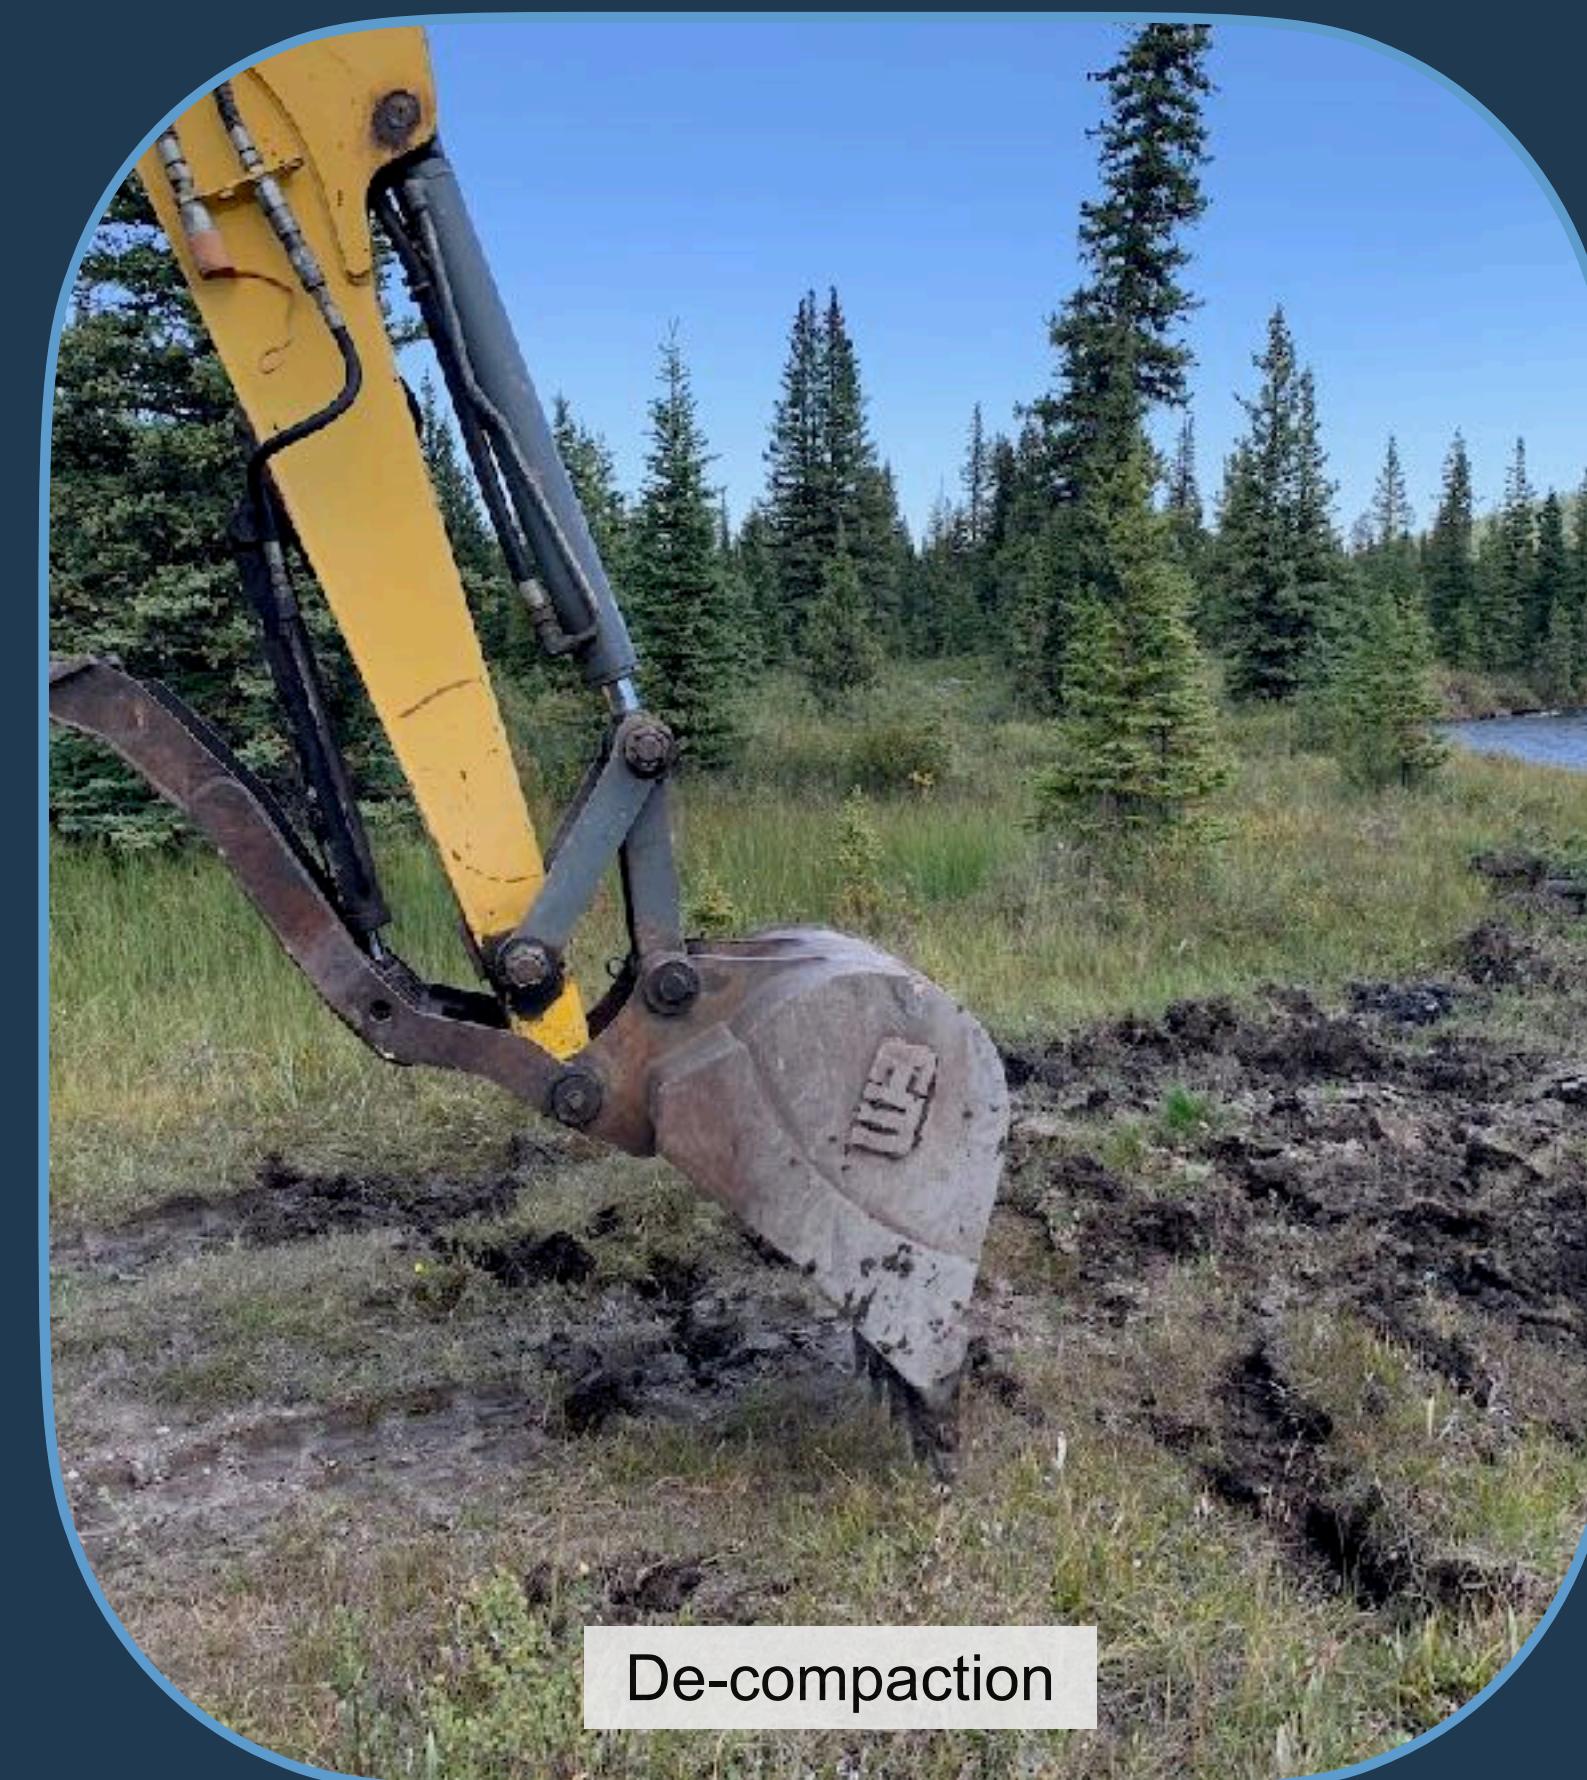
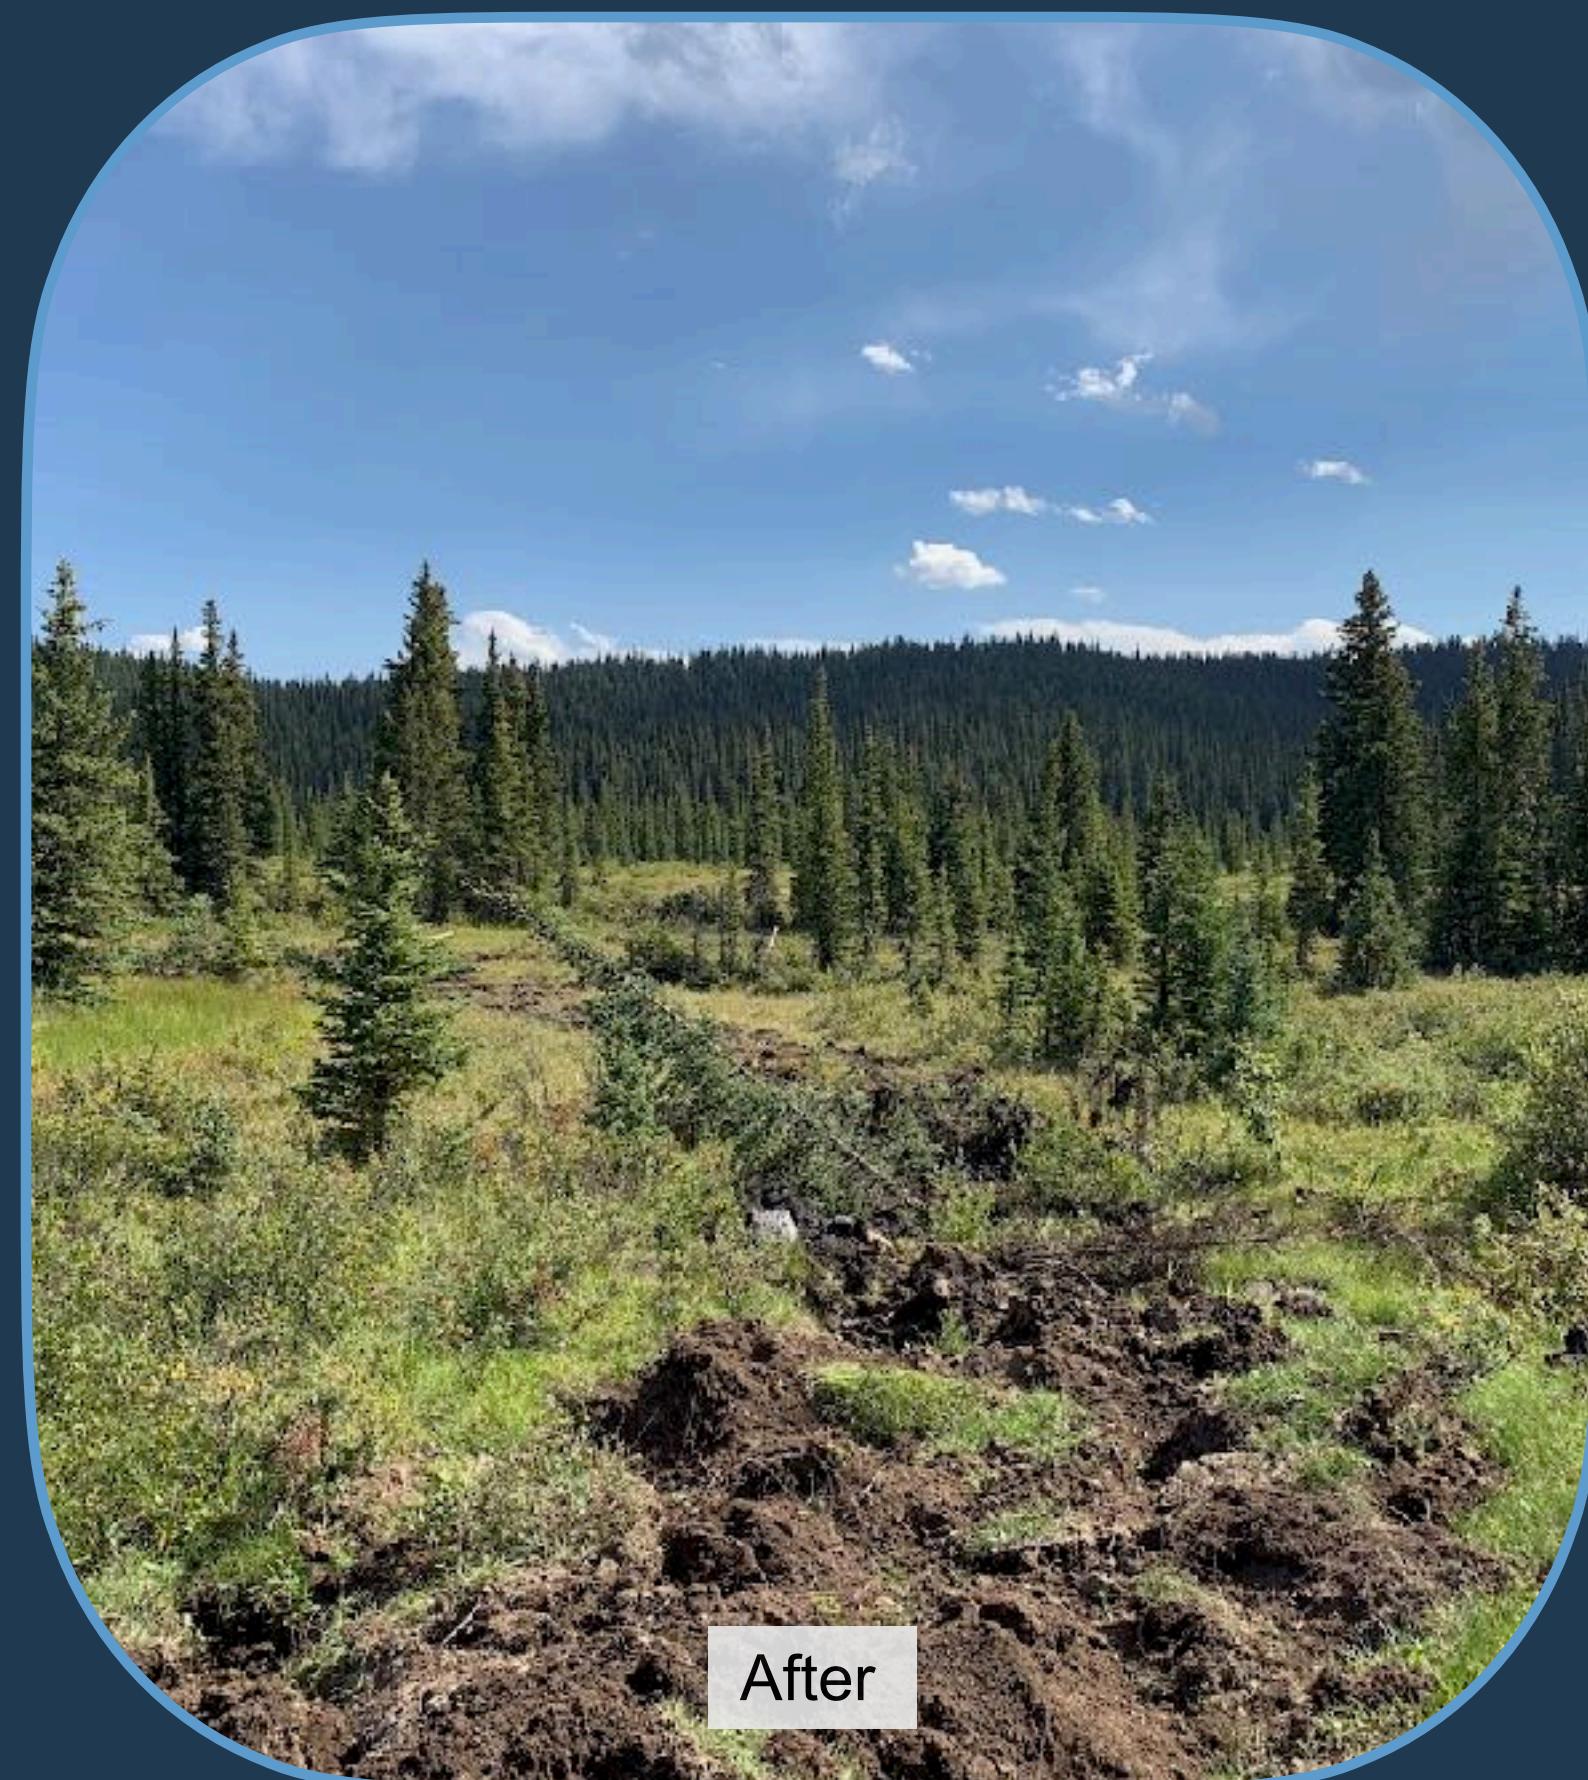
- ♦ August 26: Site preparation with equipment at Johnson Creek

Before

De-compaction

After

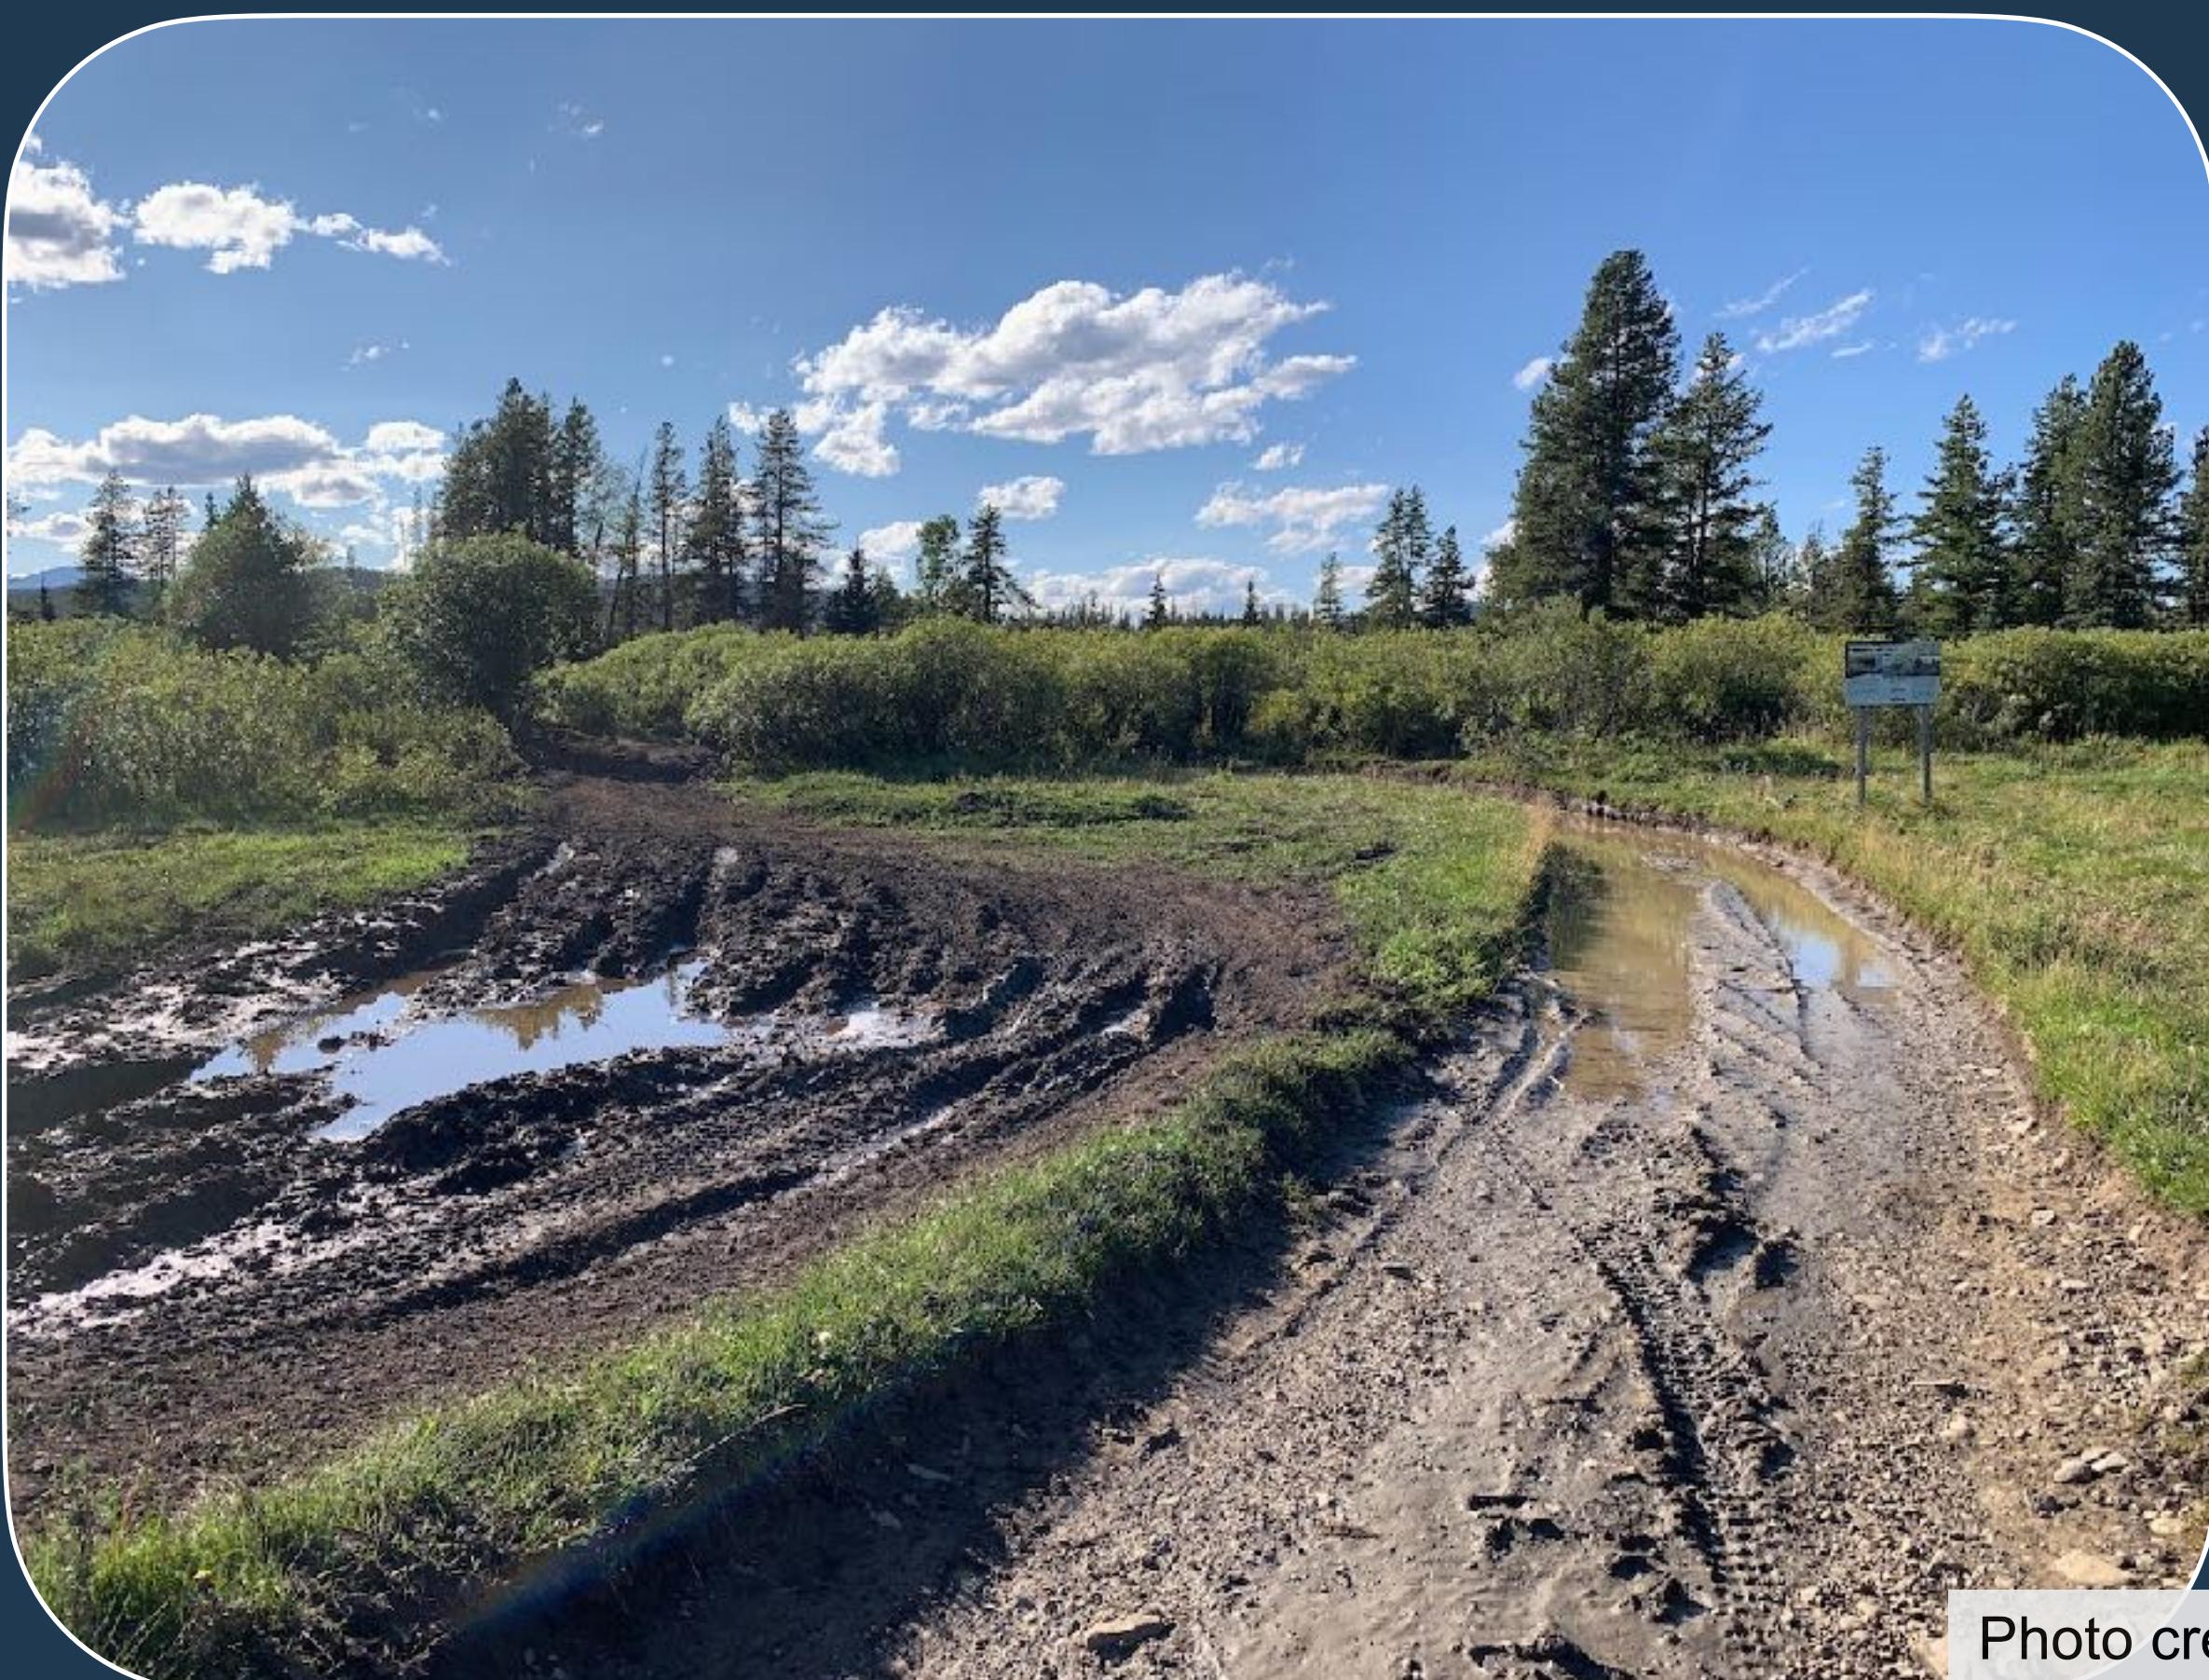
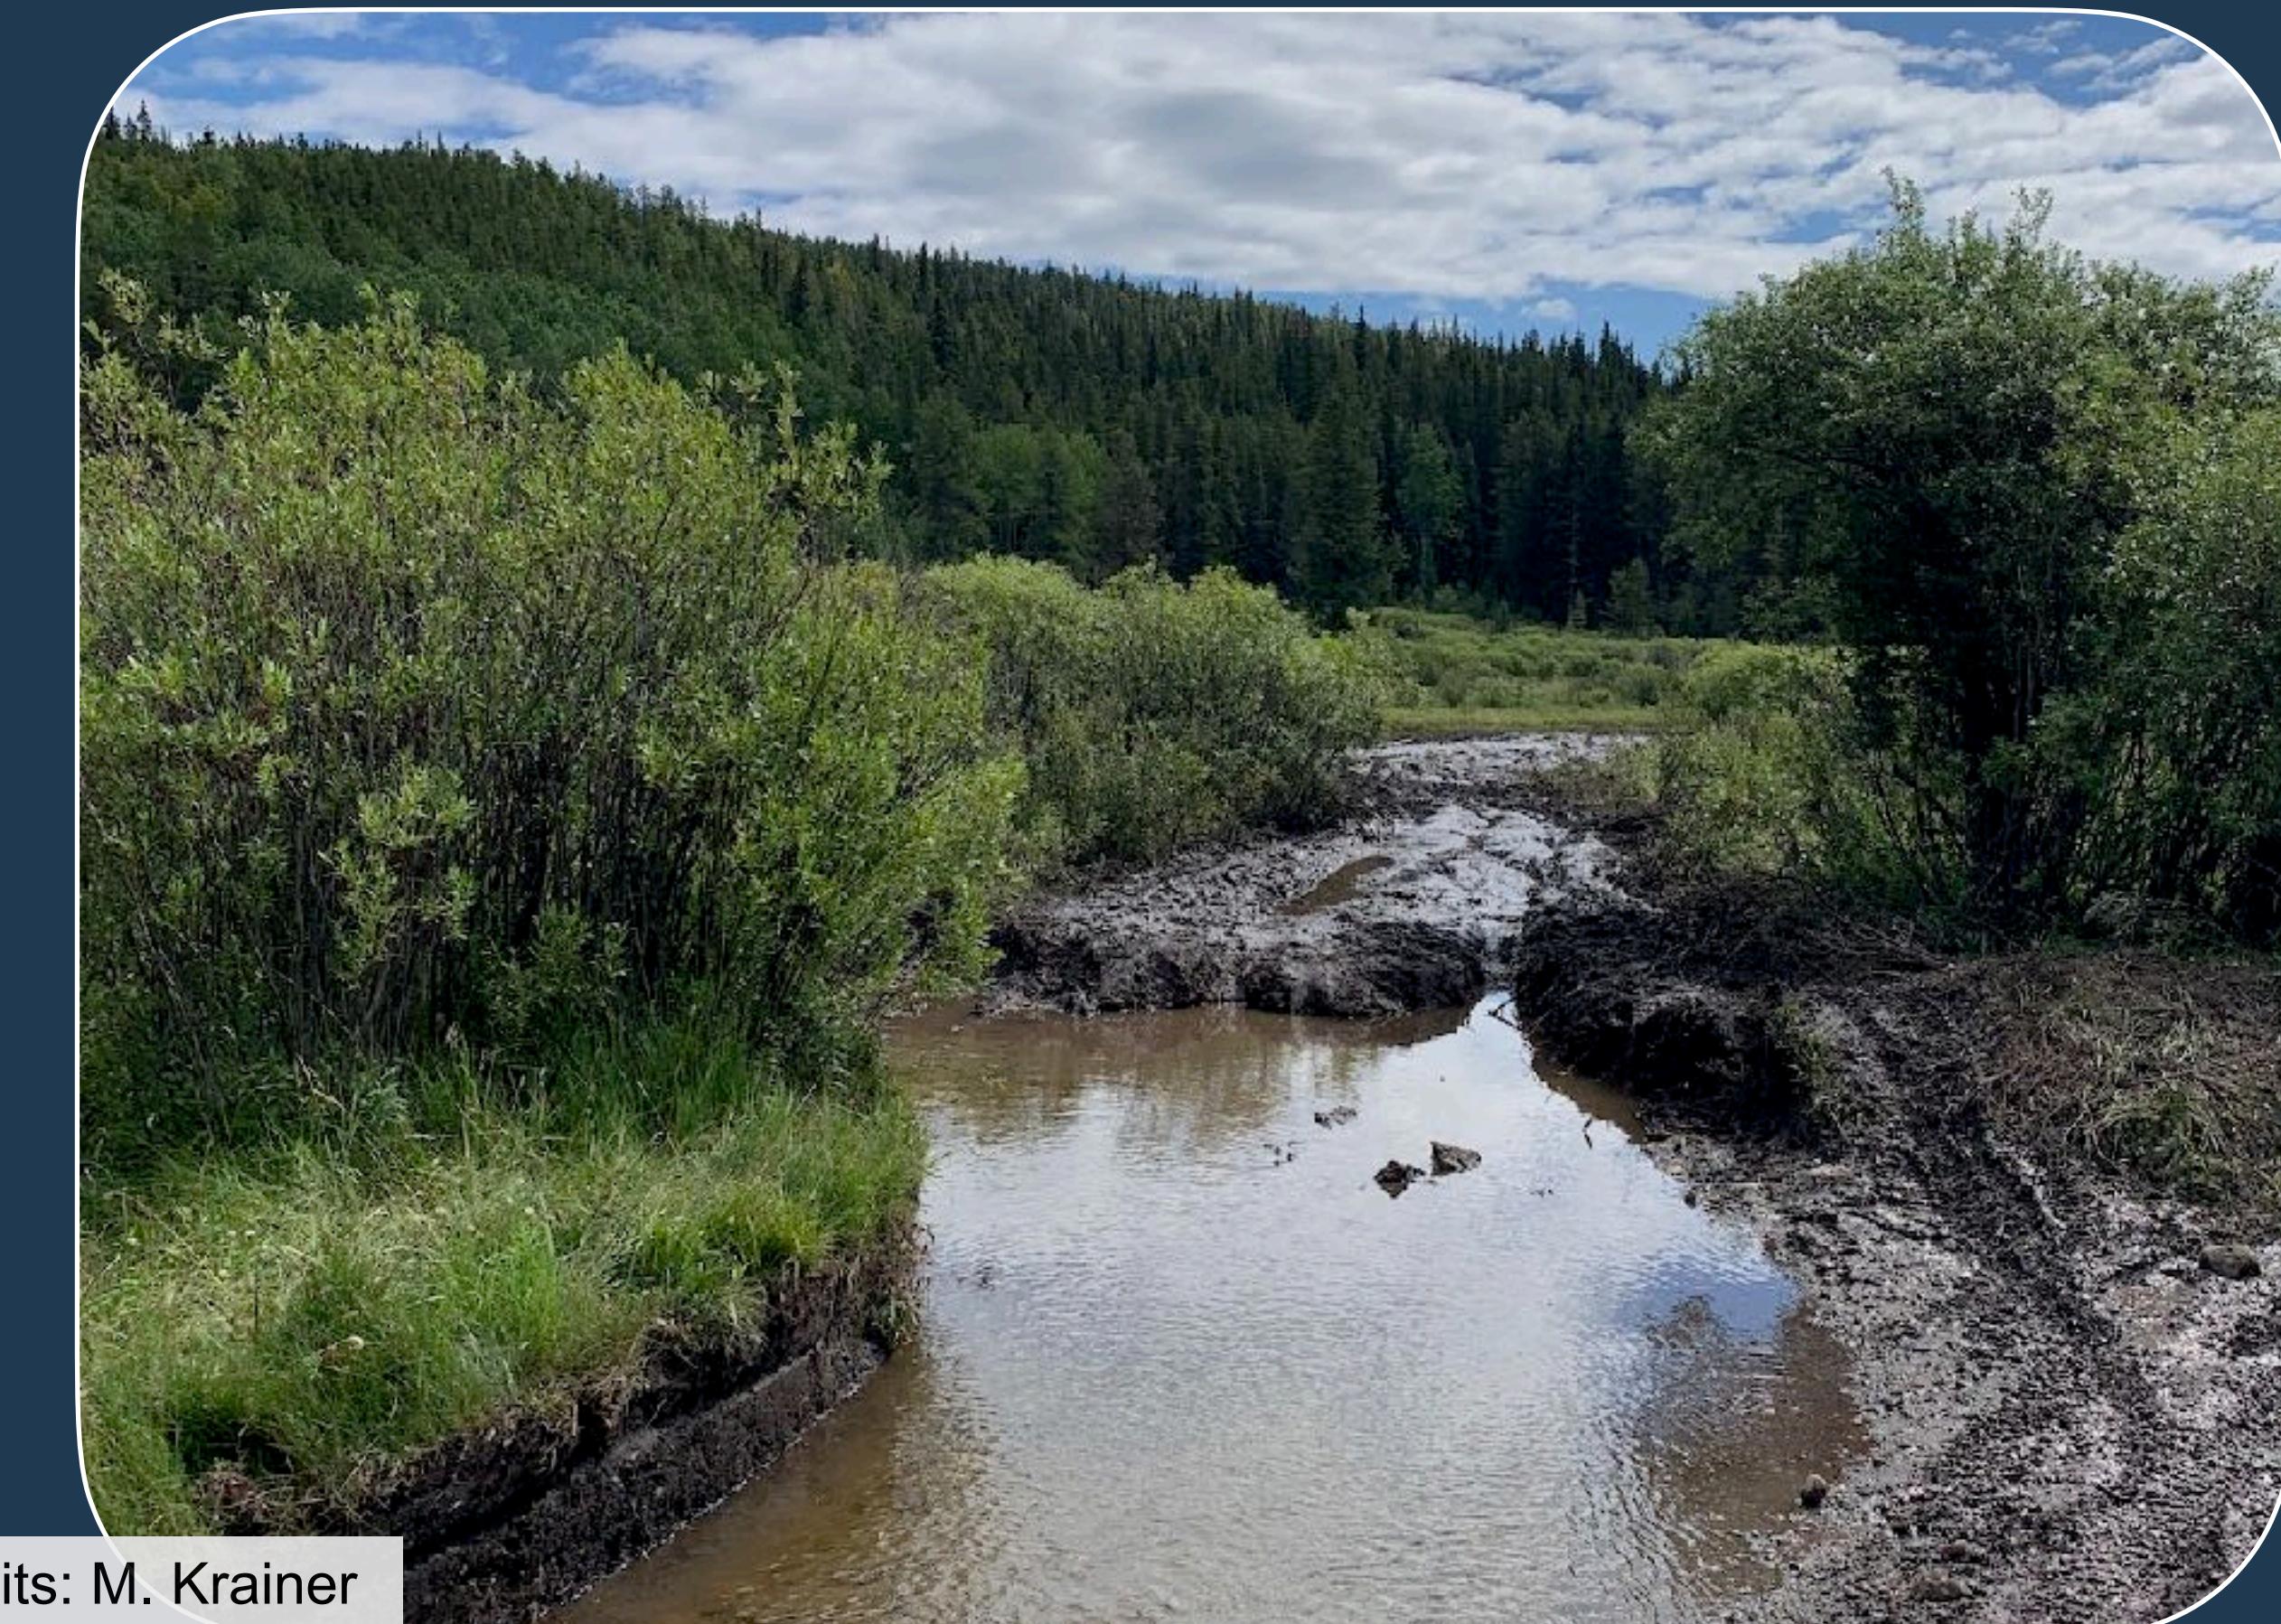
- ◆ Heavy rain caused beaver dam at gravel pit restoration site to overflow.
- ◆ Flooded designated trail and trail braiding occurred.
- ◆ Working with CARA, FCC and AEP to address the issue.
