Ghost River Watershed Riparian Health Inventory 2011 Highlights

March 10, 2012
Benchlands, AB

Ghost Watershed Riparian Health Project Area 2011

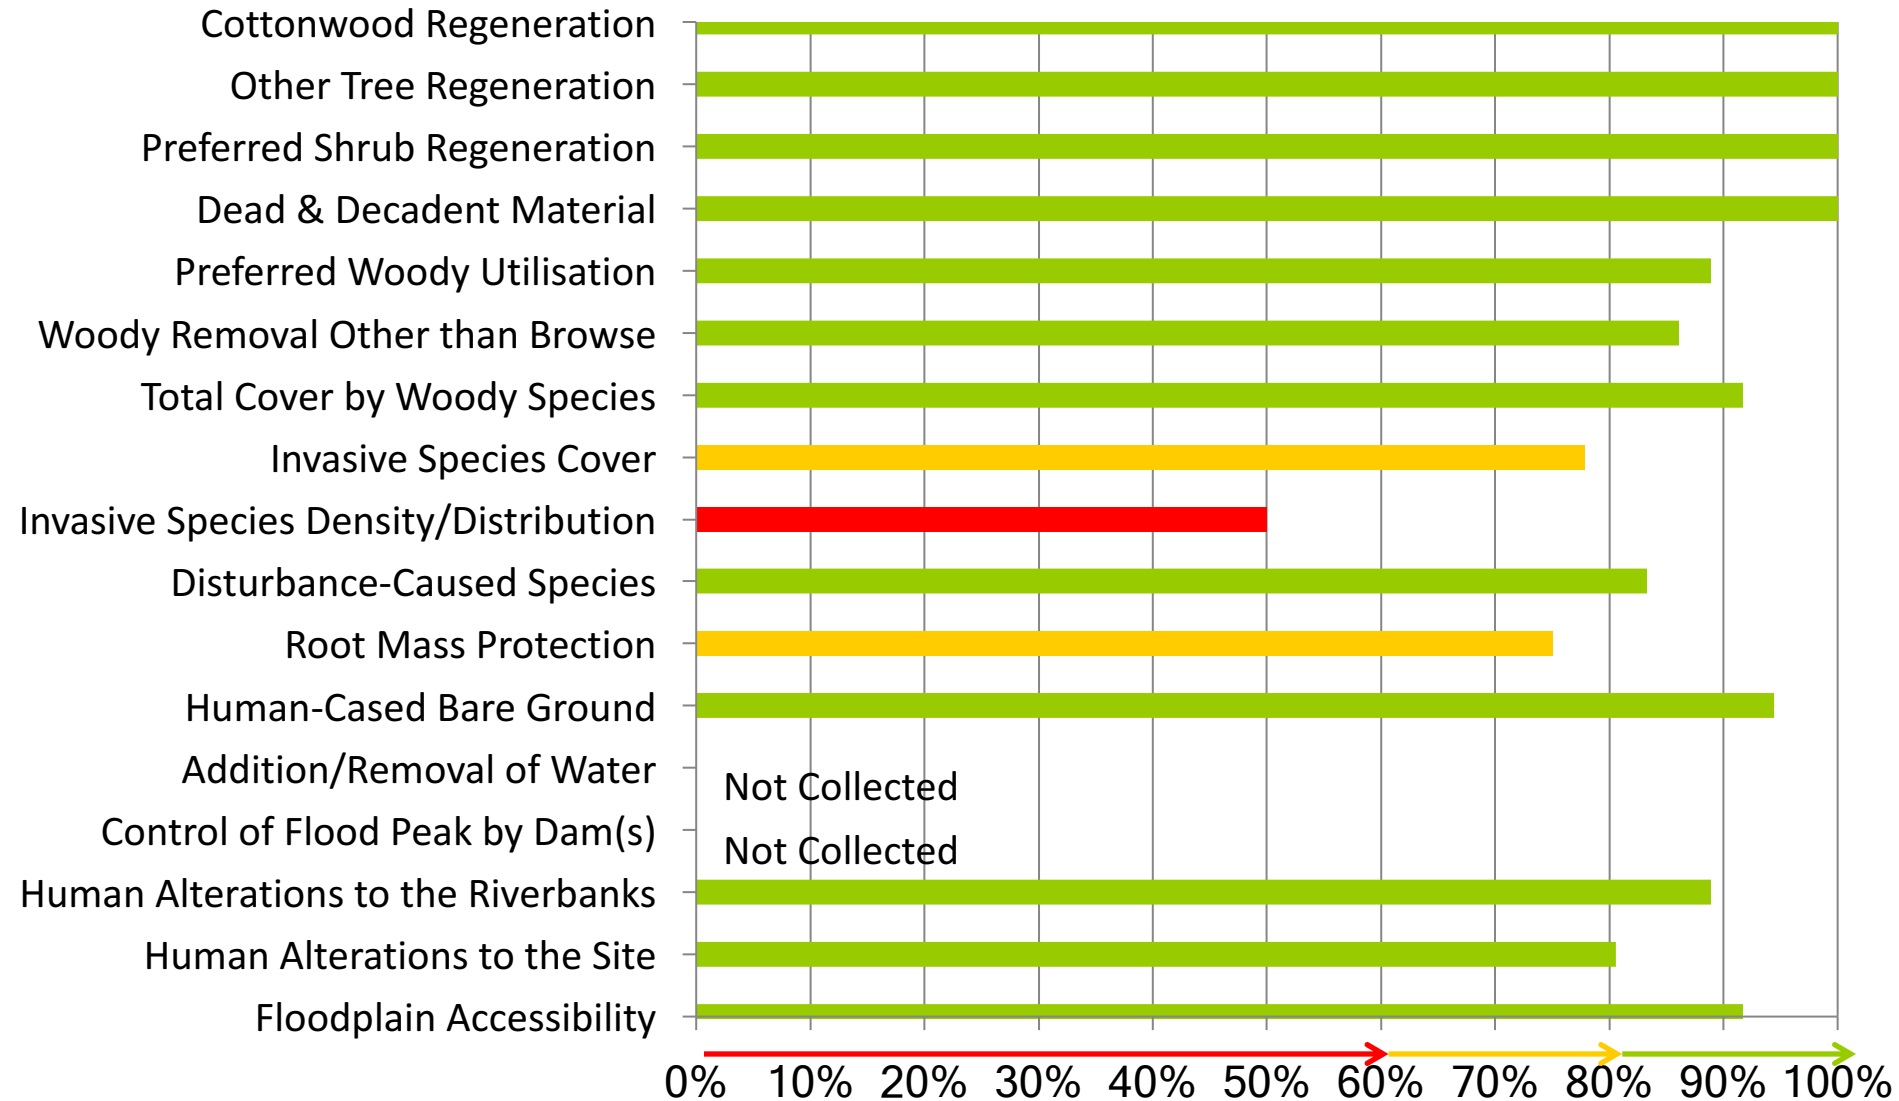
Evaluation of River Health Parameters (12 Sites)

88% Proper Functioning Condition (Healthy)

- 226 plant species identified, including ***5 invasive weeds*** and ***20 disturbance-caused plants***
- 66% covered by trees and shrubs
 - 7% of the riverbank physical altered, 88% due to construction
 - 2% exposed soil, 16% due to human-causes such as recreation

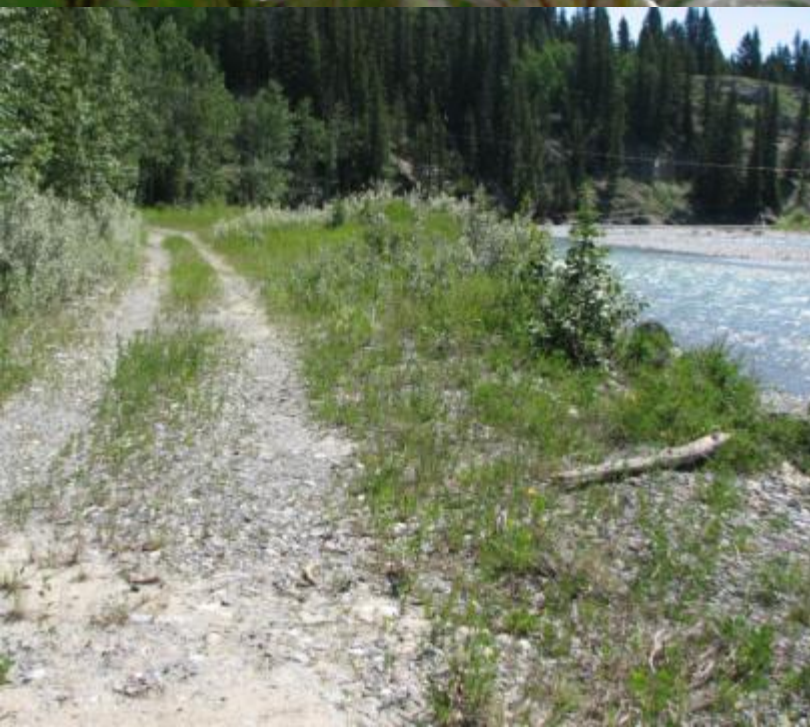
Yellow clematis
Canada thistle
Perennial sow-thistle
Ox-eye daisy
Yellow toadflax

***A Few Patches Plus Several
Sporadically Occurring Plants***

66-88% of the Riverbank with
Deep Binding Roots

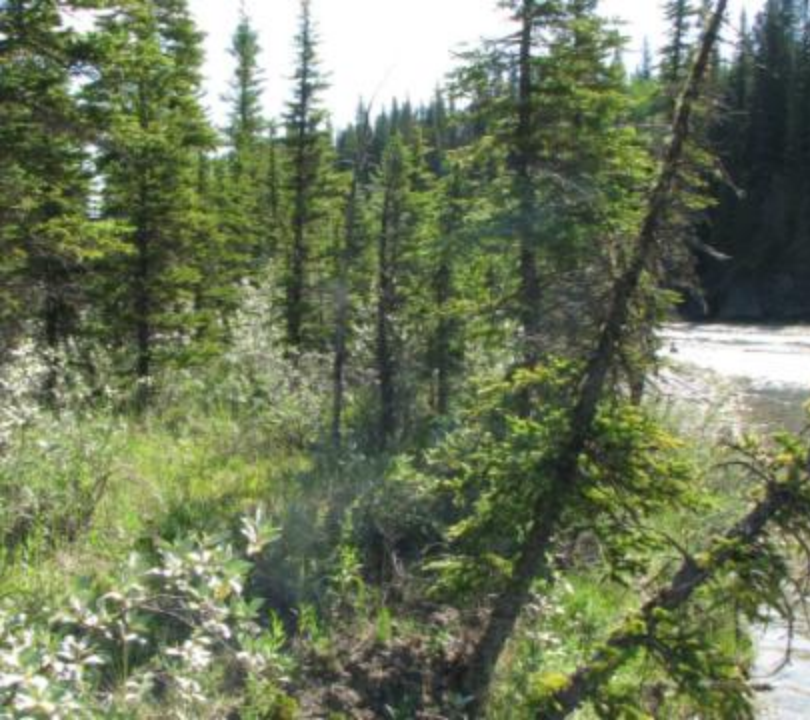
Plant community differs
immediately downstream of the
diversion

***<5% tree cover immediately
downstream of the diversion***

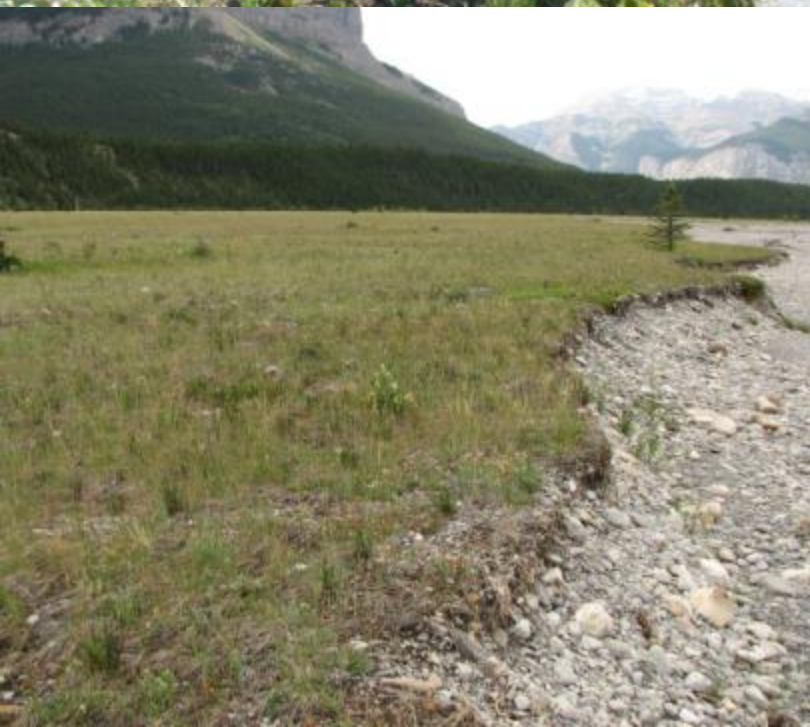
Typical white spruce and willow
community is missing

Increased sedimentation bare
ground upstream of the Ghost
River Dam

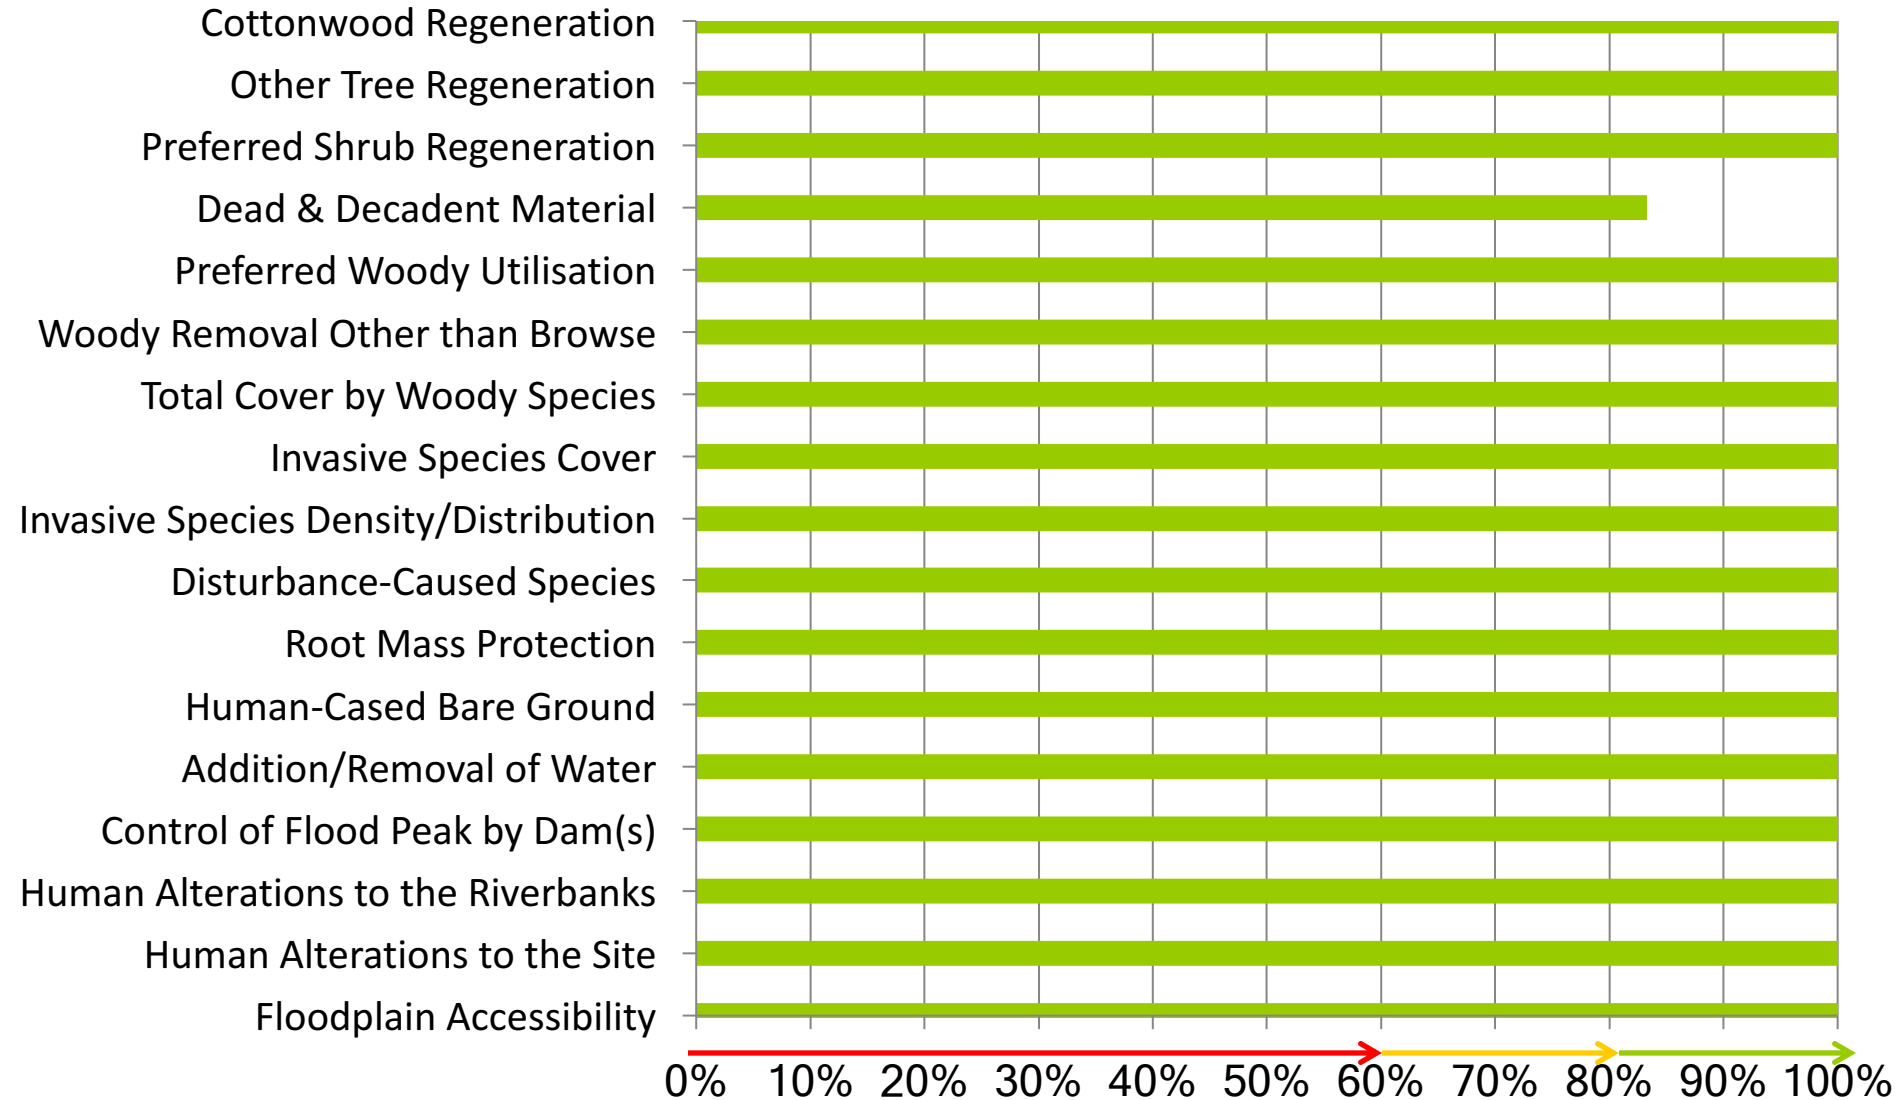
Evaluation of River Health Parameters (2 Sites)

99.5% Proper Functioning Condition (Healthy)

- 86 plant species identified, including *only 4 disturbance-caused plants*
- 80% covered by trees and shrubs
- One site with >5% of the woody community dead and/or decadent
- No human-caused alterations were observed

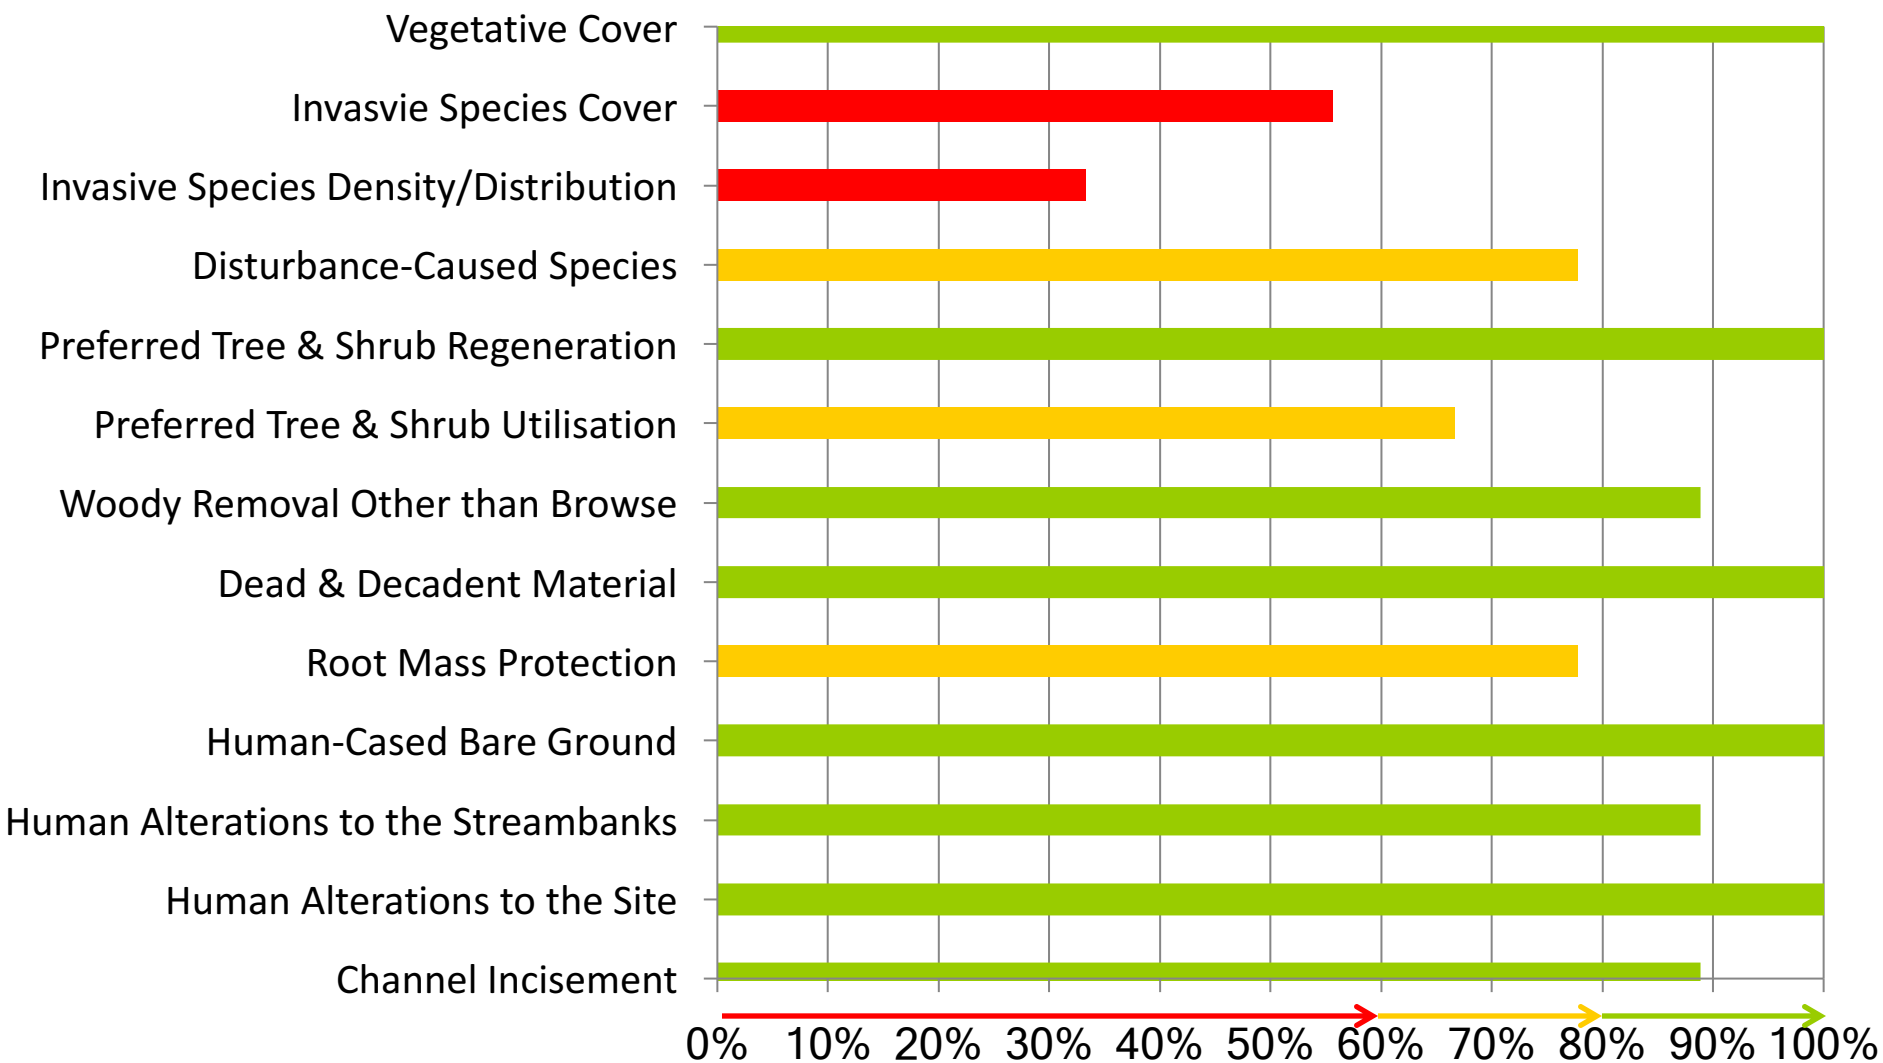
Evaluation of Stream Health Parameters (3 Sites)

86% Proper Functioning Condition (Healthy)

- 116 plant species identified, including ***2 invasive species and 11 disturbance-caused plants***
- 52% covered by trees and shrubs
- 2% of the streambank physically altered due to livestock trampling
- Only a trace amount (<1%) of bare ground observed on one site

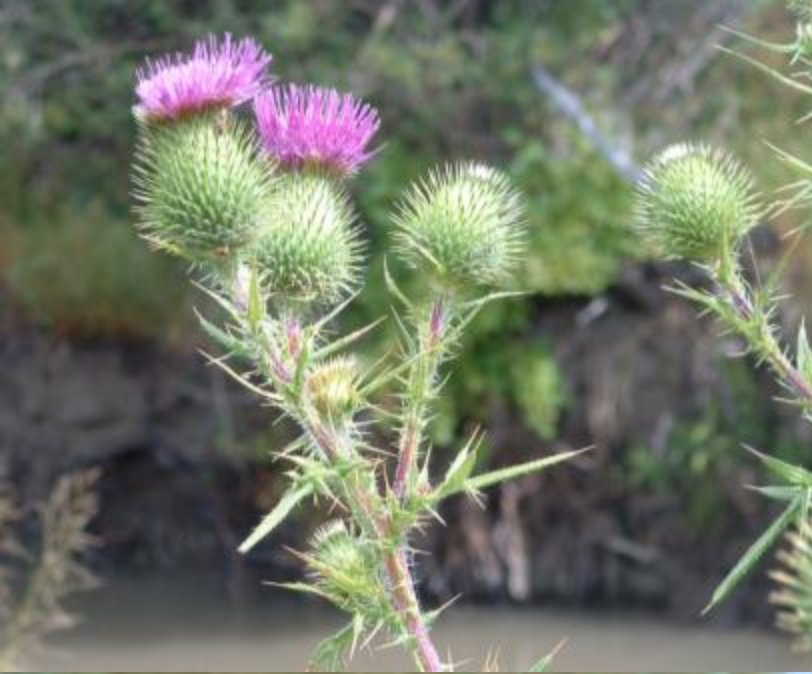
3% covered by invasive speices:
Canada thistle &
Perennial sow-thistle

***Scattered Individual Plants &
Several Well Spaced Patches***

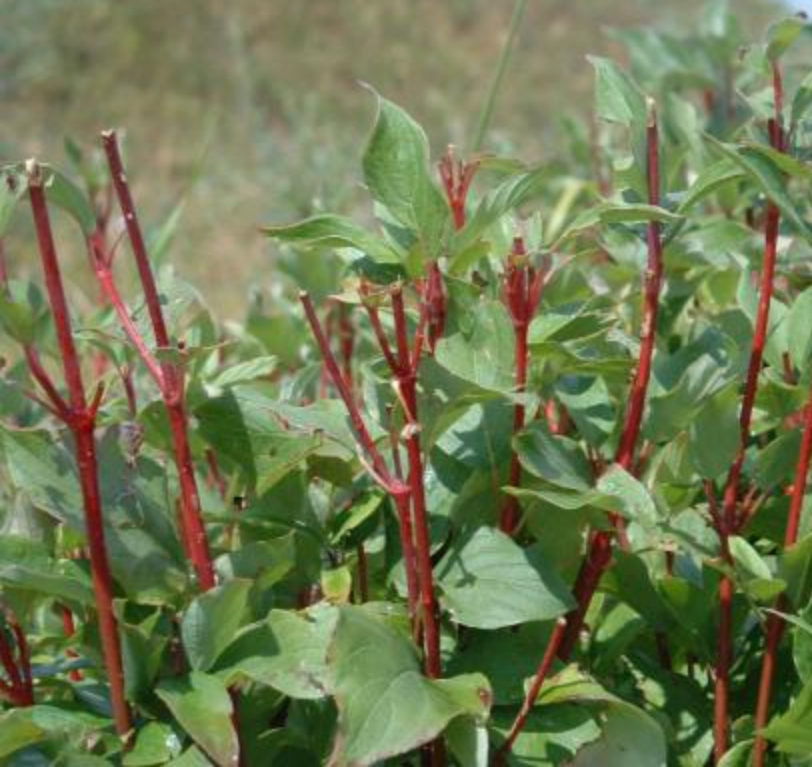
Disturbance-caused plants cover
8% of the riparian area

Browsing of preferred woody
species is light overall

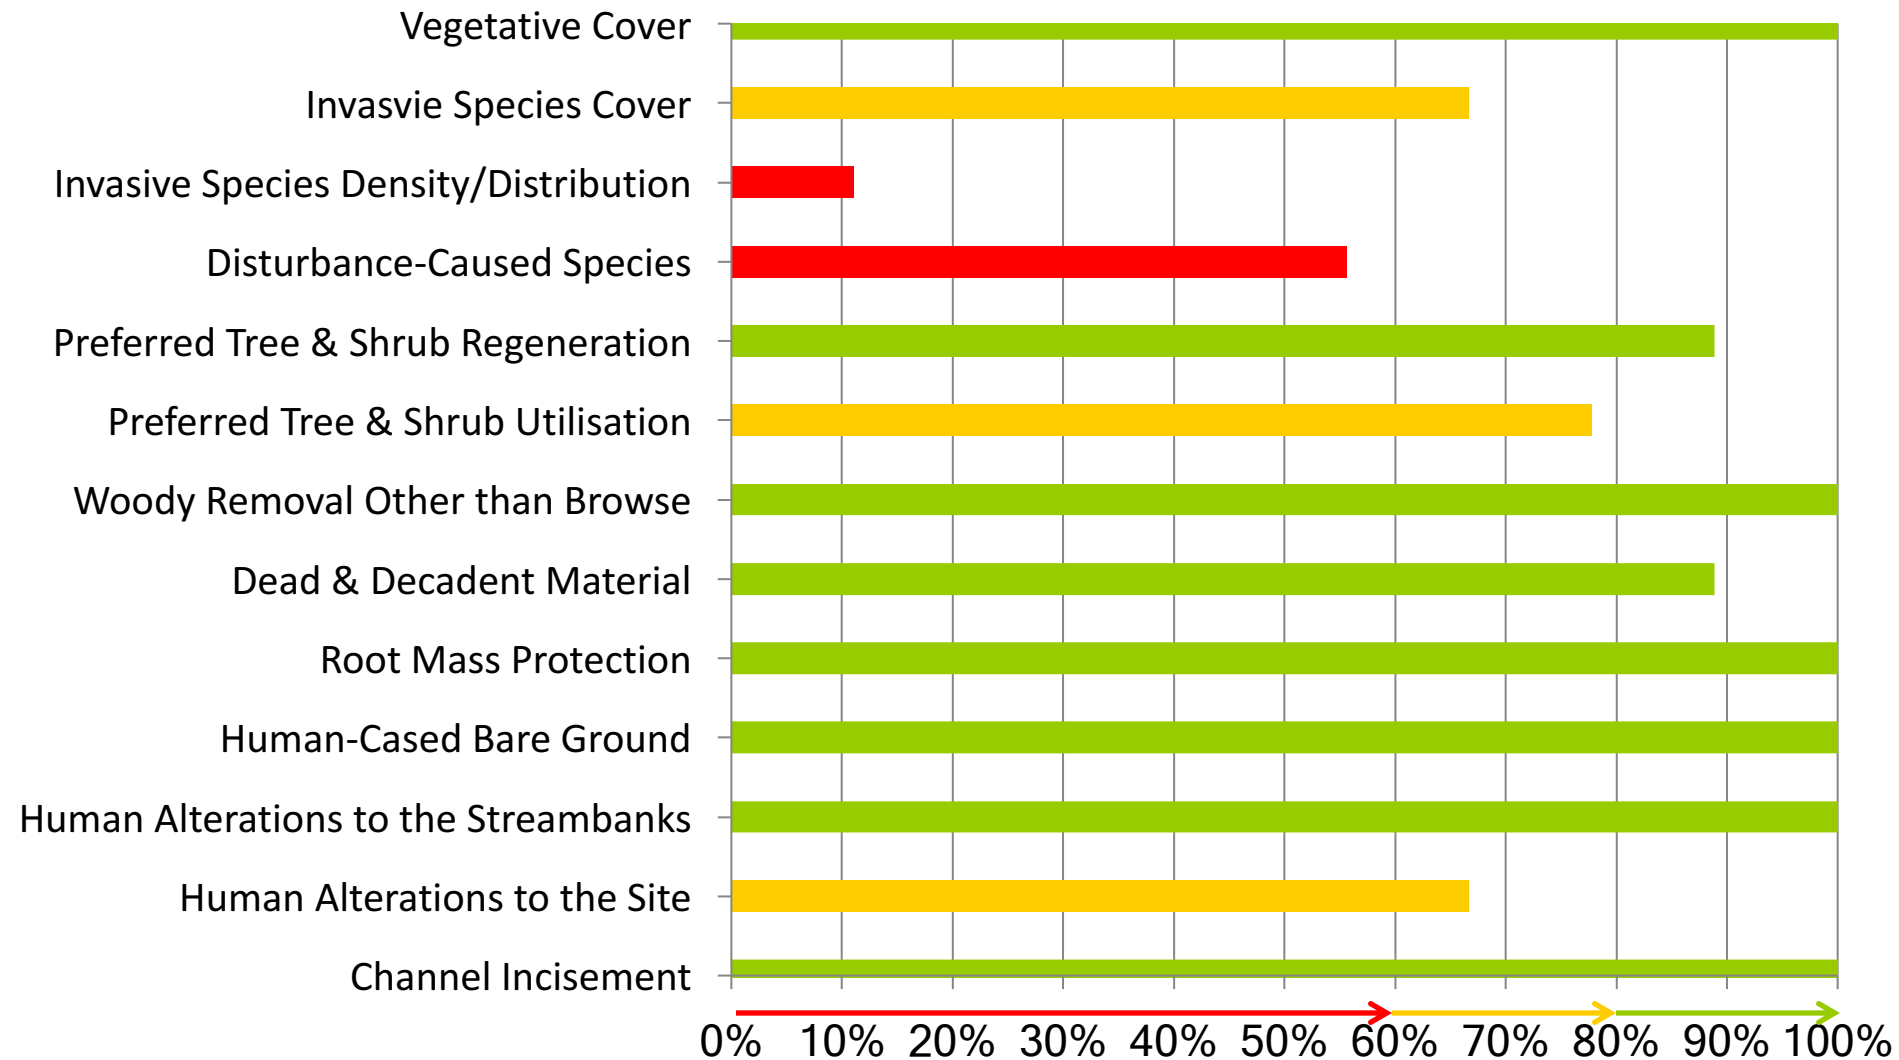
Evaluation of Stream Health Parameters (3 Sites)

87% Proper Functioning Condition (Healthy)

- 101 plant species identified, including ***2 invasive species and 13 disturbance-caused plants***
- 61% covered by trees and shrubs
 - **12% of the riparian area is physically altered by human activities**
- Only a trace amount of bare ground was observed

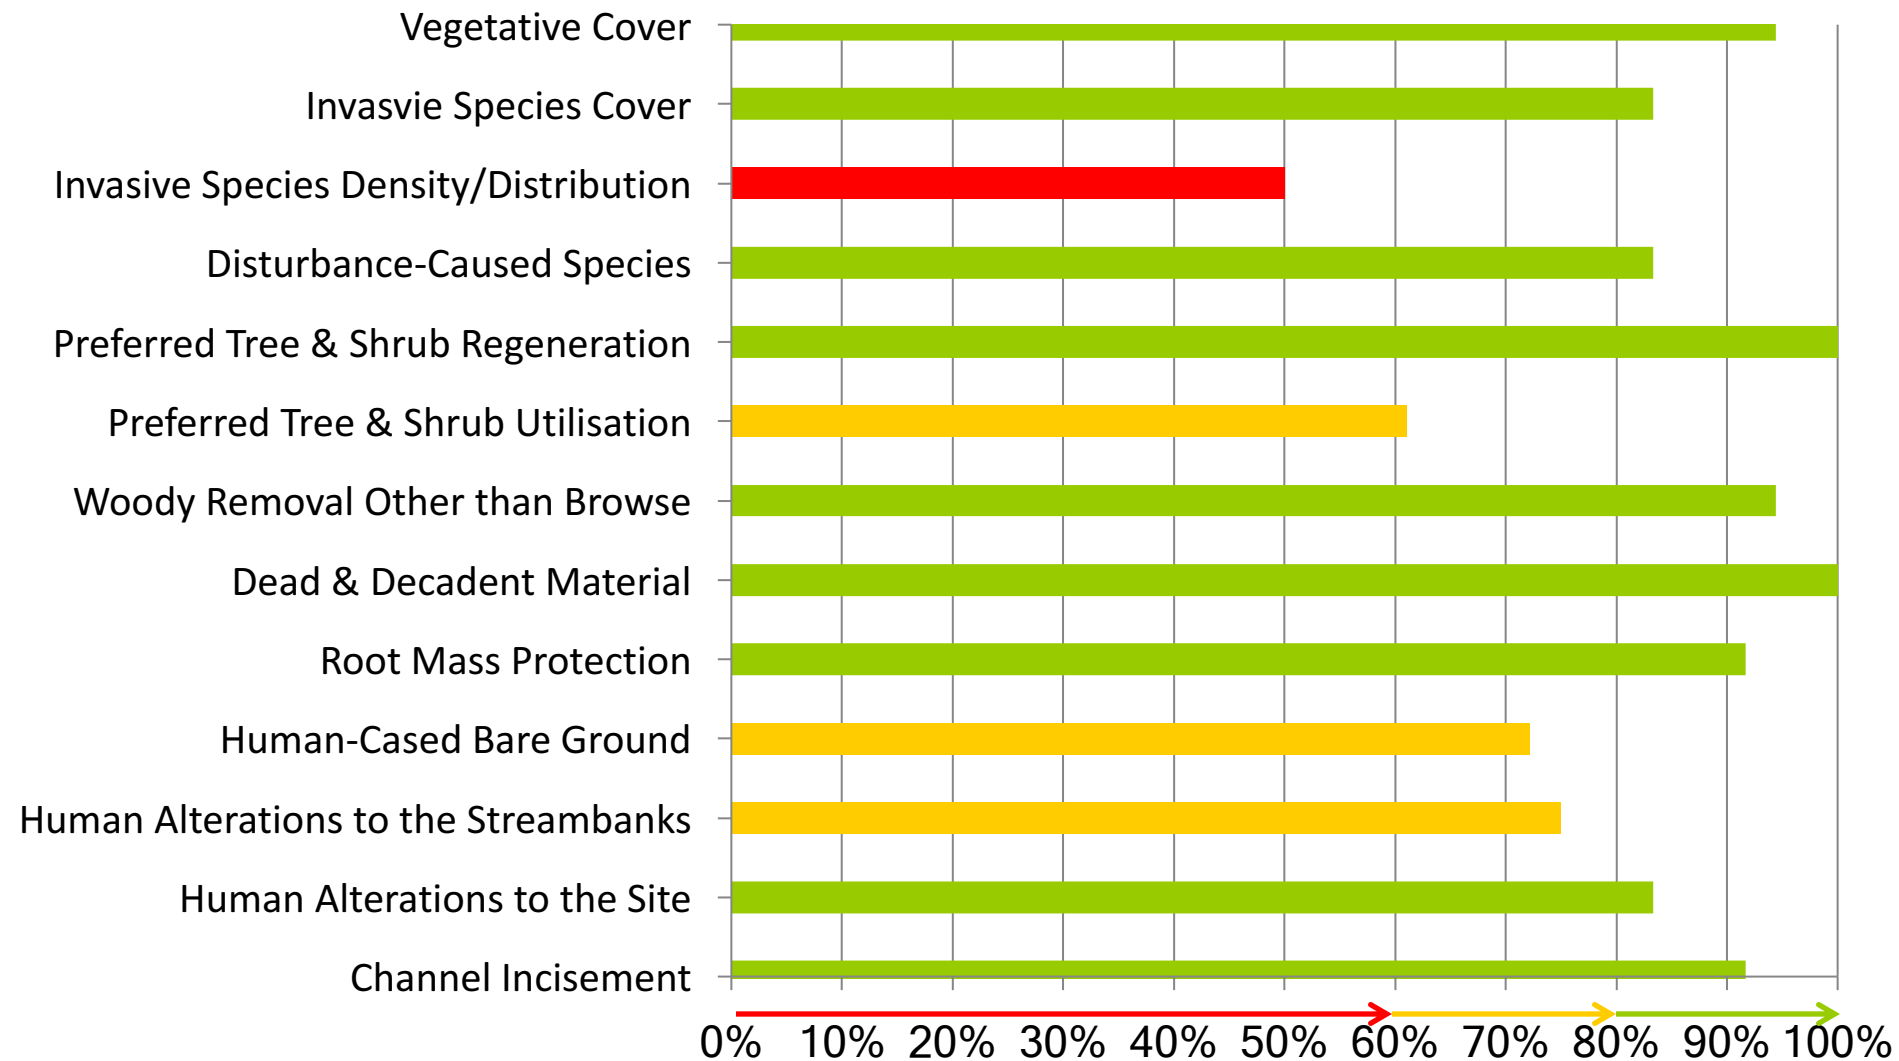
Evaluation of Stream Health Parameters (6 Sites)

85% Proper Functioning Condition (Healthy)

- 169 plant species identified, including *2 invasive species and 14 disturbance-caused plants*
- 53% covered by trees and shrubs
 - 6% of the riparian area is physically altered due to recreation
- 2% of the riparian area is bare ground

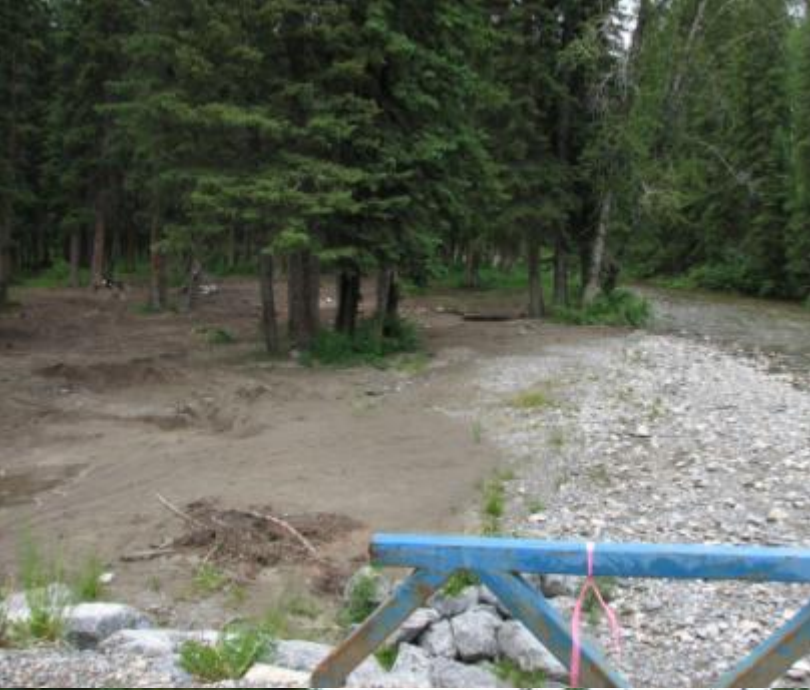
Canada thistle was found in a few patches as well as several scattered individuals

Browsing of preferred woody species is light overall

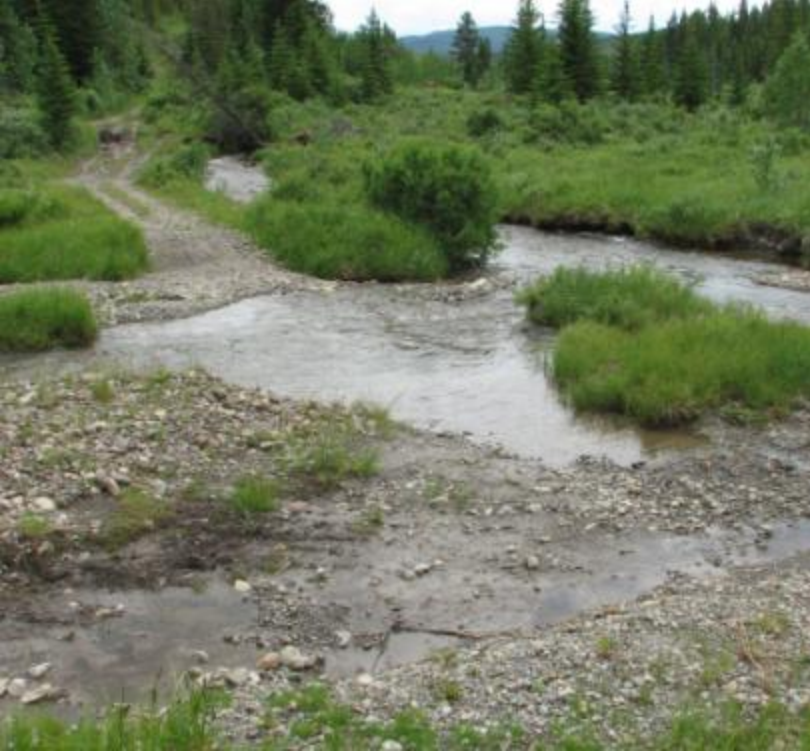
Recreational activities and human-caused bare ground are apparent within the Lesueur Creek watershed

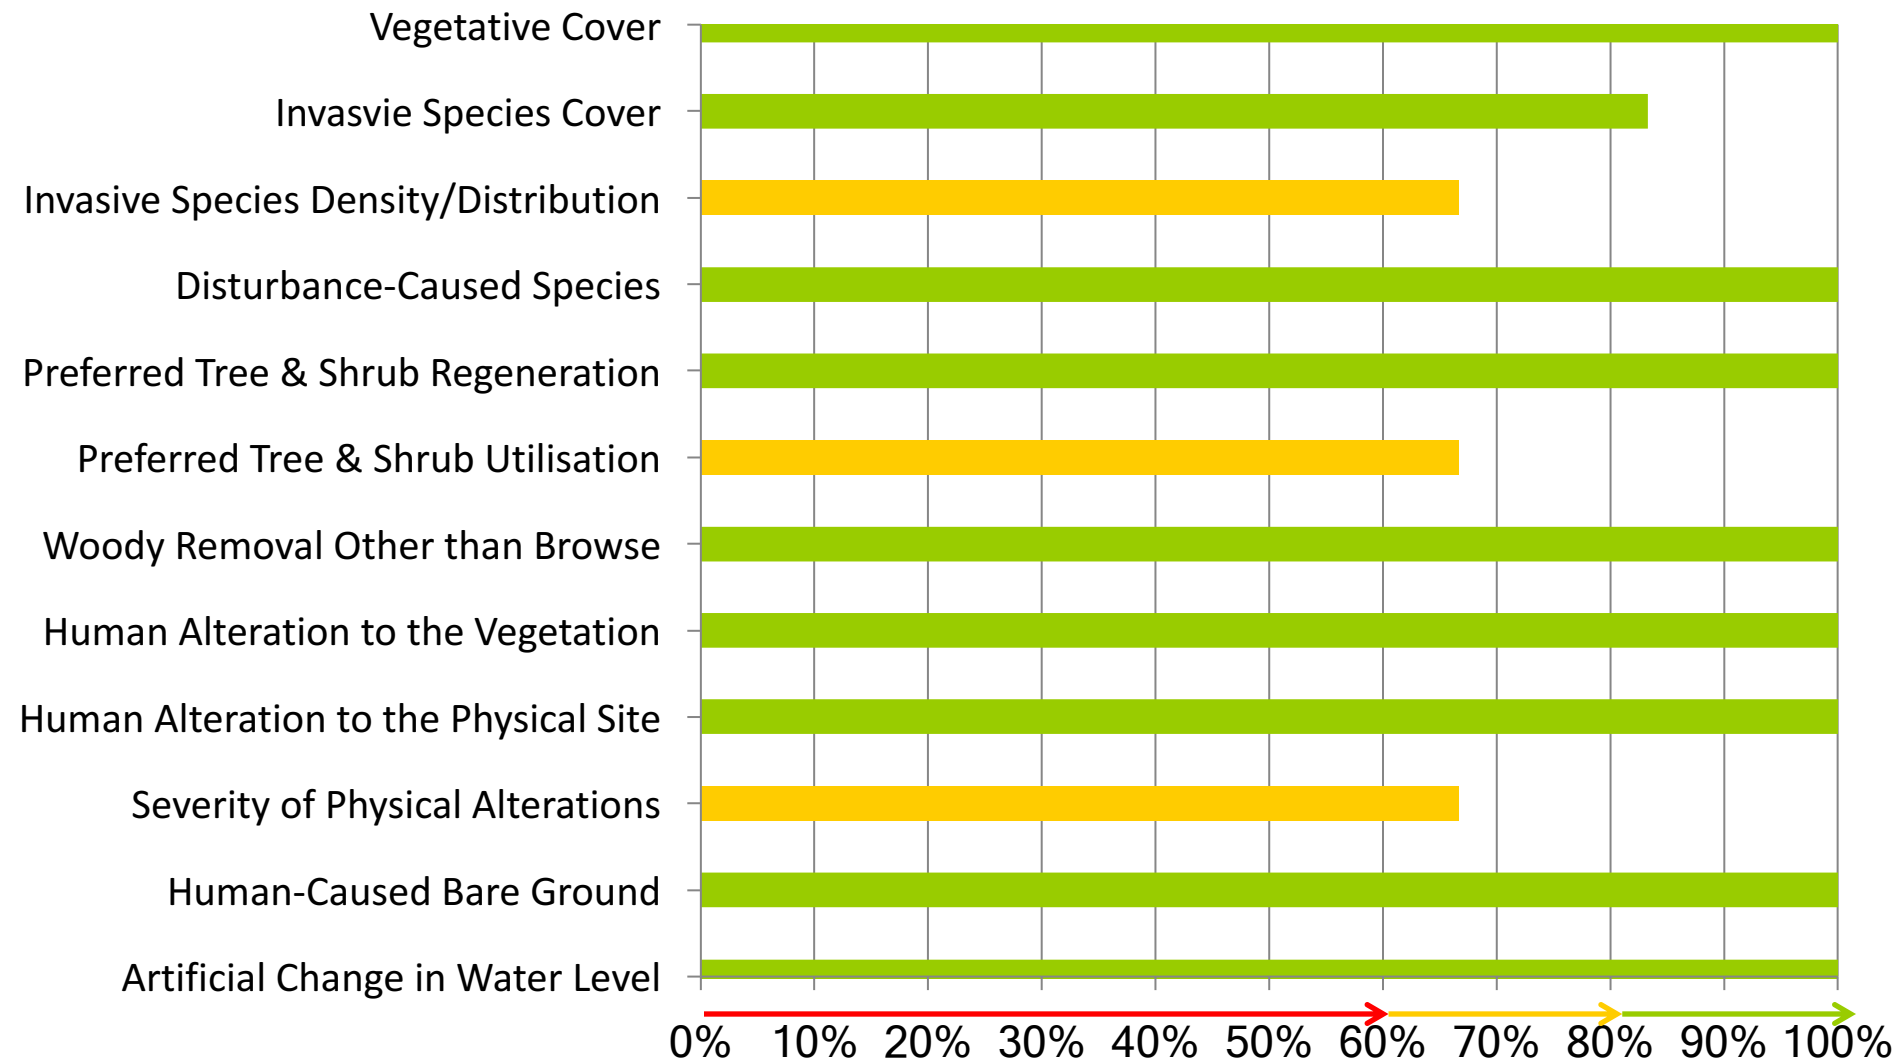
Evaluation of Wetland Health Parameters (2 Sites)

95% Proper Functioning Condition (Healthy)

- 39 plant species identified on one wetland and 79 identified on the other
- *only 1 invasive and 6 disturbance-caused species*
- 82% covered by trees and shrubs
- alteration to the vegetation was observed on only one site

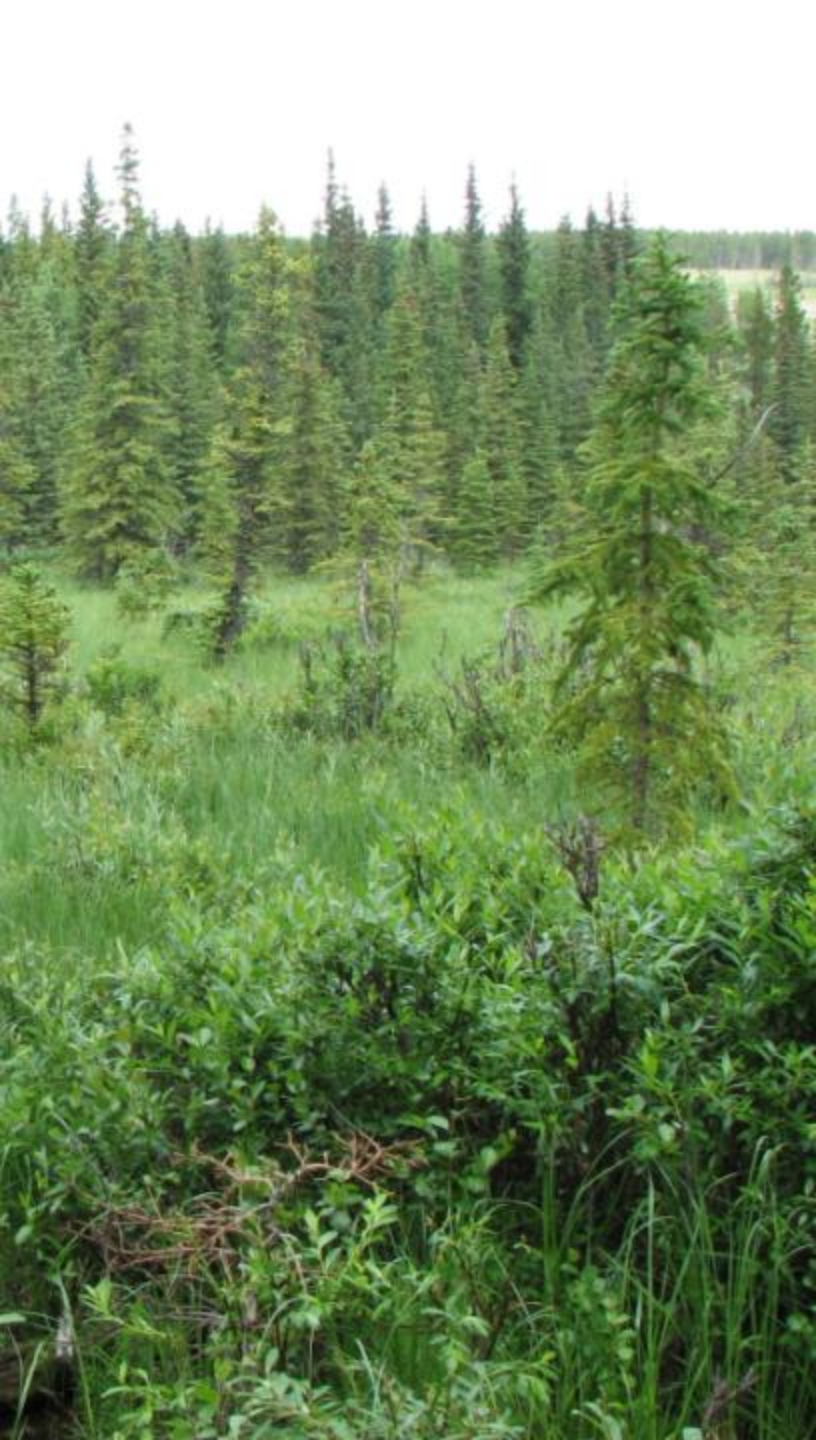
Canada thistle was found on one wetland in a single patch as well as a few scattered individuals

Browsing of preferred woody species is light overall

Few physical alterations were observed on either site and severity was only slight

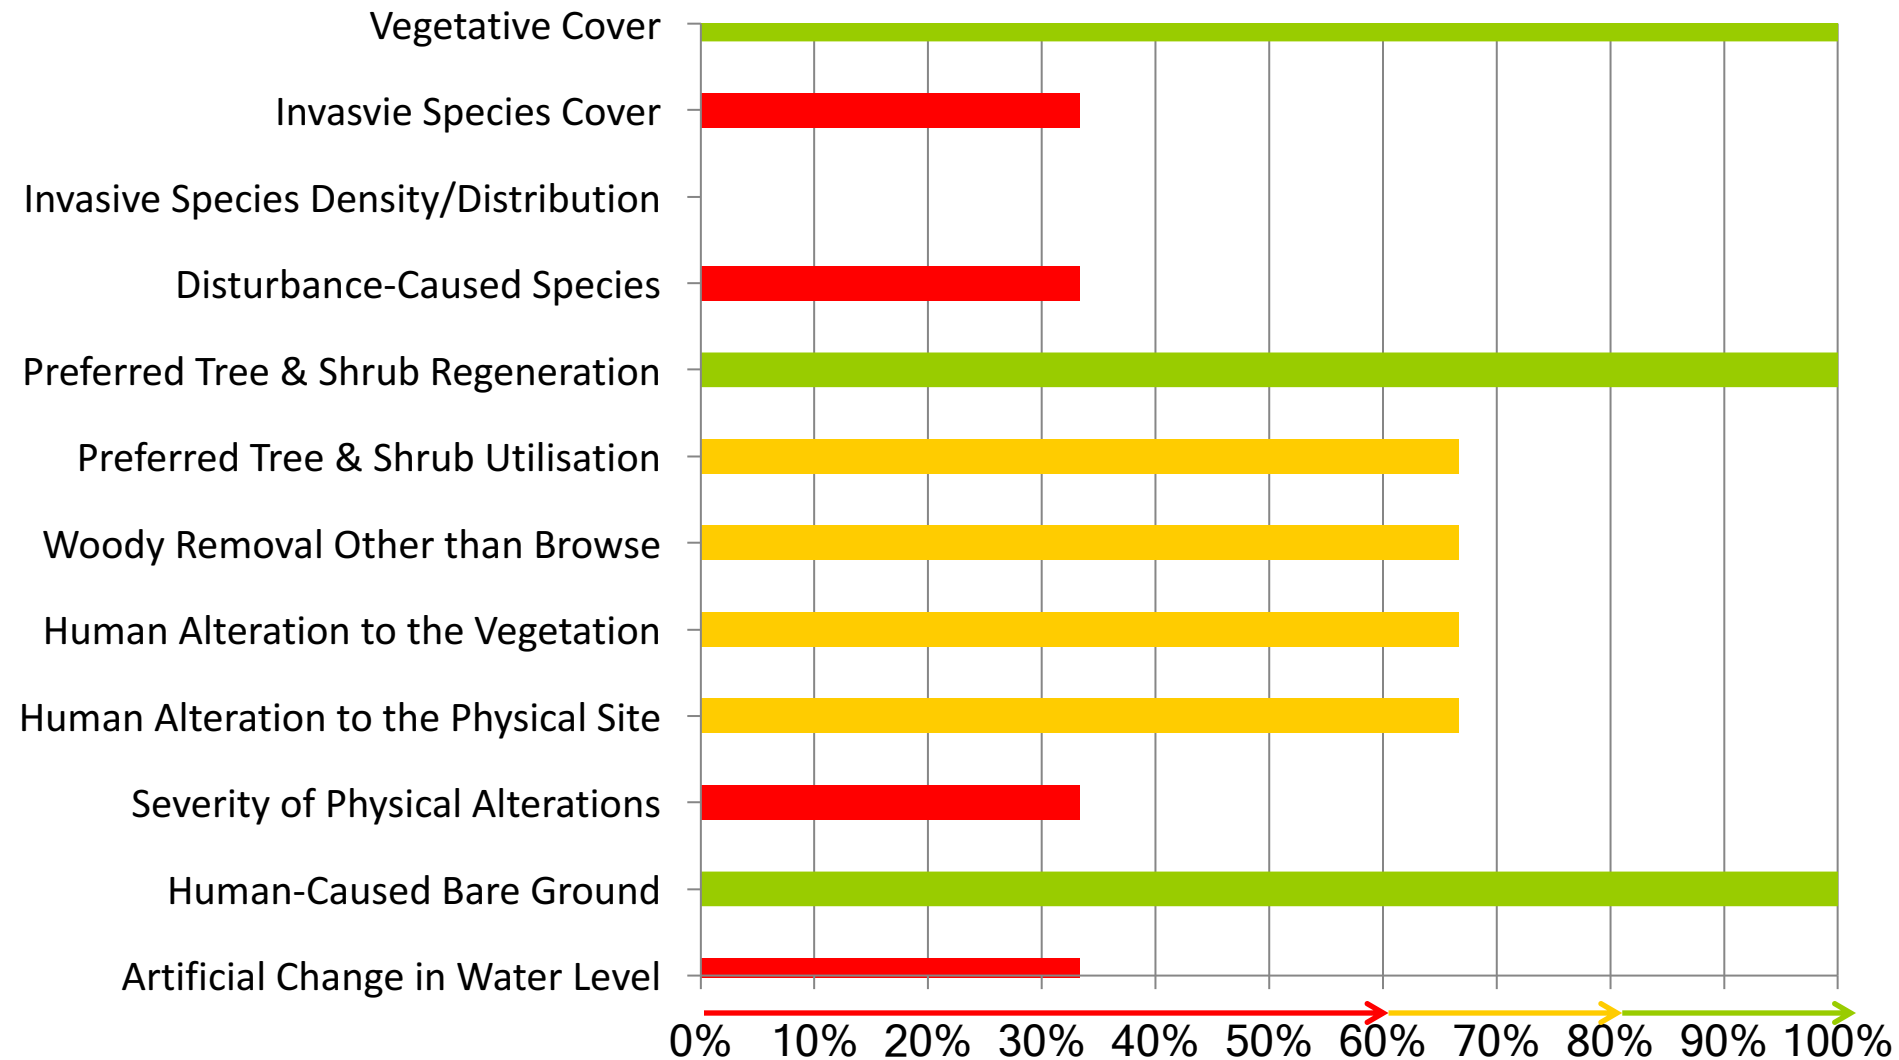
Evaluation of Wetland Health Parameters (1 Site)

63% Functional at Risk (Healthy, but with Problems)

- 79 plant species identified, including ***3 invasive and 12 disturbance-caused species***
- 40% covered by tree and shrubs
 - 10% of the vegetative community altered by human activities
- 10% of the site physical altered as well

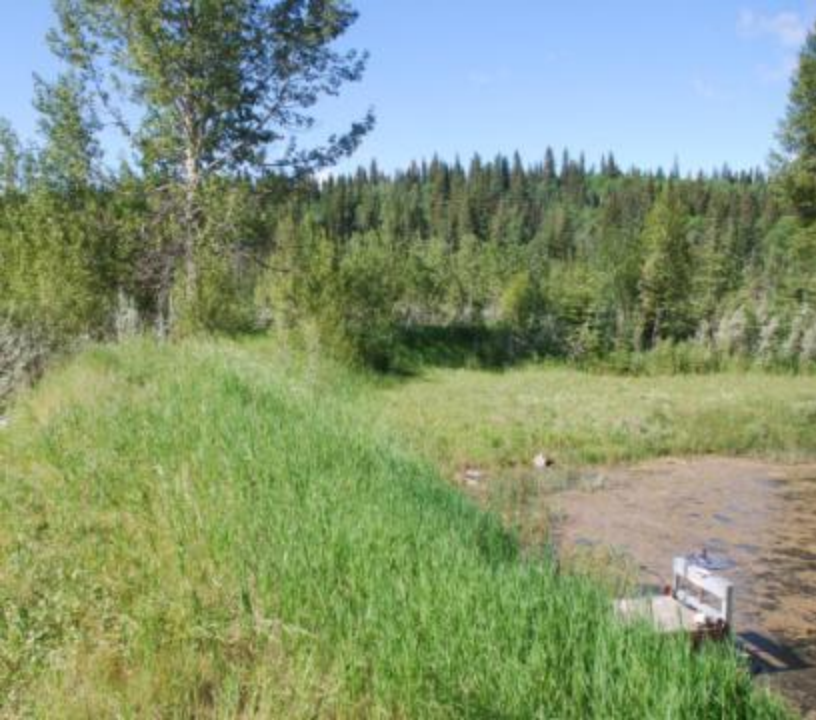
Garden bluebell, Canada thistle,
and Perennial sow-thistle cover
>3% of the riparian area

A few patches and several
sporadically occurring individuals

***40% covered by disturbance-
caused species***

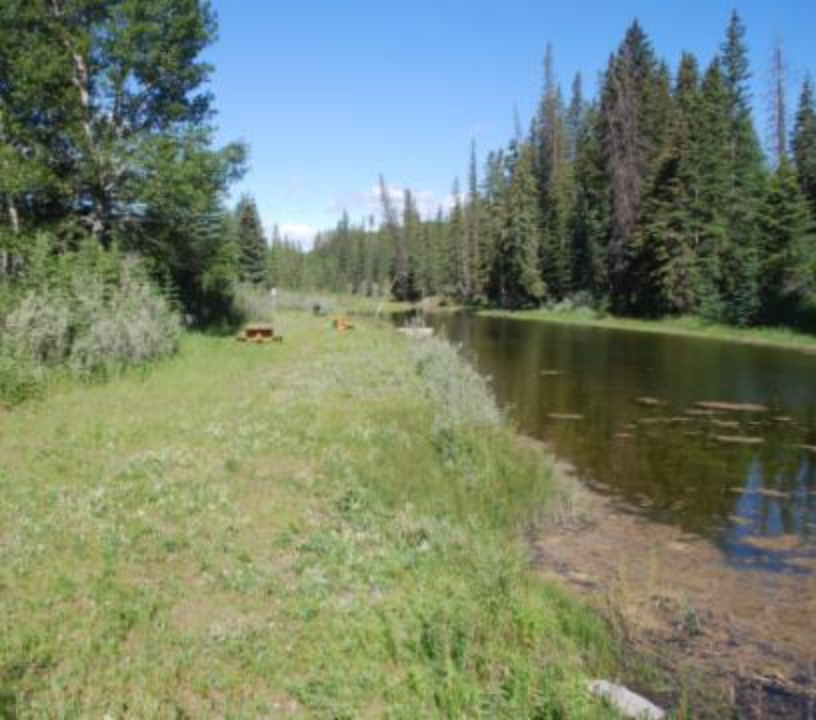
Physical alterations are
moderately severe

Water level has increased due to
the berm
