2010 Riparian Health Inventory

Waiparous Creek Watershed

Alberta Riparian Habitat Management Society
(Cows and Fish)

March 2011

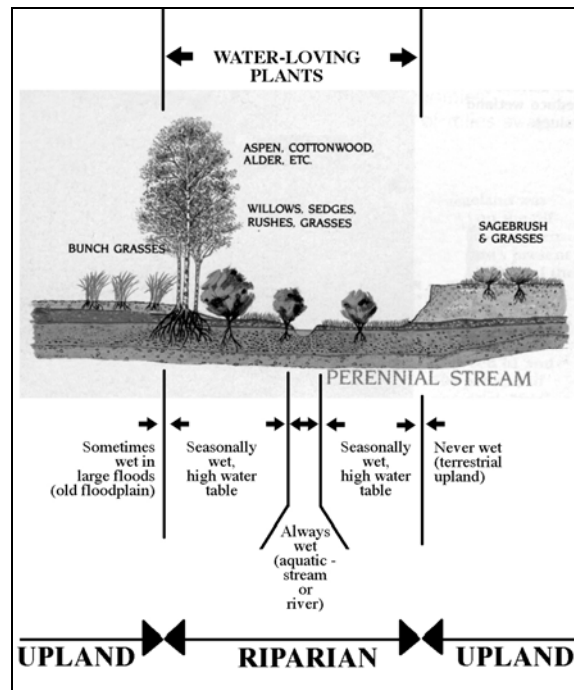
Figure 1 Diagrammatic Representation of a Riparian Area<sup>1</sup>

Riparian areas are the portions of the landscape strongly influenced by water and are recognised by water-loving vegetation along rivers, streams, lakes, springs, ponds and seeps (Figure 1). Riparian areas can be described as the lush “green zones” around lakes and wetlands and bordering rivers and streams.

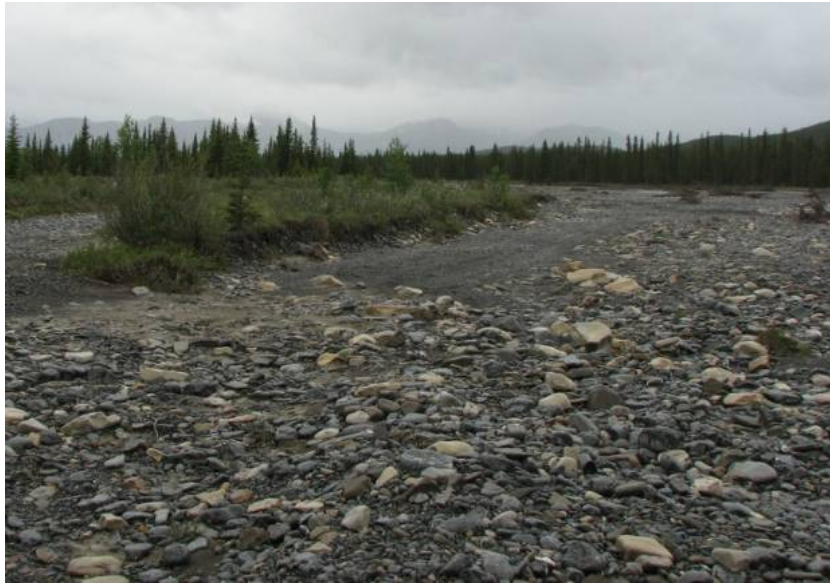
C. Ball, RHIP02WAI004.

The cobble and gravel Waiparous Creek channel is extremely wide and braided through the Ghost River Allotment.

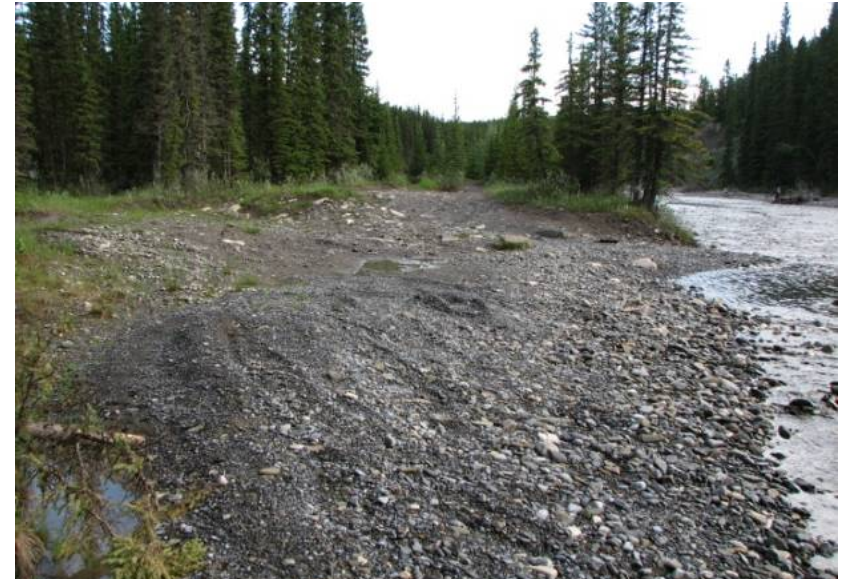
D. White, RHIP04WAI005.

Recreational trails and OHV use has caused some removal of vegetation, soil compaction, bare ground and loss of deep, binding roots in some sections along Waiparous Creek.

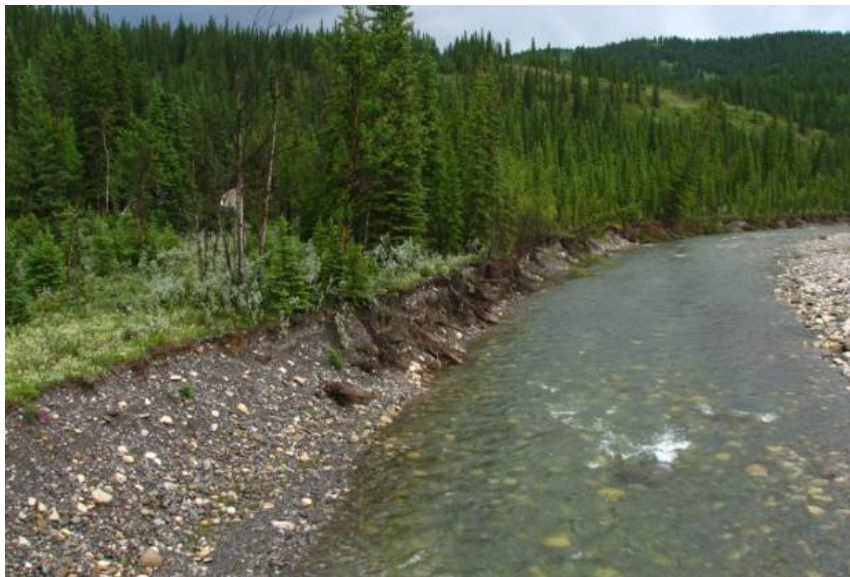
C. Ball, RHIP10WAI005.

Due to natural high flows and large amounts of gravel and cobble in the streambanks, there is a substantial amount of natural bank instability and lateral erosion that is not associated with human impacts.

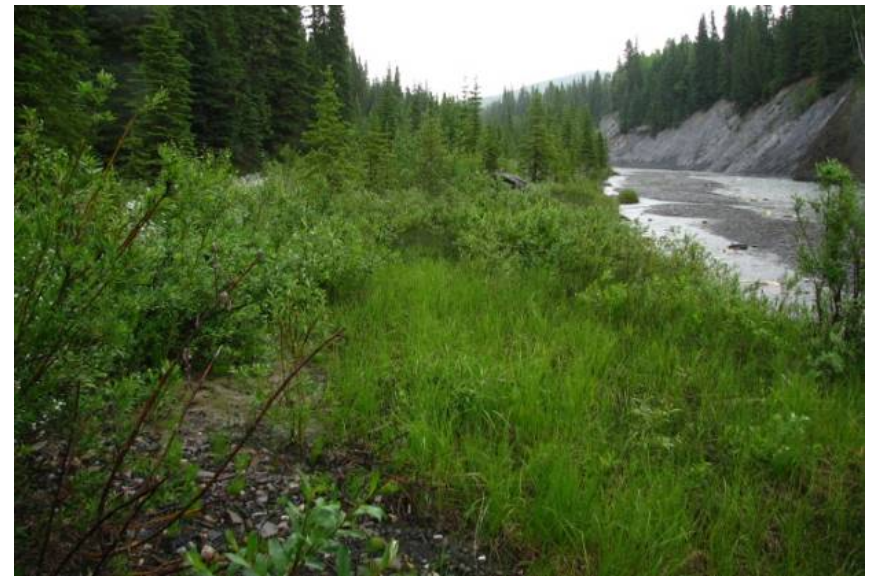
C. Ball, RHIP13WAI004.

The majority of the riparian area is comprised of a white spruce community with a diverse understory of native shrubs, forbs and grasses. No invasive species and only a trace amount of non-native disturbance-caused plants were observed.

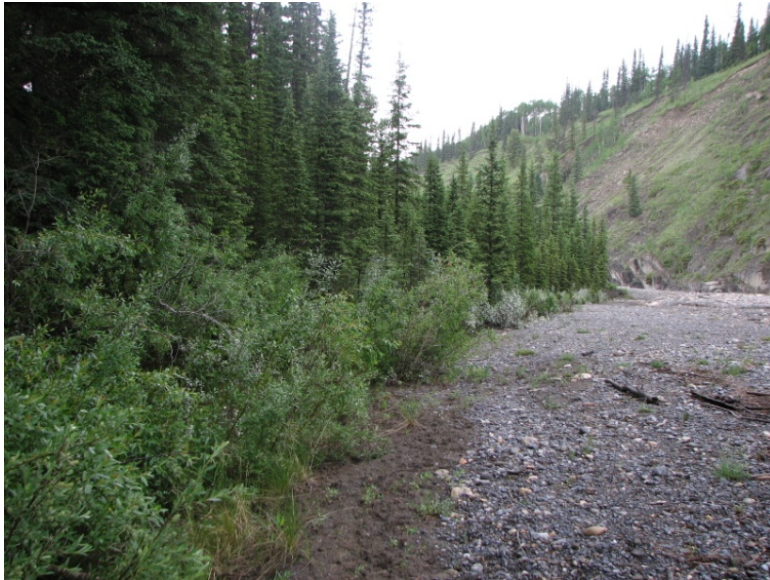
D. White, RHIP11WAI004.

A white spruce plant community with an understory of preferred shrub species is typical of all sites along Waiparous Creek in the Aura Cache allotment.

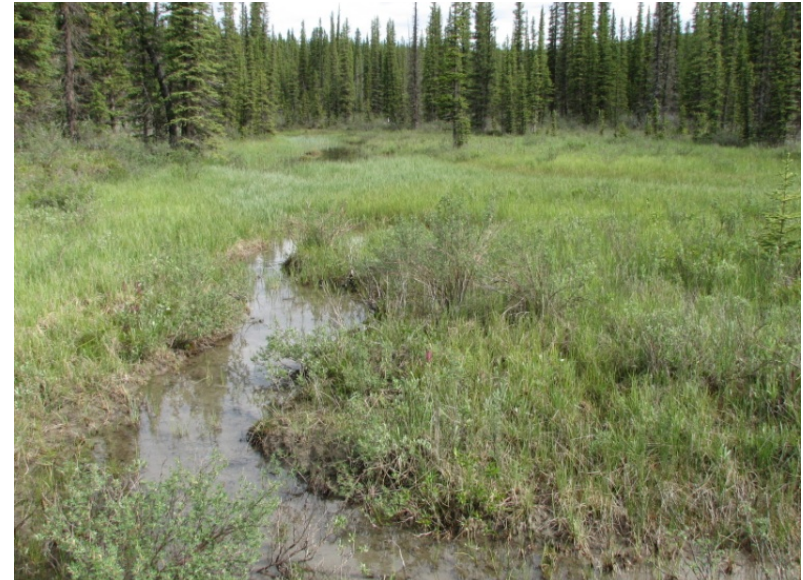
C. Ball, RHIP03WAI010.

This large water sedge meadow in the WAI3 polygon (near the north end of the allotment, close to Highway 40) is highly susceptible to physical alterations due to saturated, fine textured soils.

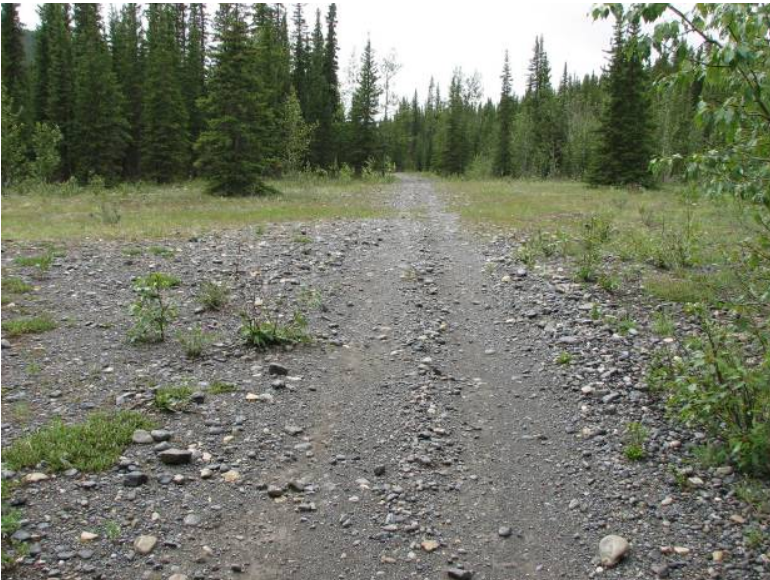
C. Ball, RHIP01WAI005.

Recreational activities, such as OHV use, are contributing to soil erosion and compaction in WAI1 (near Camp Howard) in particular. These activities can damage sensitive riparian plants.

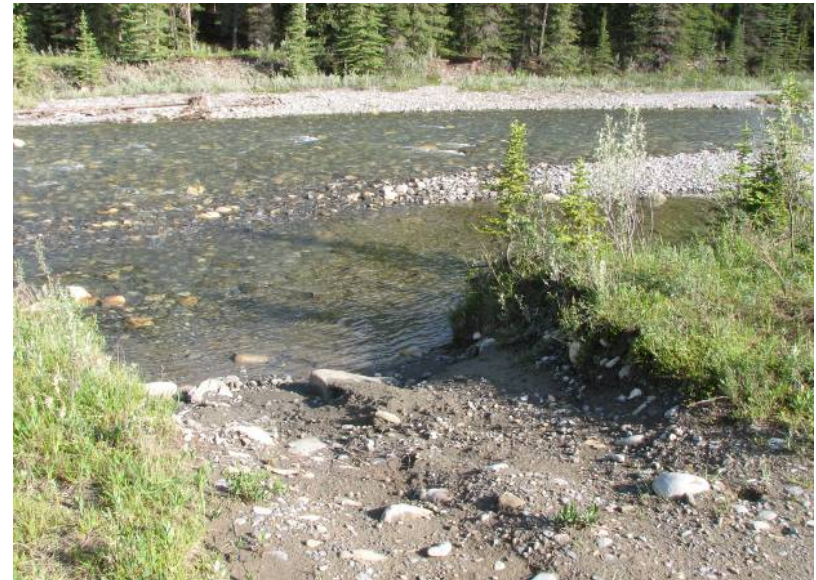
C. Ball, RHIP03WAI007.

Creek fords such as this one in the WAI3 site, contribute to sediment delivery into Waiparous Creek and may harm fish habitat.

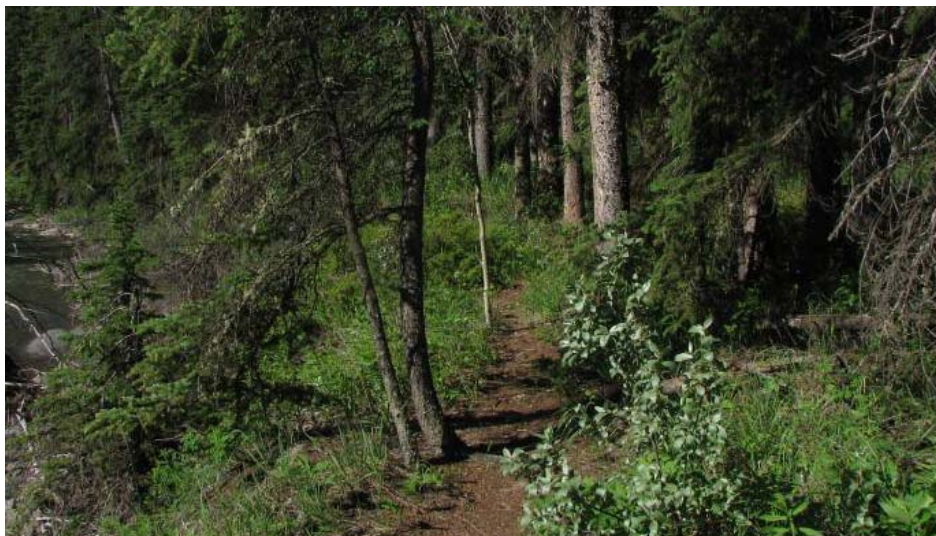
C. Wood, RHIP09WA1002.

The riparian area is dominated by a white spruce plant community with a diversity of native shrubs, forbs and a few grasses in the understory.

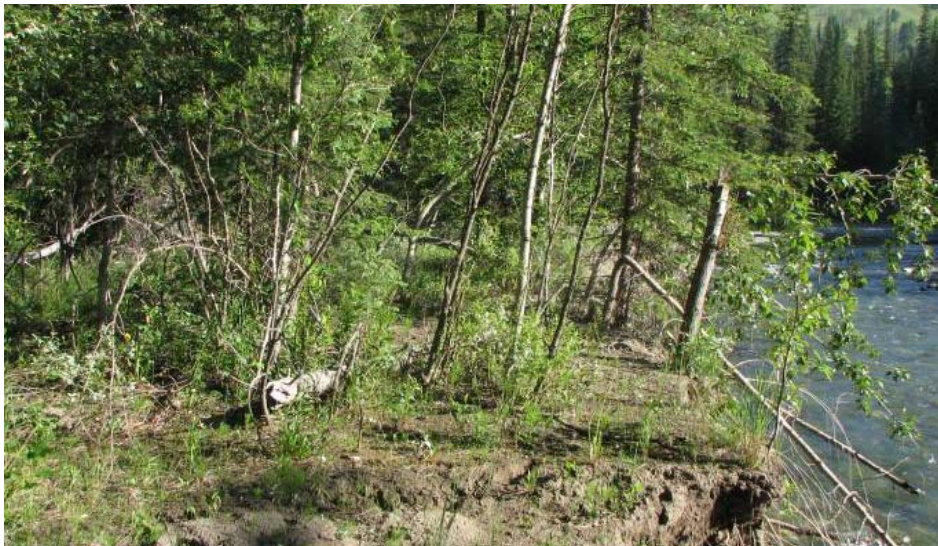
C. Wood, RHIP09WA1004.

Both human-caused and natural bare ground is present within the riparian area from recreational trails and natural sediment deposition, as seen here.

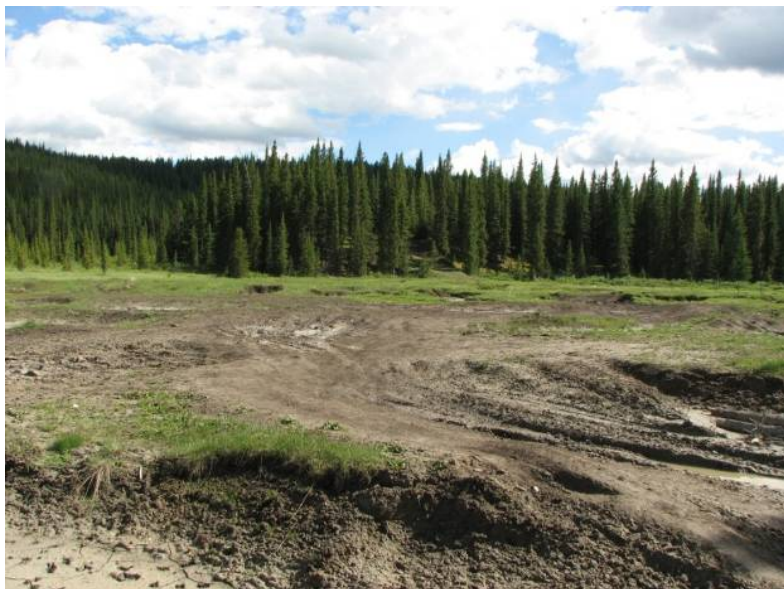
C. Wood, RHIP01JON008.

“Johnson Bog” at the upstream, southern portion of the JON1 site is an area that in the recent past has been heavily used by motorized vehicles to the point that deep ruts have been created resulting in water pooling or channelling of water. Attempts have been made to fence out and restrict OHV use at former crossing locations at the upstream end of the JON1 site. These fences seem to be ineffective since they are in disrepair and they do not form a good access barrier.

OHV use has caused significant physical alterations and human-caused bare ground in some areas along Johnson Creek, in particular to 'Johnson Bog' at the upstream end of the JON1 site (near to the confluence with Waiparous Creek).

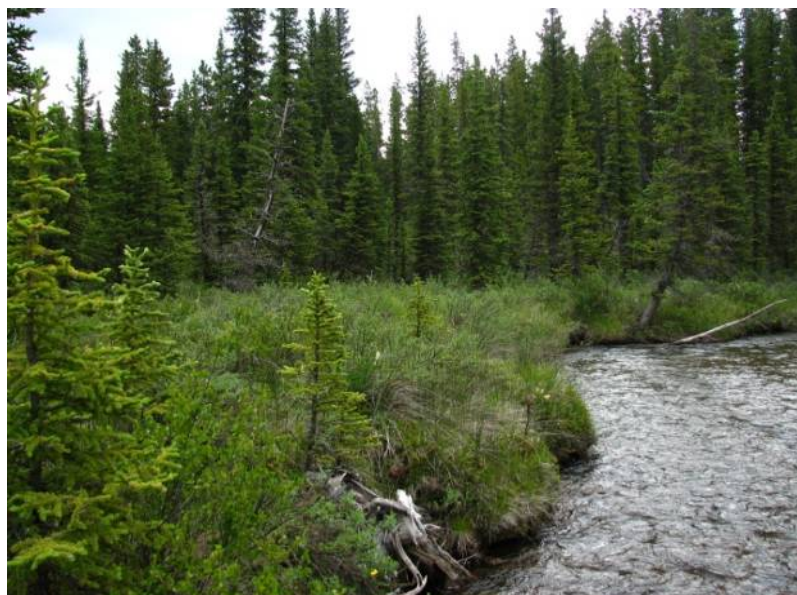
C. Ball, RHIP03JON002.

Trees and shrubs are regenerating well throughout Johnson Creek and its tributary.

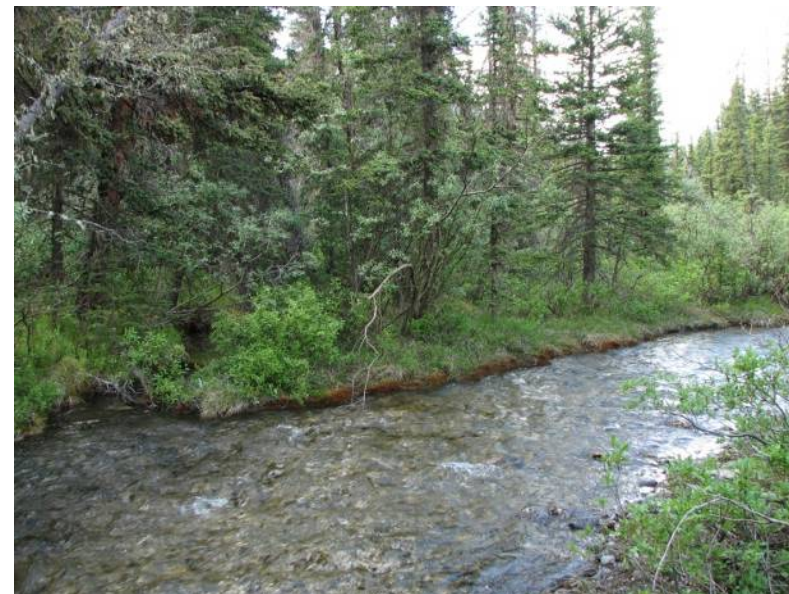
C. Ball, RHIP02JON004.

Healthy white spruce communities with an understory of native shrubs provide good streambank stability along Johnson Creek.

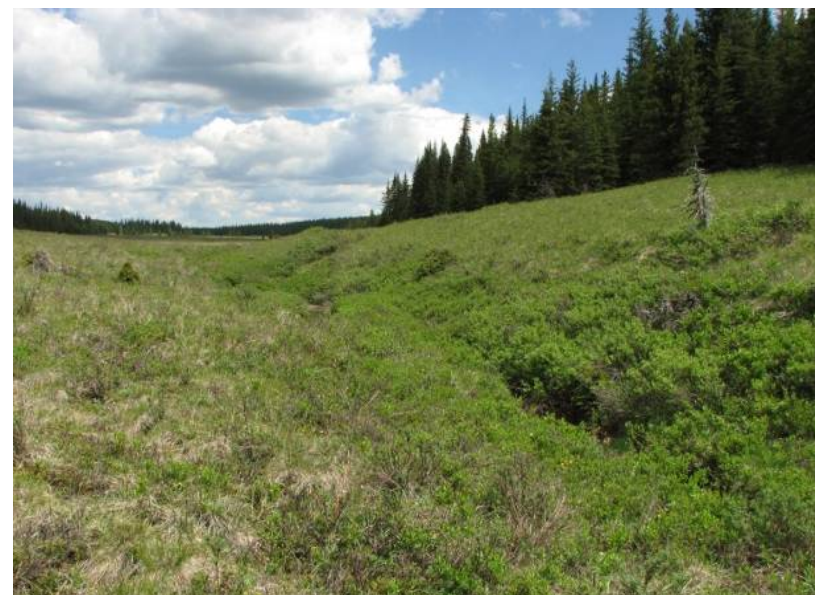
C. Wood, RHIP01JON004.

Sedges and other grass-like species are the dominant ground cover along the unnamed tributary to Johnson Creek and the associated Devil's Head Meadow wetland complex.

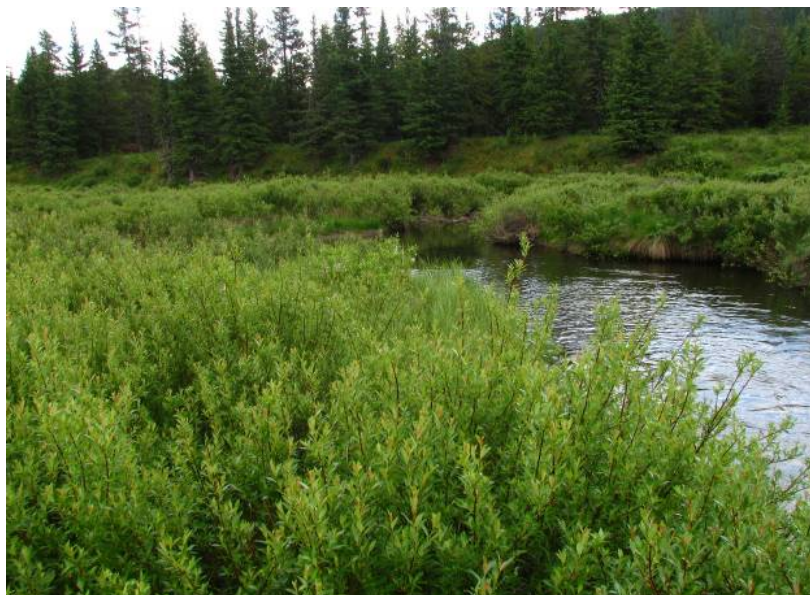
C. Ball, RHIP02MDW002.

Most of the Meadow Creek basin is dominated by this flat-leaved willow and water sedge plant community. White spruce occurs along the outer fringe of the riparian zone and extends into the uplands.

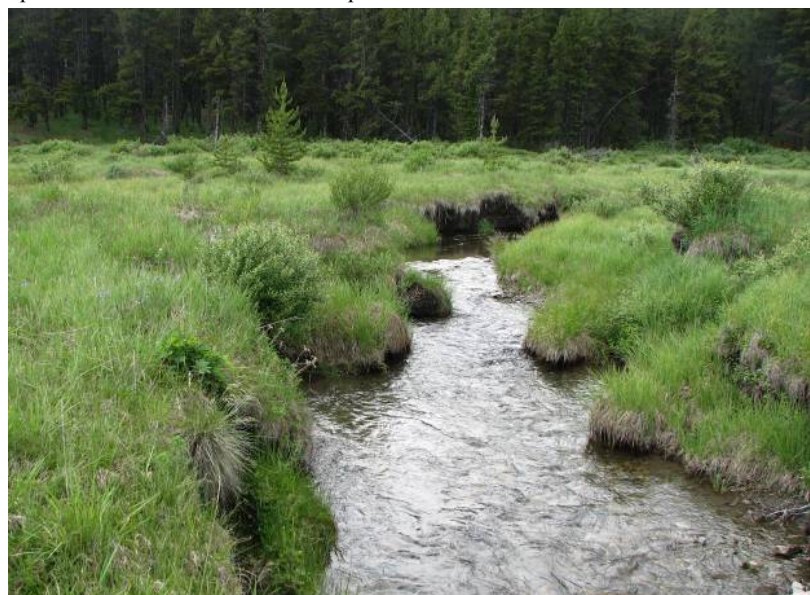
K. Hull, RHIP01MDW008

Increased cover from disturbance species such as Kentucky bluegrass in response to long-term livestock use can contribute to bank instability and slumping. Kentucky bluegrass is a shallow rooted grass which lacks bank binding ability.

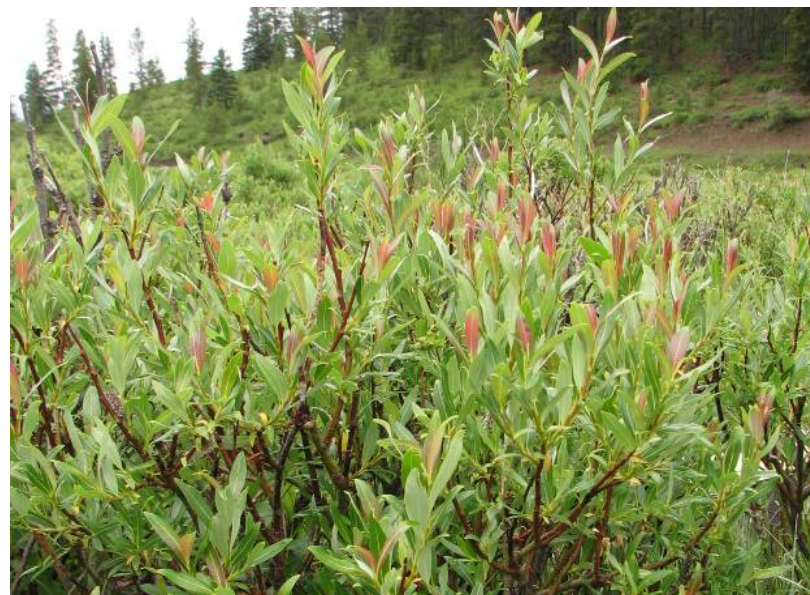
D. White, RHIP01MDX009.

Heavy livestock use in the riparian zone is occurring in the MDX1 site. Flat-topped willow growth forms are a sign of long-term heavy use. Continued heavy use can eventually kill the plant and impede regeneration of woody species.

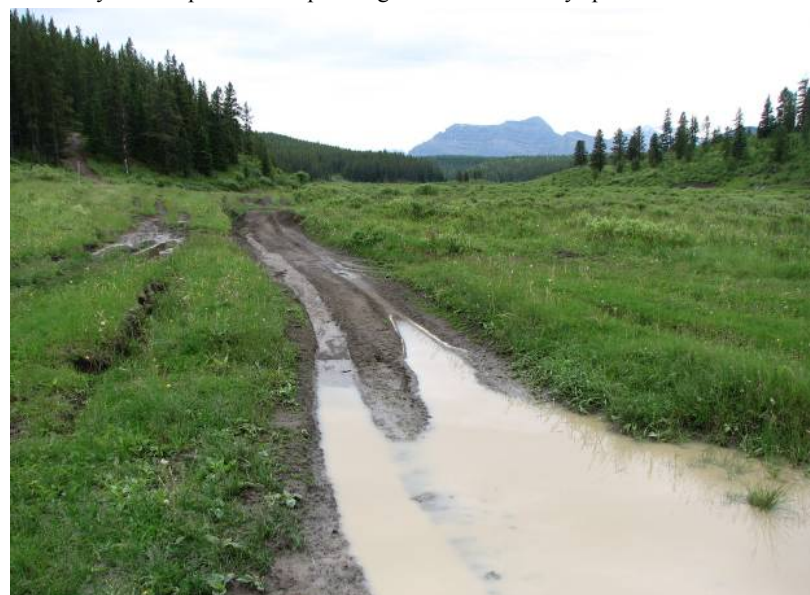
D. White, RHIP01MDX011.

OHV trails impact portions of the riparian zone in the MDW2, MDW3 and MDX1 sites, contributing to the spread of non-native disturbance and invasive species, soil compaction, erosion and sedimentation of Meadow Creek.

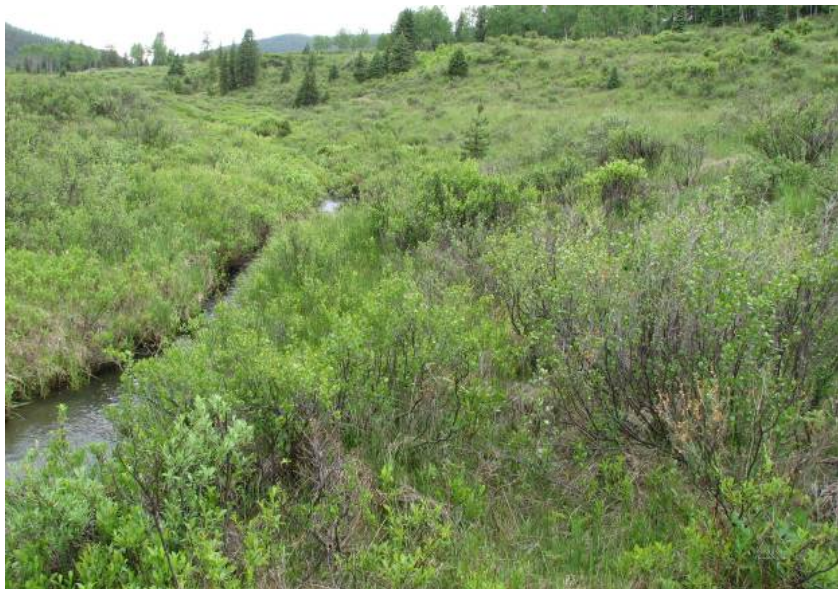
K. Adair, RHIP01LOK004.

Most of the riparian zone in the Lost Knife Creek basin is characterized by a flat-leaved willow / water sedge Habitat Type.

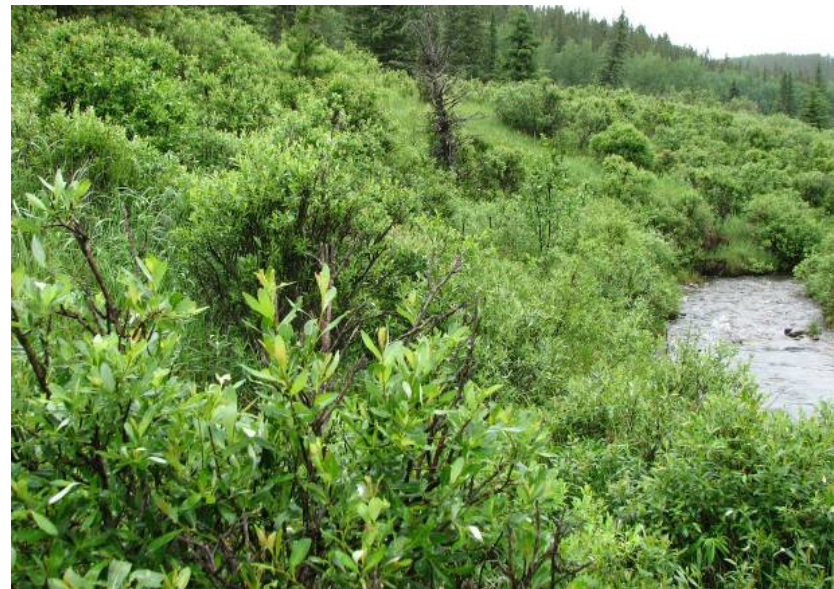
D. White, RHIP03LOK002.

Dense willows growing along Lost Knife Creek provide abundant forage for wildlife such as moose, habitat for songbirds, and overhanging cover for fish.

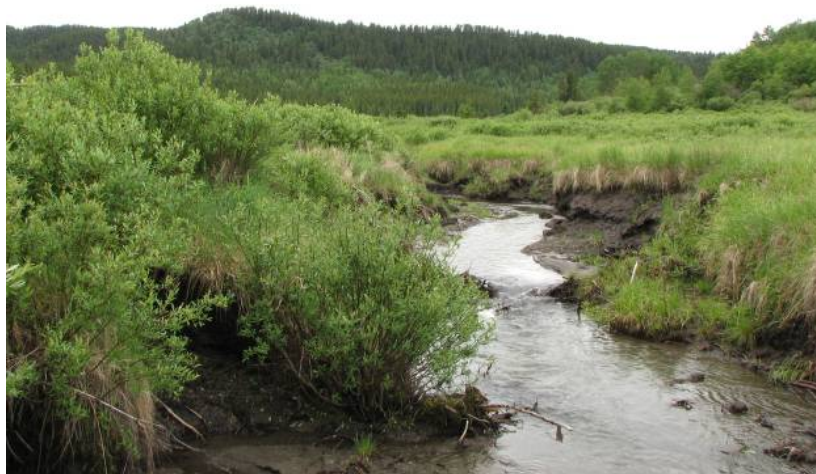
C. Wood, RHIP02LOK004.

Lost Knife Creek is highly influenced by beaver activities. Beaver dams raise the water table and allow for accumulation of fine textured organic sediment that eventually forms wide lush and productive moist riparian meadows.

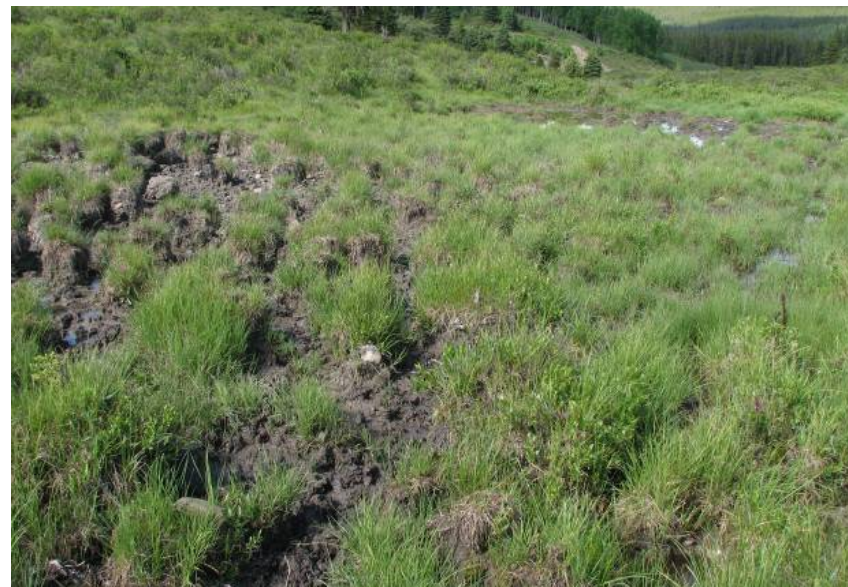
K. Adair, RHIP01LOK005.

Heavy trampling by livestock compacts soft, saturated riparian soils. This can lead to gradual drying out and less moisture retention in the riparian zone. It also promotes encroachment of invasive and disturbance-caused plant species.

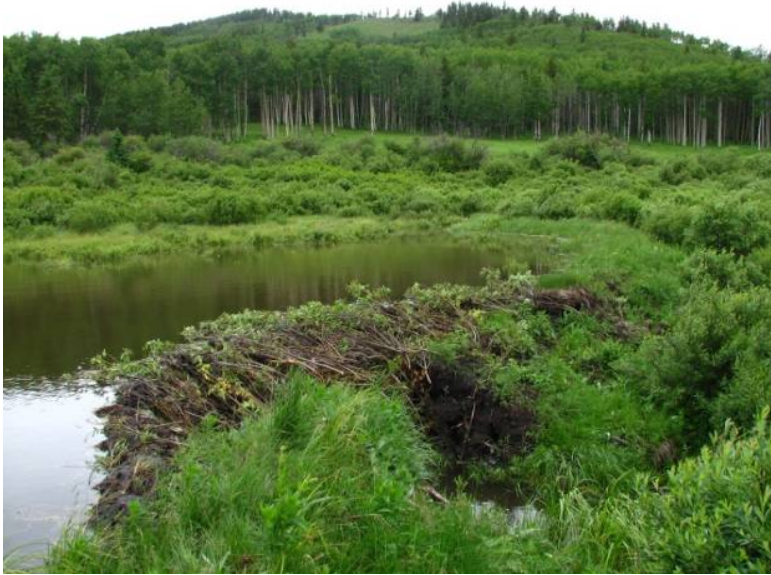
C. Ball, RHIP03FOU007.

Beavers continue to shape and influence the hydrology and riparian plant communities in the Four Mile Creek basin. Active beaver ponds provide excellent habitat for amphibians, waterfowl and other fish and wildlife species.

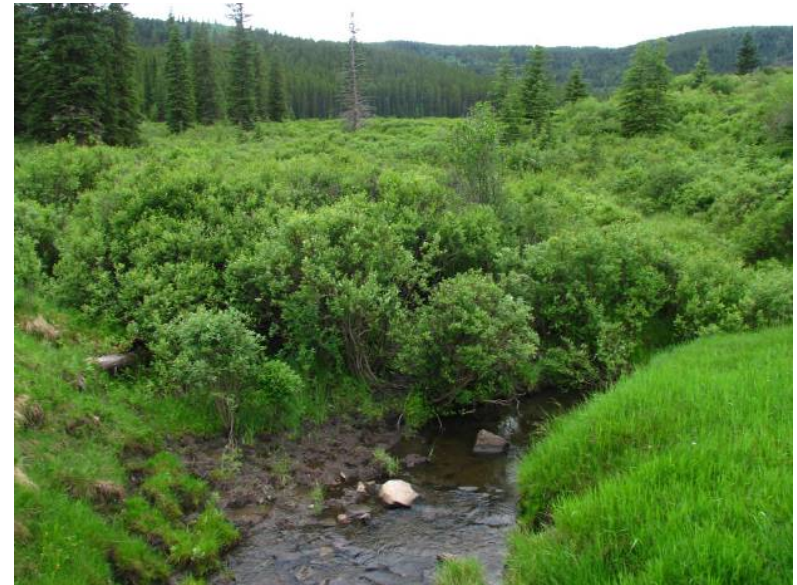
C. Ball, RHIP03FOU004.

The riparian zone along Four Mile Creek has dense and diverse willow stands and an understory of native sedges. White spruce is encroaching along the drier outer fringes of the valley bottom from adjacent upland forests.

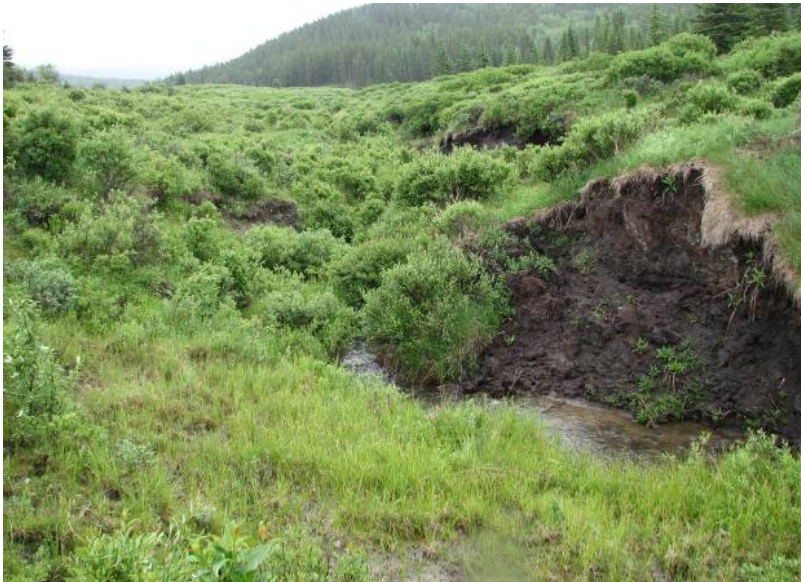
C. Ball, RHIP02FOU007.

When old beaver dams eventually give way, the sudden rush of water can wash away even well vegetated streambanks. However, this allows for new floodplains to develop with new plant communities, continuing the natural succession of riparian areas.

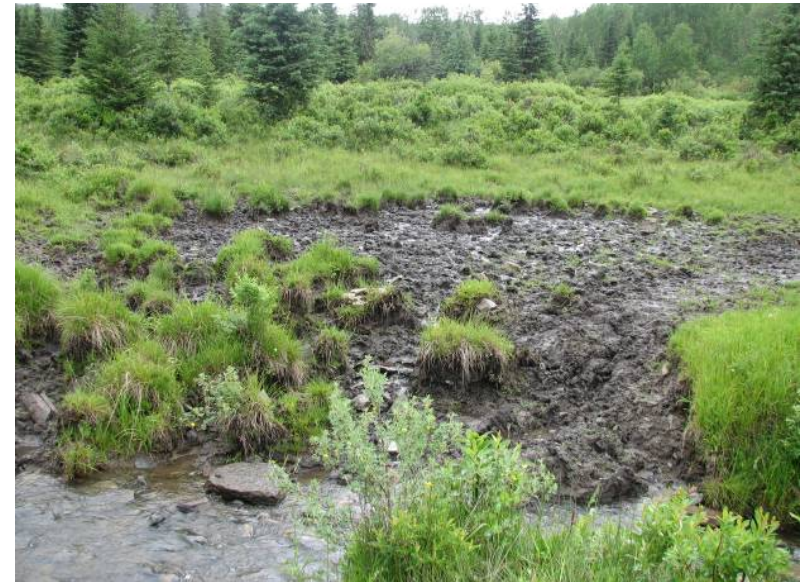
C. Ball, RHIP02FOU003.

Although few in number, localized watering points, like this one in FOU2, may need to be temporarily fenced off to prevent ongoing erosion and sedimentation of the creek. With sufficient rest, this compacted area of bare ground will recover naturally.

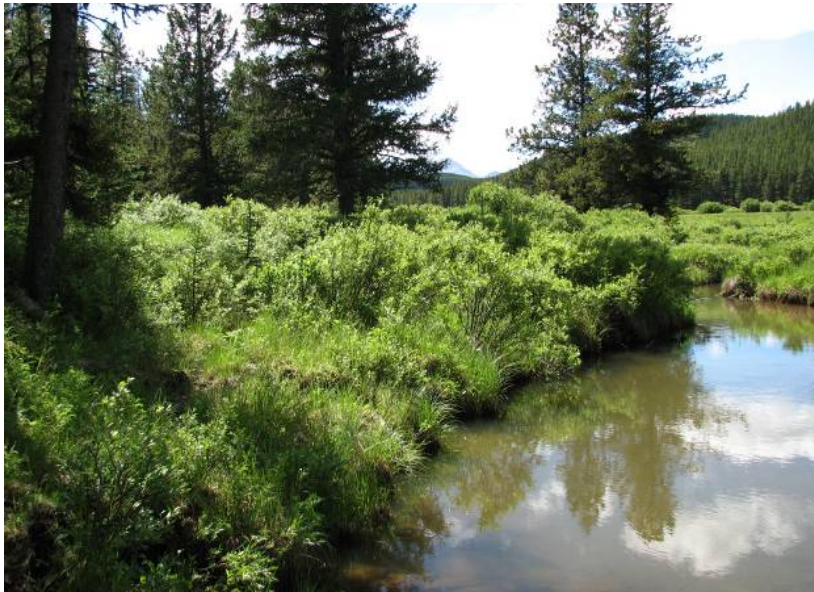
C. Ball, RHIP01WAZ001.

White spruce occurs along the southern periphery of the riparian zone near the upstream end of this site.

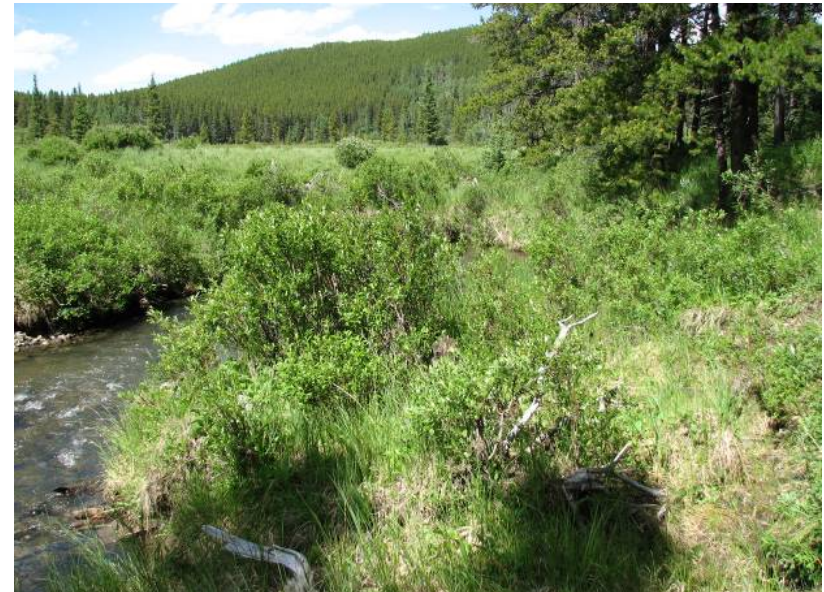
C. Ball, RHIP01WAZ002.

Most of the upstream portion of the riparian zone has dense cover from a variety of willows and some bog birch. These shrubs and native sedges in the understory help to stabilize the streambank and slow erosion.

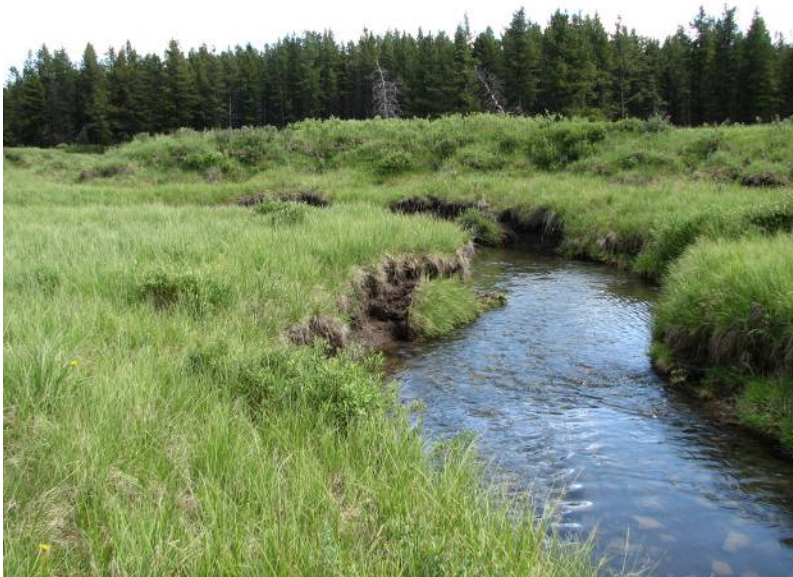
C. Ball, RHIP01WAZ003.

The stream channel of the unnamed tributary is slightly incised as it enters the lower elevation Waiparous Creek valley. Incisement here is also due to natural processes from historic beaver activity and down-cutting following rupture of beaver dams.

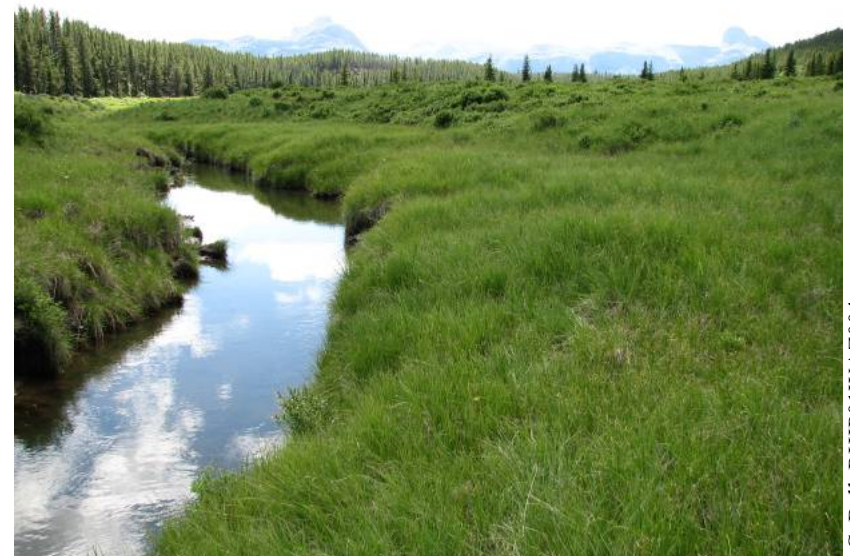
C. Ball, RHIP01WAZ004.

Wide sedge meadows along this tributary are indicative of beaver modified watersheds.

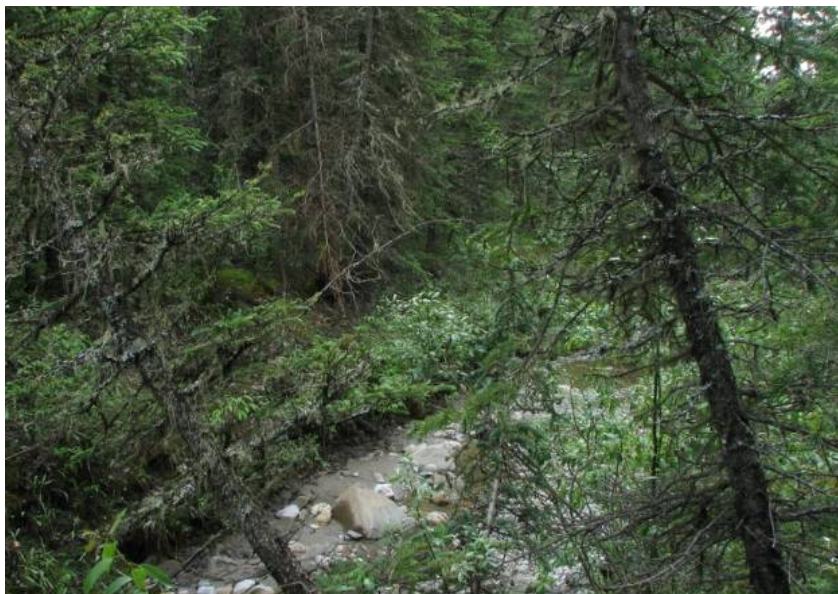
C. Wood, RHIP01AUR002.

The relatively narrow riparian valley along Aura Creek is comprised of white spruce with an understory of willows and other native shrubs.

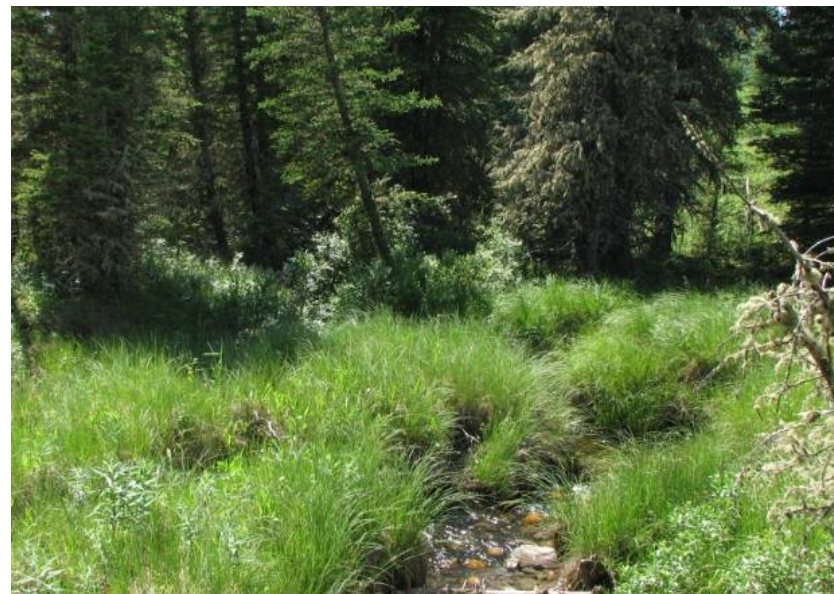
C. Wood, RHIP02AUR002.

Sedges, in addition to trees and shrubs, stabilize the banks of Aura Creek and its tributary with their deep binding roots.

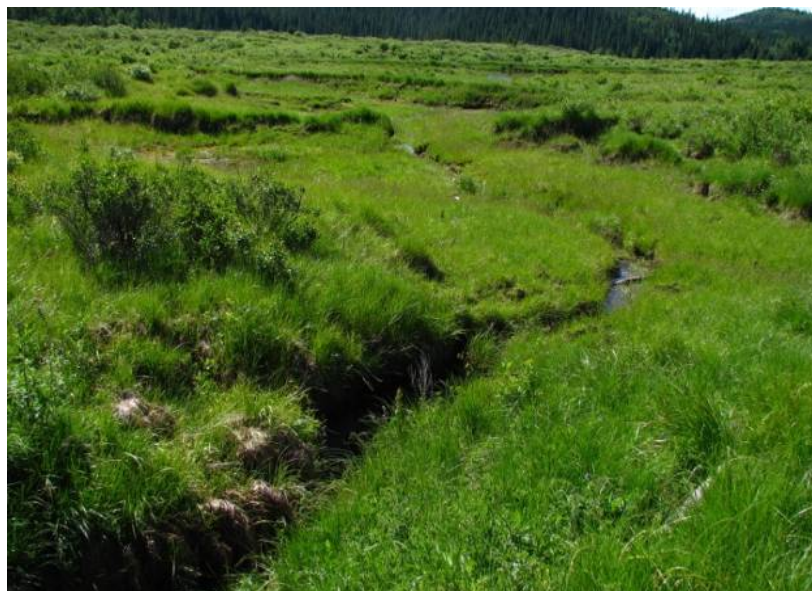
D. White, RHIP01AUY006.

The unnamed tributary to Aura Creek (AUY1) has less woody cover overall due to flooding and historic clearing by beavers. The riparian zone along this tributary is characterized by beaver modified willow – sedge meadows as shown here.

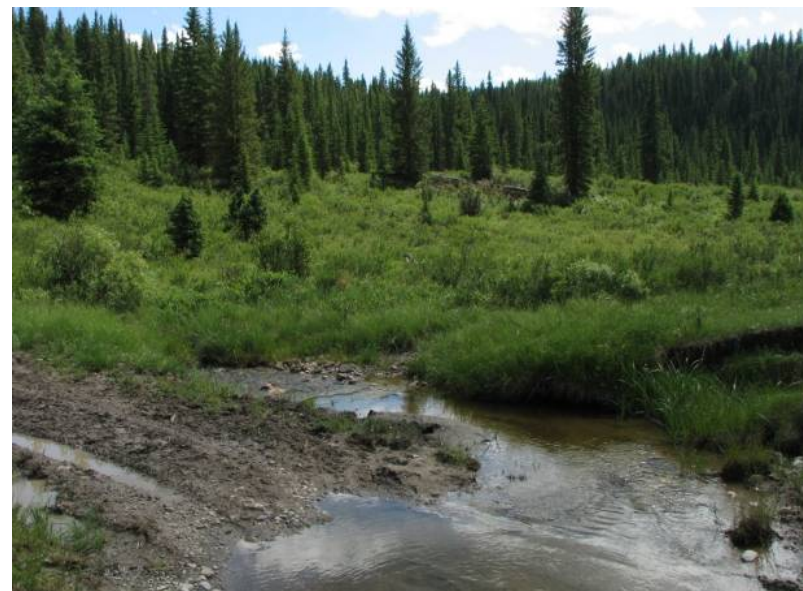
C. Wood, RHIP02AUR003.

This OHV crossing is located at the downstream end of the AUR2 site. Although recreational impacts are few in this site, forded crossings like this can have a significant impact on water quality from erosion and sediment inputs.

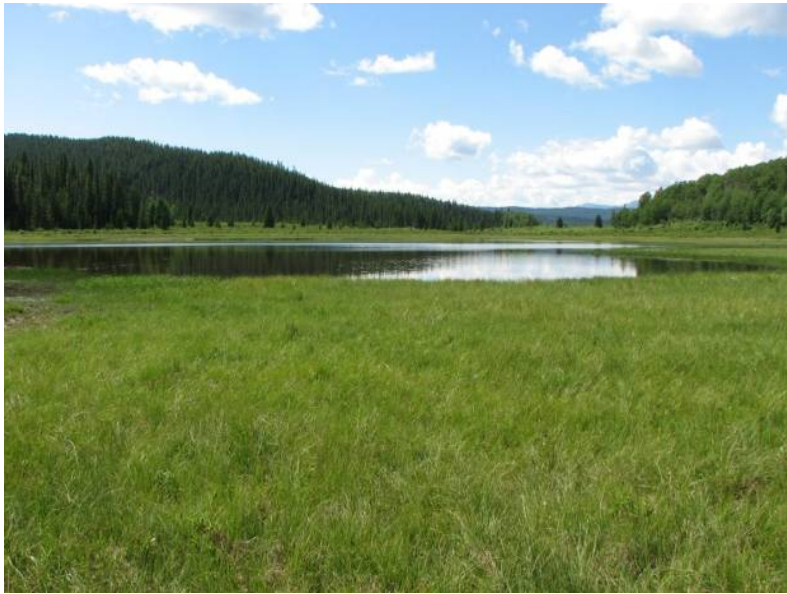
C. Wood, RHIP03AUR003.

Sedge communities dominate the Aura wetland (AUR3) at the headwaters of Aura Creek. This portion of the wetland has not been altered by human activities.

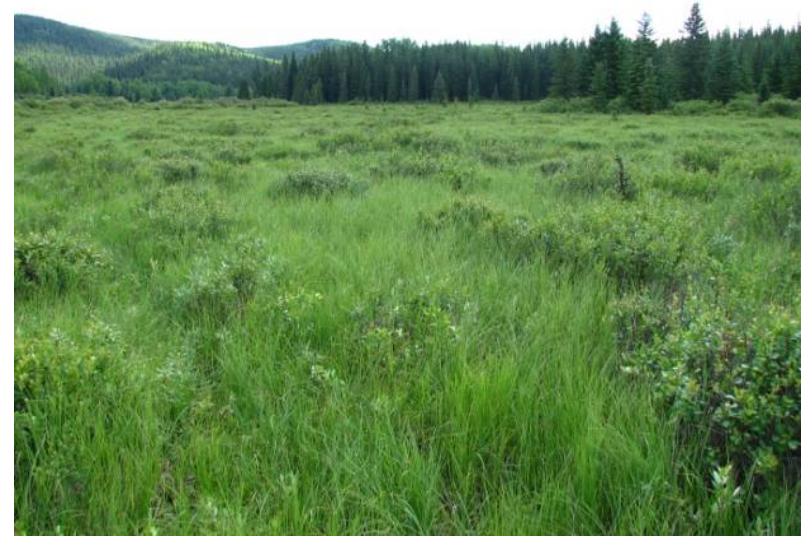
C. Ball, RHIP01AUX004.

Part of the AUR3 wetland and 80% of the AUX1 wetland is comprised of a flat-leaved willow/water sedge Habitat Type as shown here.

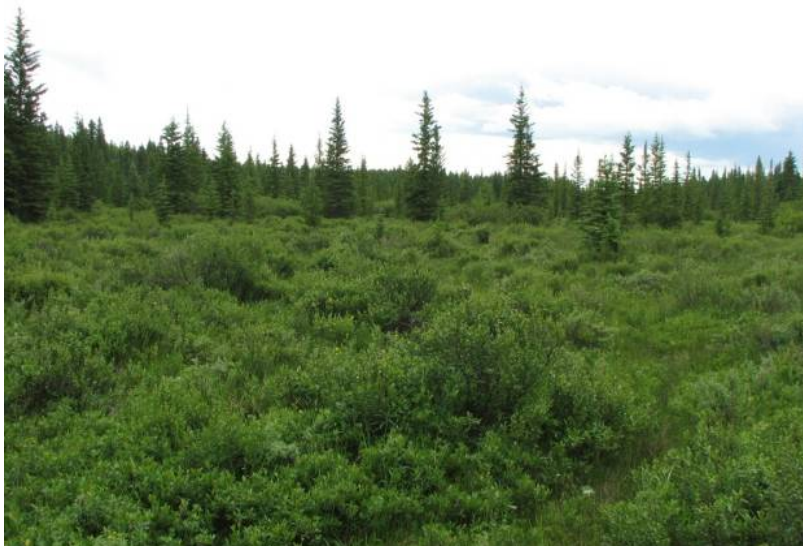
C. Wood, RHIP01AUZ003.

A white spruce community with an understory of willows and bog birch is the dominant community type in the AUZ1 wetland and in 20% of the AUX1 wetland.

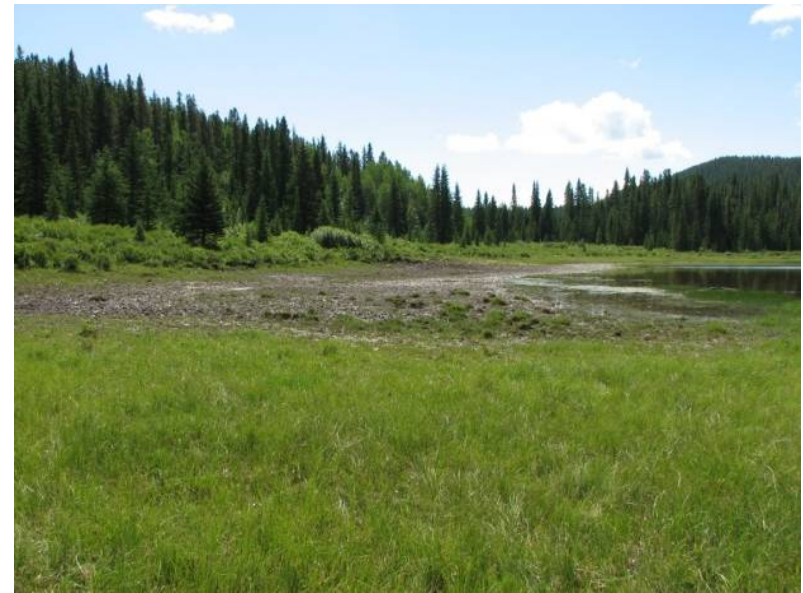
C. Wood, RHIP03AUR002.

Feral and / or domestic horse and livestock use is negatively impacting the health of the Aura wetland (AUR3). Trampling and grazing pressure has caused large areas of bare ground, as shown here, that are susceptible to weed infestation and erosion.
